**BD Jct G-16
2009**

**RICE OPERATING COMPANY
JUNCTION BOX FINAL REPORT**

BD Junction G-16

Unit G, Section 16, T21S, R37E

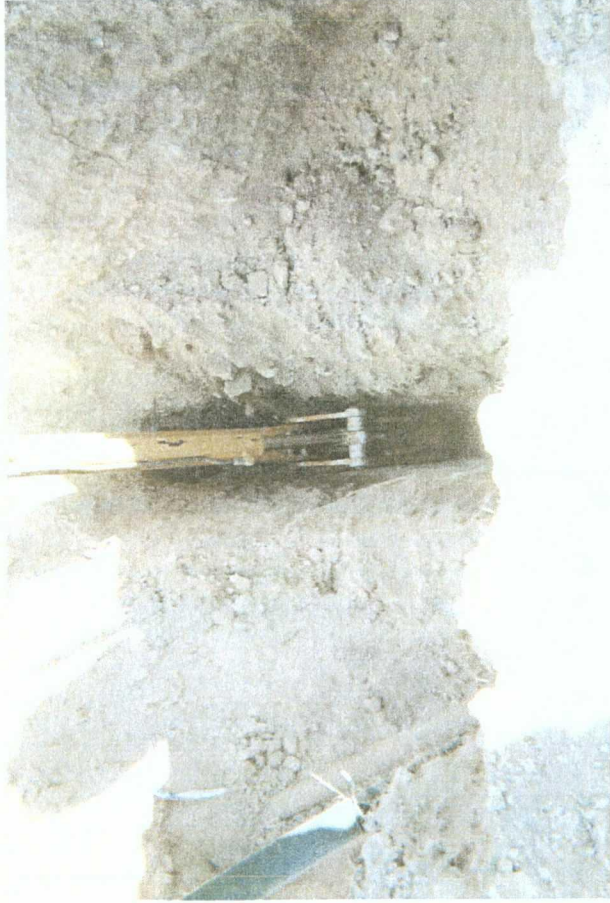
12/17/2009

Delineation trench at former junction box

General Description of Remedial Action: This junction was eliminated under the

pipeline replacement/upgrade program. After the former junction was removed, an

investigation was conducted using a backhoe to collect soil samples at regular intervals.

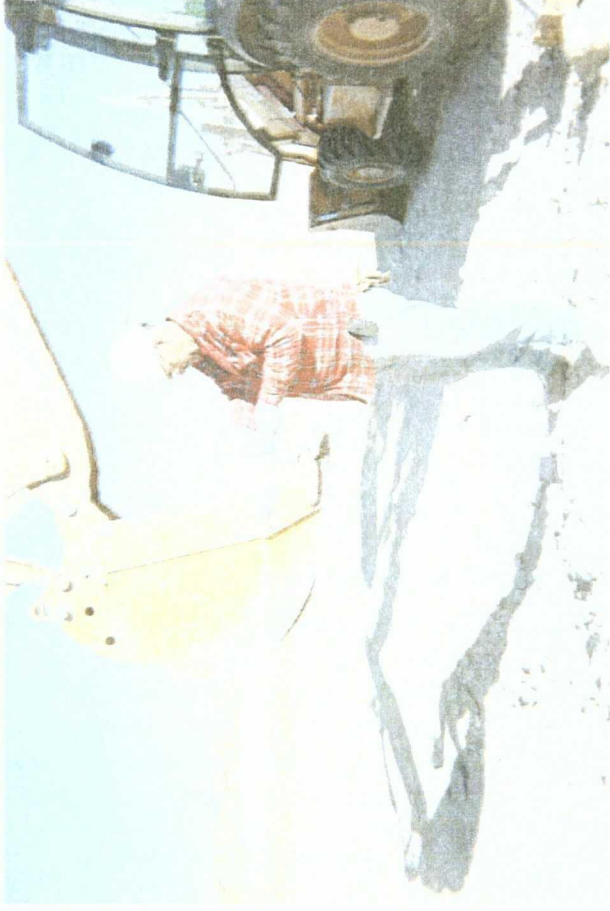
12/17/09

Sample being taken

Chloride field tests were performed on each sample, which yielded low concentrations of

chloride. Organic vapors were measured using a PID, which also yielded low

concentrations. The deepest sample, 12 ft BGS, was sent to a commercial laboratory for analysis, which confirmed low concentrations

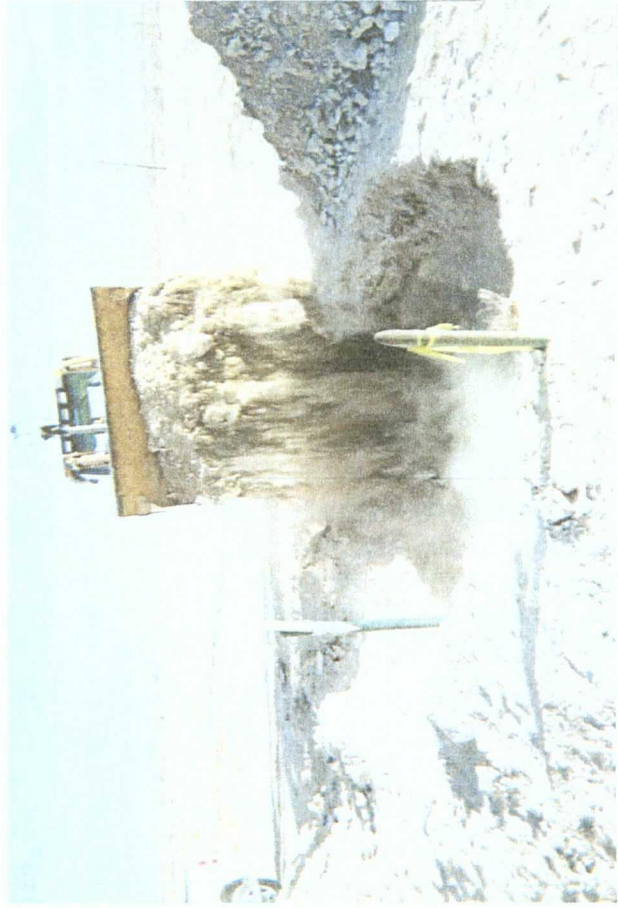
12/21/2009

Backfilling excavation

of chloride and organics. The excavated soil was returned to the excavation to ground surface and contoured to the surrounding area.

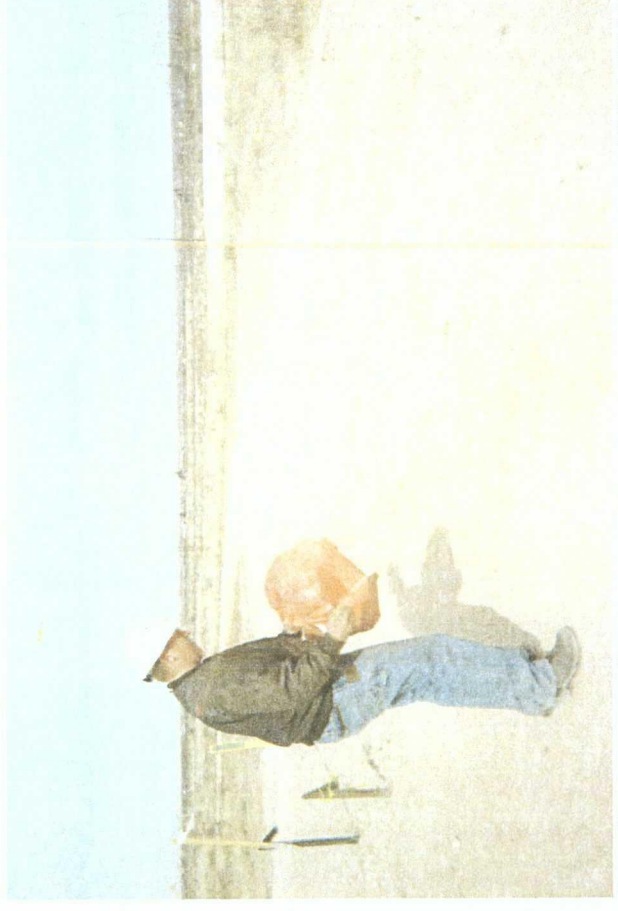
12/21/2009

Seeding excavation

On 12/21/09, site was seeded with a blend of native vegetation and is expected to return to a productive capacity at a normal rate.

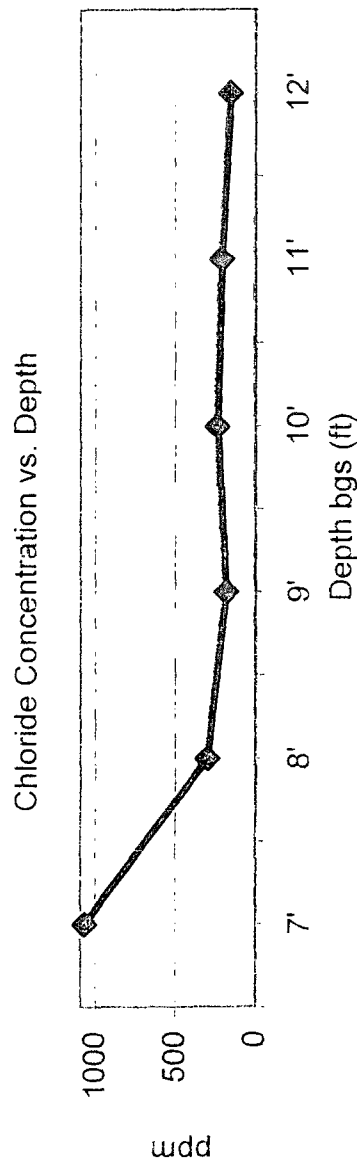
CHLORIDE CONCENTRATION CURVE

Backhoe samples at the junction (source)

Depth bgs (ft)	[Cl ⁻] ppm
7'	1068
8'	296
9'	178
10'	233
11'	203
12'	145

Groundwater = 60 ft
