CLOSURE

**RICE OPERATING COMPANY
JUNCTION BOX FINAL REPORT**

BD Junction H-11

Unit H, Section 11, T22S, R36E

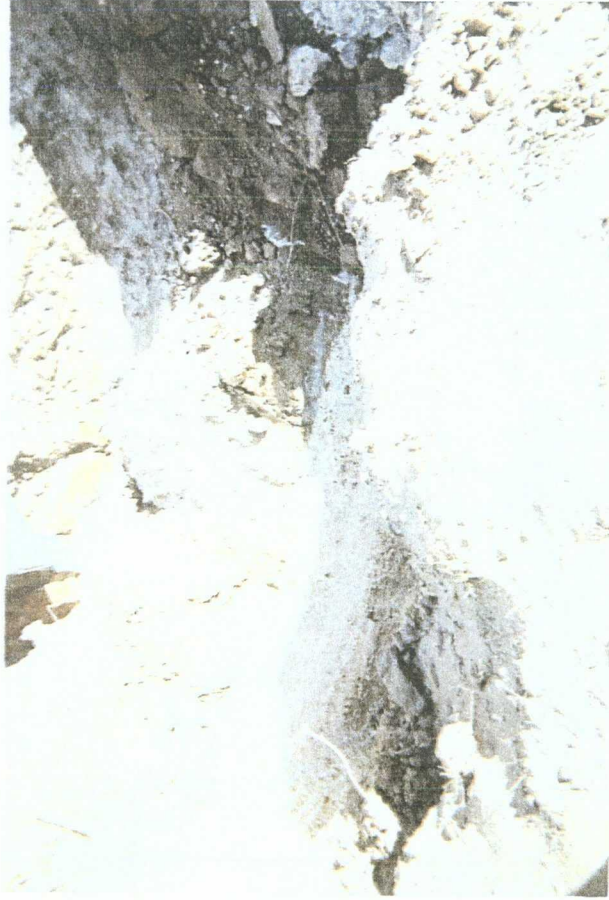
11/17/2009

Delineation trench at former junction box

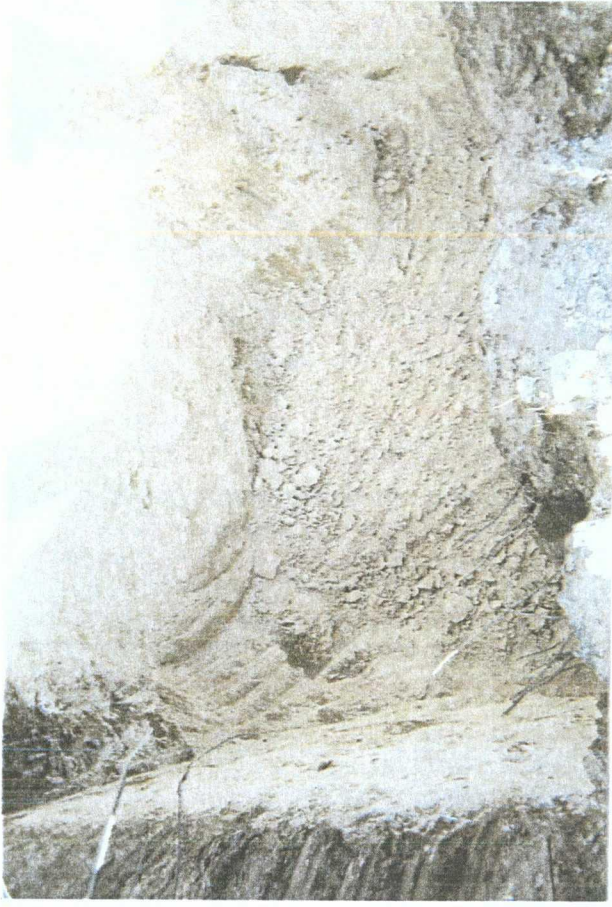
11/19/2009

Excavation complete

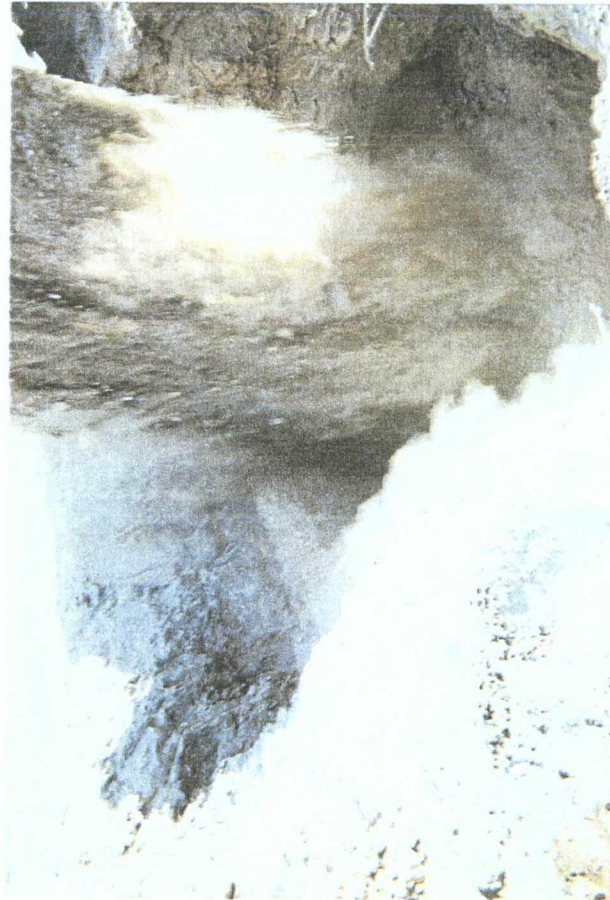
11/25/2009

Backfilling excavation

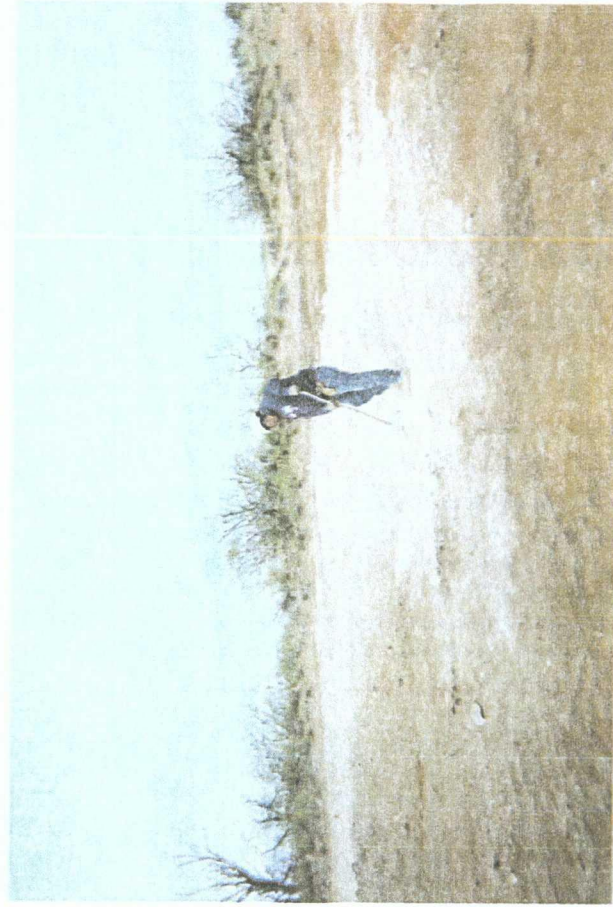
11/30/2009

Seeding location
