FINAL CLOSURE REPORT

BRAHANEY GATHERING SYSTEM

NMOCD REF. 1RP-2484-0

On behalf of Centurion Pipeline, L.P., Environmental Plus, Inc., (EPI) submits the following *Final Closure Report Letter* which addresses remediation of a spill release caused by rupture of a crude oil pipeline. For clarity and cross reference elimination purposes, the *Final Closure Report Letter* offers Site Background history, Emergency Response, Remedial Activities, Analytical Data and Conclusions.

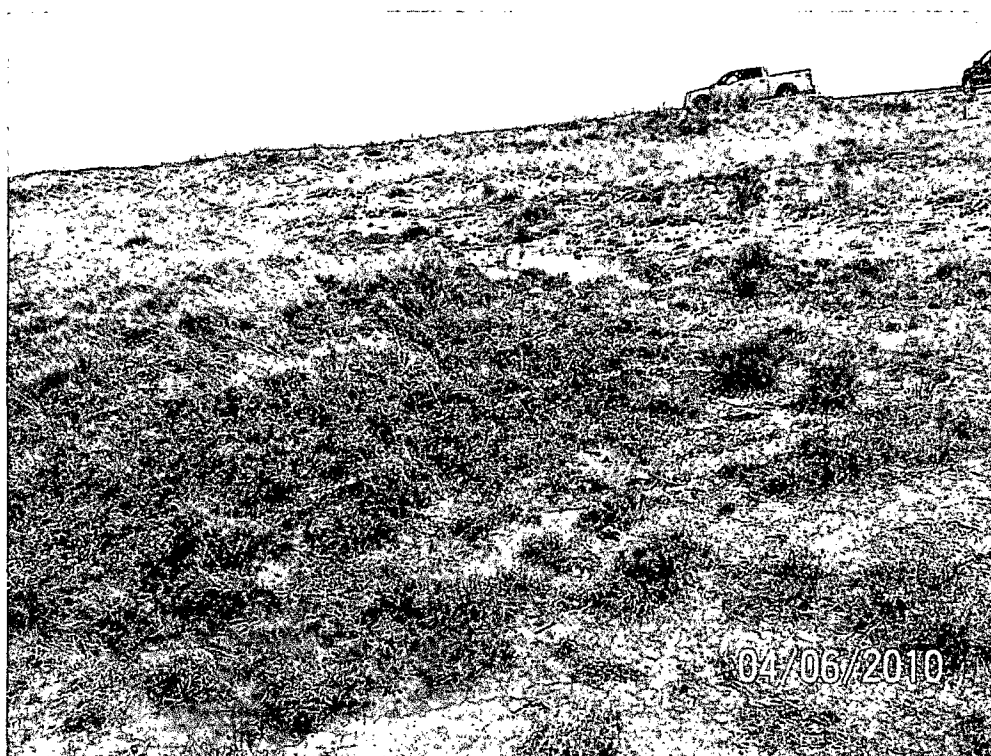
Photograph No. 2 – Looking southwesterly at free standing sweet crude oil

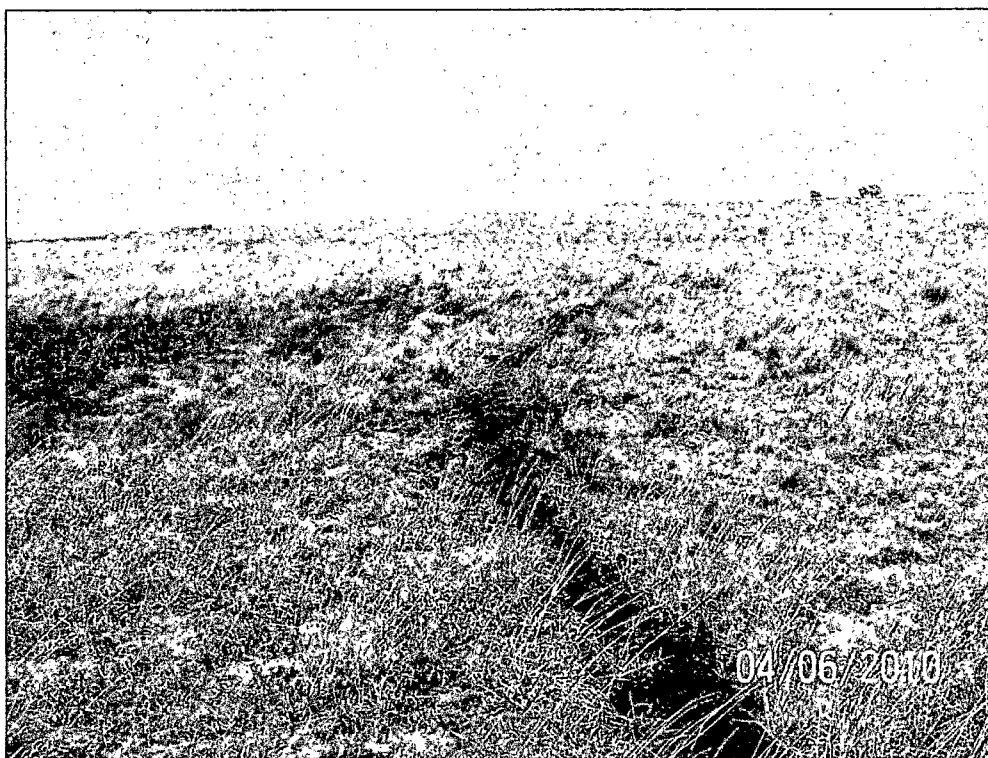
Photograph No. 3 – Looking northerly at sweet crude oil following a trail

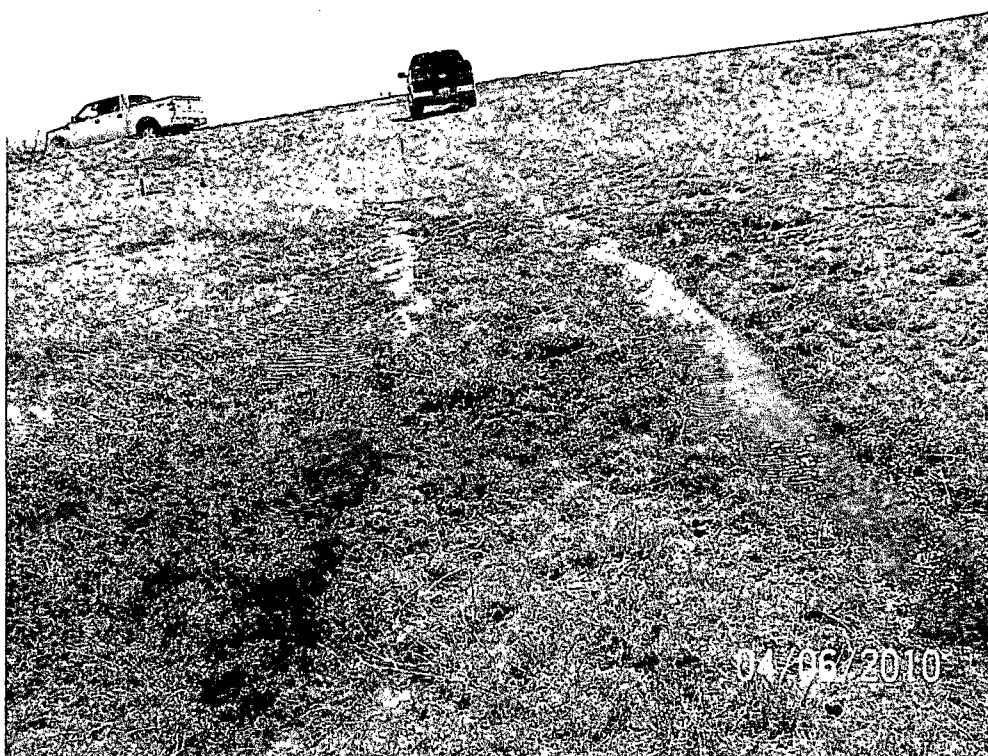
Photograph No. 4 – Looking southerly at free standing sweet crude oil near point of release
