Re: Investigation and Characterization Plan Report & Corrective Action Plan Francis Drive NMOCD Case No. 1R427-211

EME K-6 EOL EME SWD System Rice Operating Company.

This letter-report presents our findings of our field evaluation of soil chloride and TPH levels at the EME K-6 EOL site per the NMOCD ICP approved on September 2<sup>nd</sup>, 2009 and presents a Corrective Action Plan for this project.

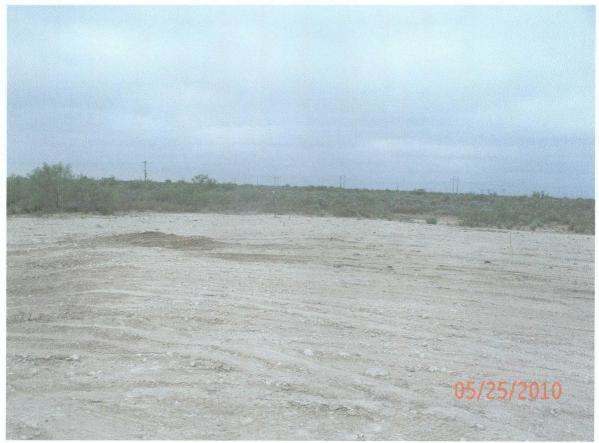
indicate weathered asphaltene that has flowed overland from this former up-source facility (Figures 4a, 4b & 5).

Figure 5 – Site photographs, May 2010.

We submit that relatively low levels of residual soil chlorides found do not pose a risk of causing chloride impacts to groundwater. Nevertheless, as this location has been a relatively high traffic area for oil field vehicles there is a need for surface restoration. We therefore propose a **Corrective Action Plan** with the following work elements:
