RE: ICP REPORT
Rice Operating Company – EME SWD System
EME P-8-3 boot (1R427-231): UL/P sec. 8 T20S R37E

EME P-8-3 boot

Case #: 1R427-231

ICP soil bore installation

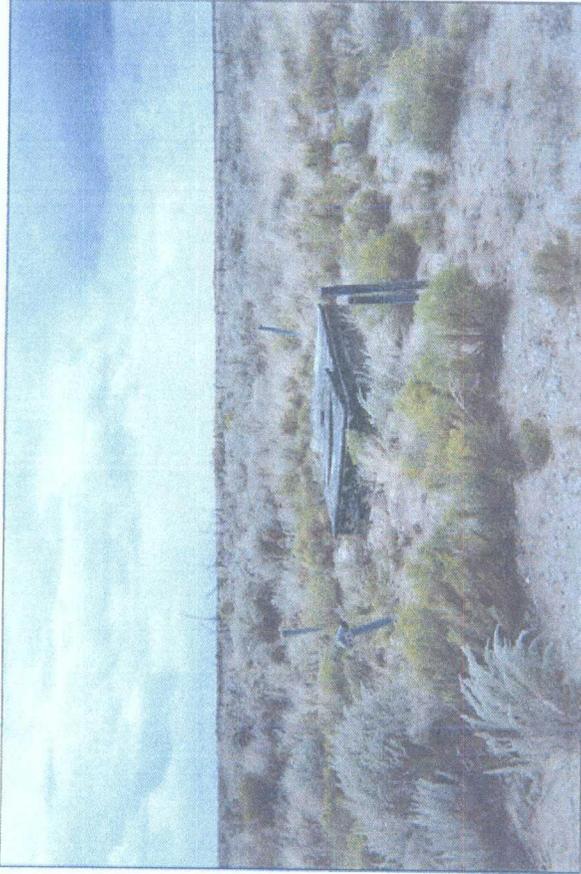
undisturbed junction box during initial investigation

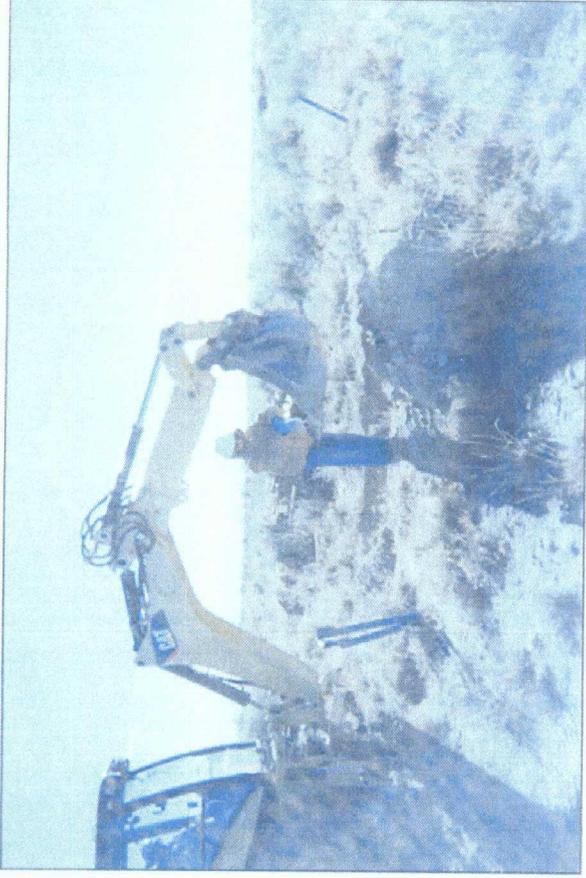
collecting samples from delineation trench

This junction was eliminated with the pipeline replacement/upgrade program. After the box lumber was removed, a vertical delineation trench 15-ft-deep was made at the site using a backhoe. Soil samples were collected at every foot of depth below the pipeline and field tested for chloride and organic vapors. PID screenings resulted in low concentrations (<100 ppm), but chloride concentrations generally increased with depth. A grab sample from the bottom of the trench was collected for laboratory analysis which confirmed TPH (non-detect concentrations) meets NMOCD guidelines. The excavated soil from the trench was taken to a disposal facility and 24 cubic yards of clean, imported soils were used to backfill the trench and spread on the surface. This soil was then seeded with a blend of native vegetation on 12/28/2007. NMOCD was notified of potential groundwater impact at this site on 3/13/2008.

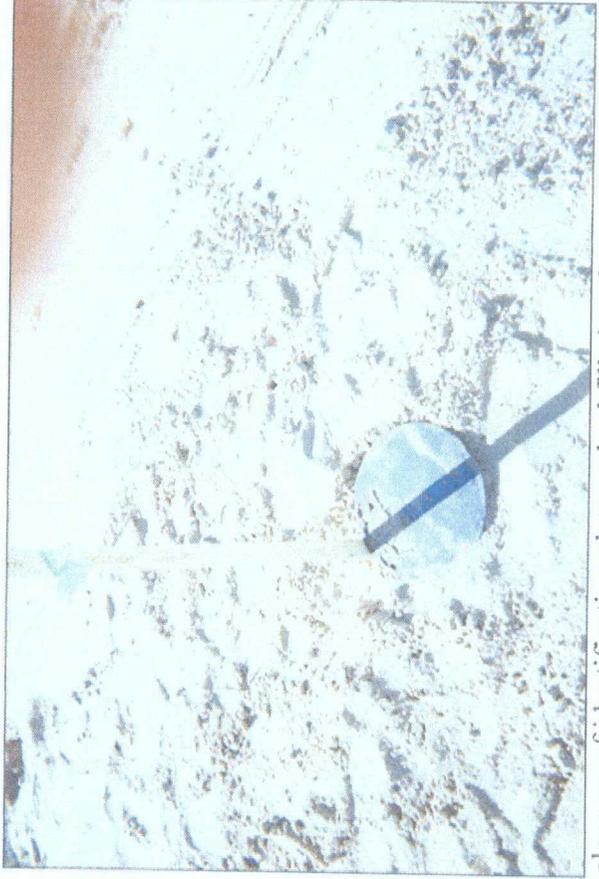
close-up of identification plate on backfilled surface
