EME Jct. H-14

RICE OPERATING COMPANY JUNCTION BOX FINAL REPORT

BOX LOCA	TION					
SWD SYSTEM	JUNCTION	UNIT	SECTION	TOWNSHIP	RANGE	COUNTY	BOX D	IMENSIONS	S - FEET	
Eunice Monument				000	205		Length	Width	Dep	oth
Eumont (EME)	Jct. H-14	Н	14	20S	36E	Lea		Eliminated		
LAND TYPE: E	3LM	STATE	FEE LA	NDOWNER	Jimmie Coope	r etux. Betty-J.T	Trust_OTHER			
Depth to Grour	ndwater	20	feet	NMOC	D SITE AS	SESSMENT	RANKING S	CORE:	20	
Date Started	6/15/	2010	Date Co	mpleted	6/25/2010	OCD	Witness	<u></u>	0	
Soil Excavated	6.7	cubic yar	ds Exc	avation Ler	ngth5	Width	3	Depth	12	fe
Soil Disposed	0	cubic yar	ds Of	fsite Facility	r	v/a	Location		n/a	
			Comm	le Date	6/15/20	10	Sample De	_ 6 L	12 ft

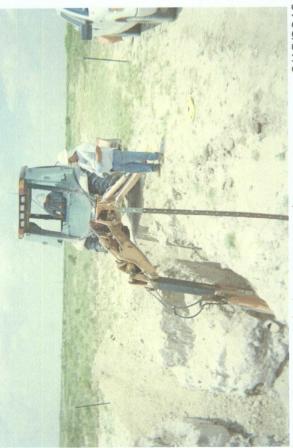
Delineation trench being excavated

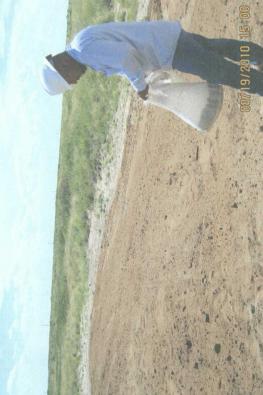
Unit H, Sec. 14, T20S, R36E

6/15/2010

General Description of Remedial Action:	This junction and line were eliminated
during the pipeline replacement/upgrade program.	After the former junction box was
removed, an investigation was conducted using a l	backhoe to collect soil samples at

regular intervals creating a 5x3x12-ft deep excavation. Chloride field tests yielded

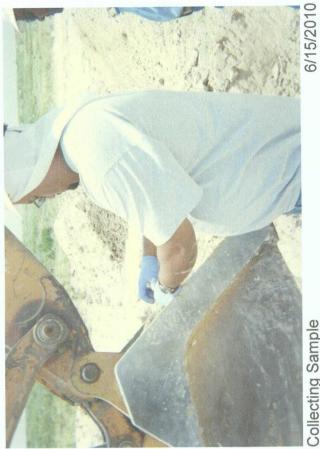
Collecting Sample

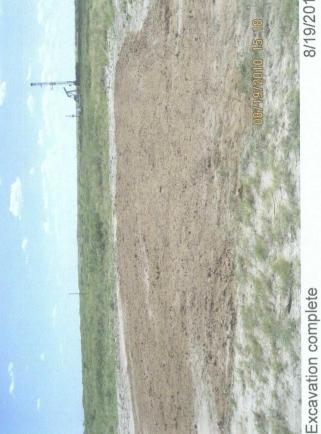
Seeding excavation

seeded with a blend of native vegetation and is expected to return to a productive capacity at a normal rate.

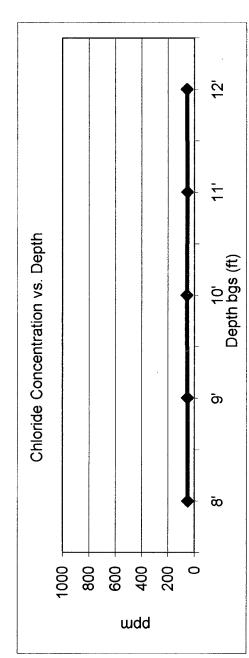
CHLORIDE CONCENTRATION CURVE

Backhoe samples at the junction (source)

[ĊŀĴ ppm	52	54	59	55	58
Depth bgs (ft)	8	6	10'	11'	12'

Groundwater = 20 ft
