**EME Jct. G-20**

**CLOSURE**

RICE OPERATING COMPANY  
JUNCTION BOX FINAL REPORT

SWD SYSTEM	JUNCTION	UNIT	SECTION	TOWNSHIP	RANGE	COUNTY	BOX DIMENSIONS - FEET		
Eunice Monument Eumont (EME)	Jct. G-20	G	20	19S	37E	Lea	Length	Width	Depth
							Eliminated

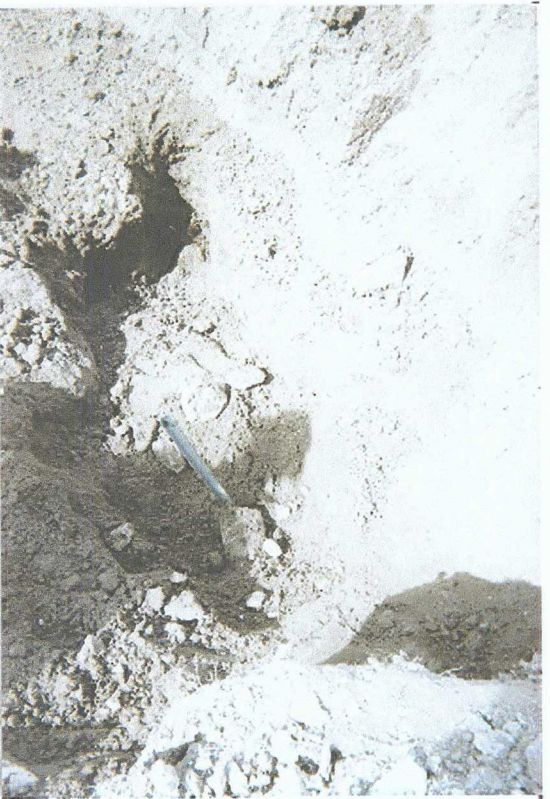
Site prior to delineation

2/25/2010

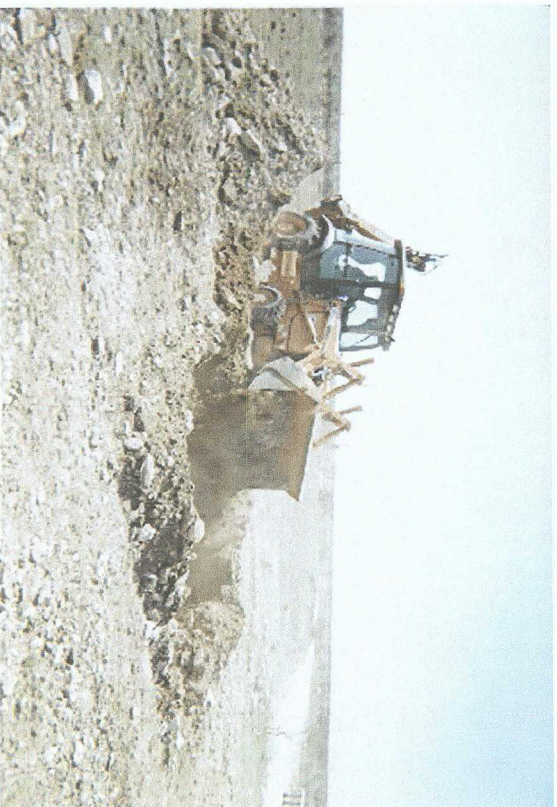
Backfilling excavation

2/25/2010

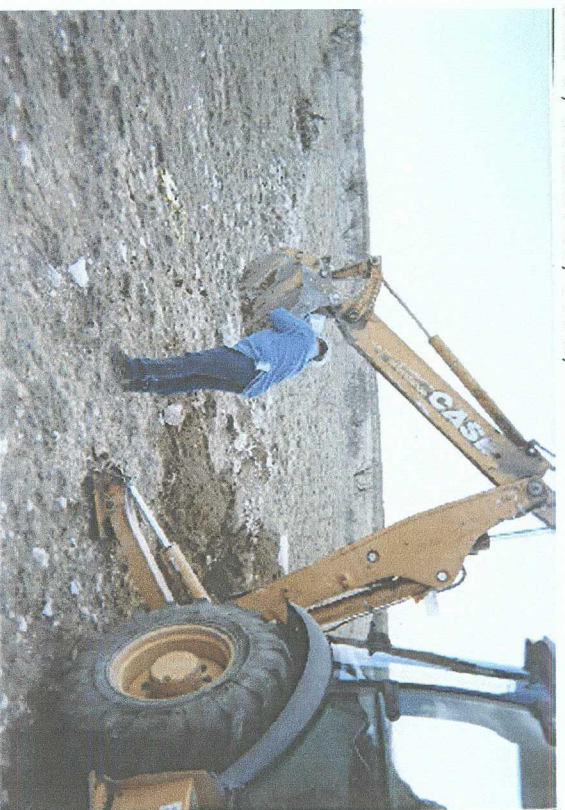
Collecting a sample

2/25/2010

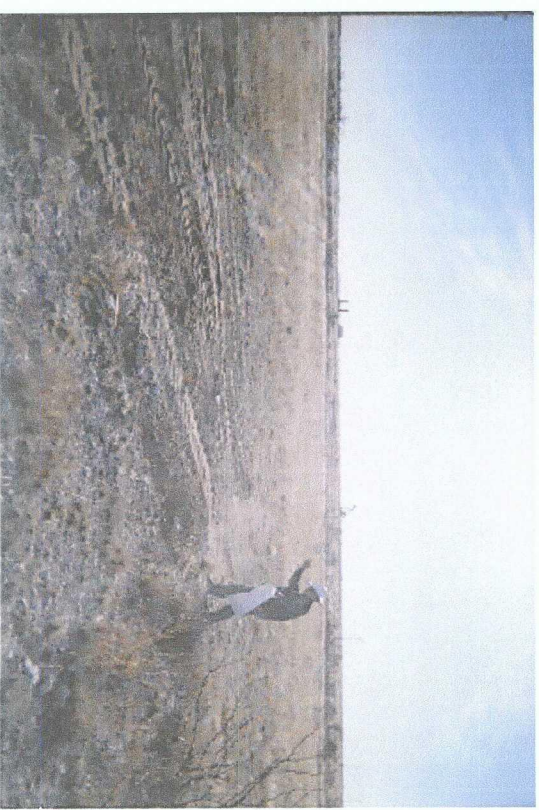
Seeding excavation

11/30/2010
