EME Jct. C-10

CLOSURE

**RICE OPERATING COMPANY
JUNCTION BOX FINAL REPORT**

Unit C, Section 10, T21S, R36E

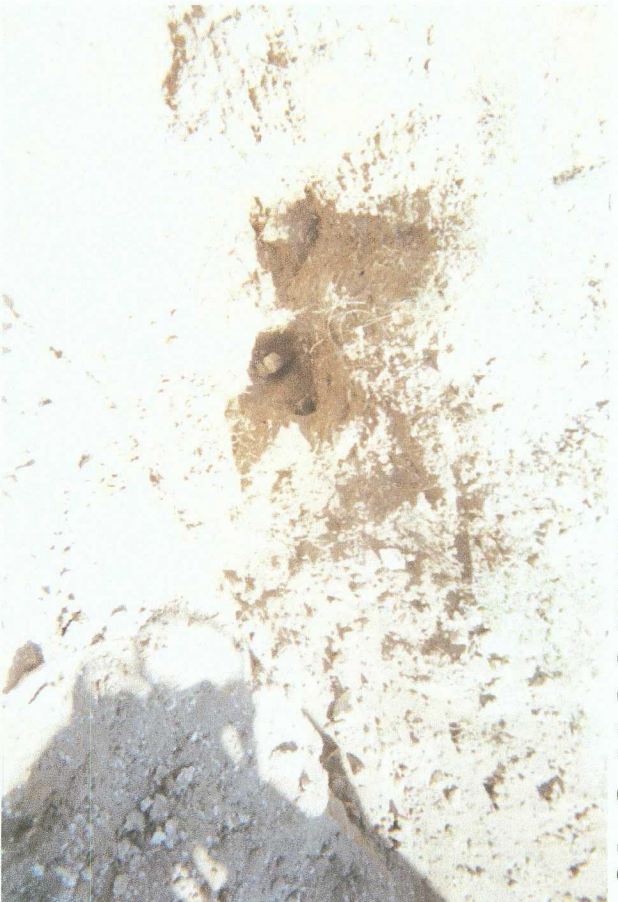
Site Prior to delineation

9/13/2010

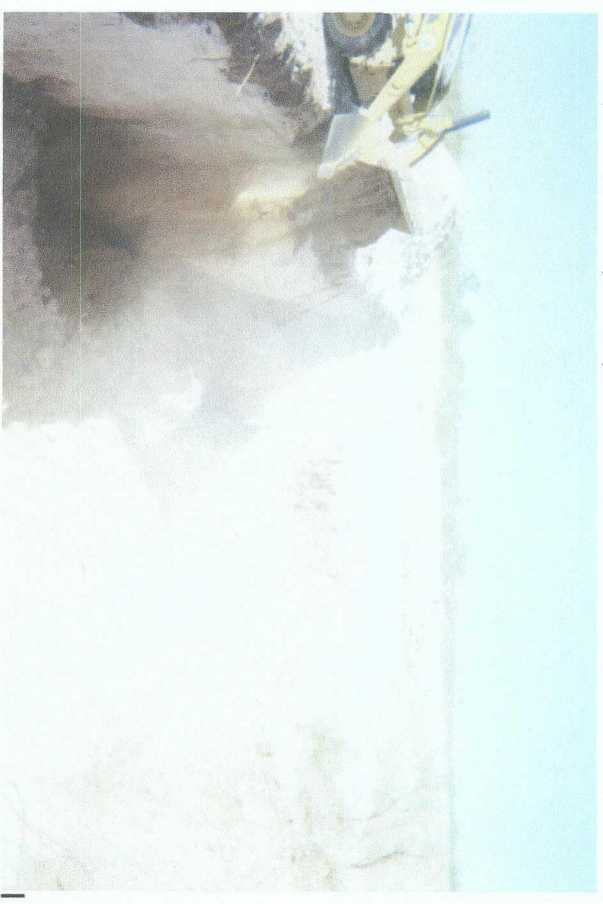
Installing 6" pad below liner

11/02/2010

to an NMOCD approved facility. At 12 ft. below ground surface (BGS) a 20 ml plastic liner was installed with a six inch pad of blow sand

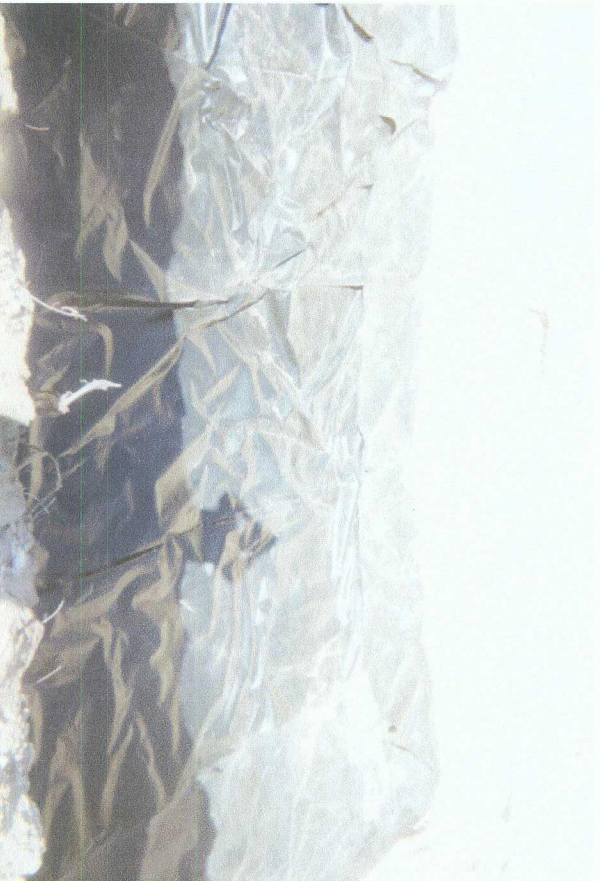
Plastic liner installed

11/02/2010

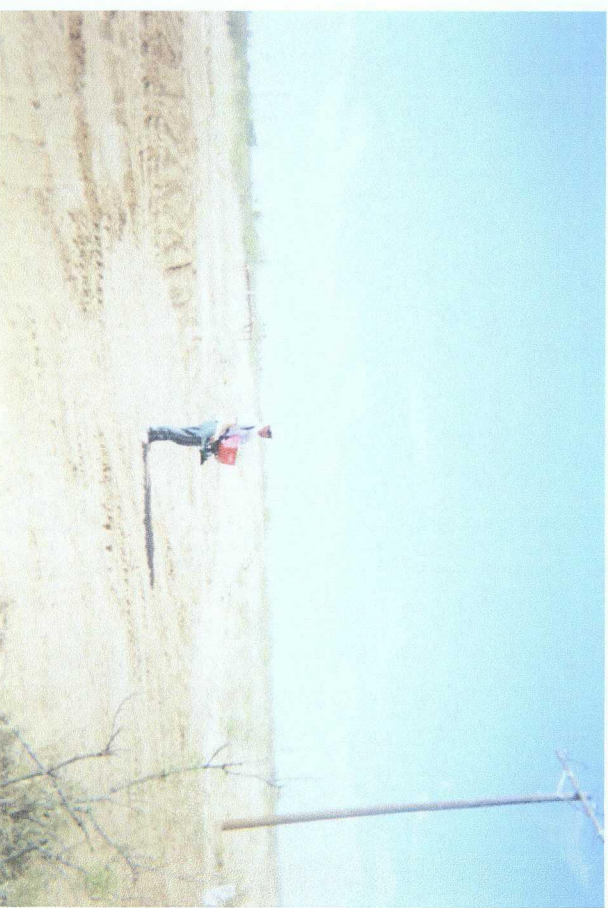
Seeding excavation

11/04/2010

surrounding area. On 11/04/2010, the site was seeded with a blend of native vegetation and is expected to return to a productive
