EME Jct. M-13

CLOSURE

**RICE OPERATING COMPANY
JUNCTION BOX FINAL REPORT**

Unit M, Section 13, T20S, R36E

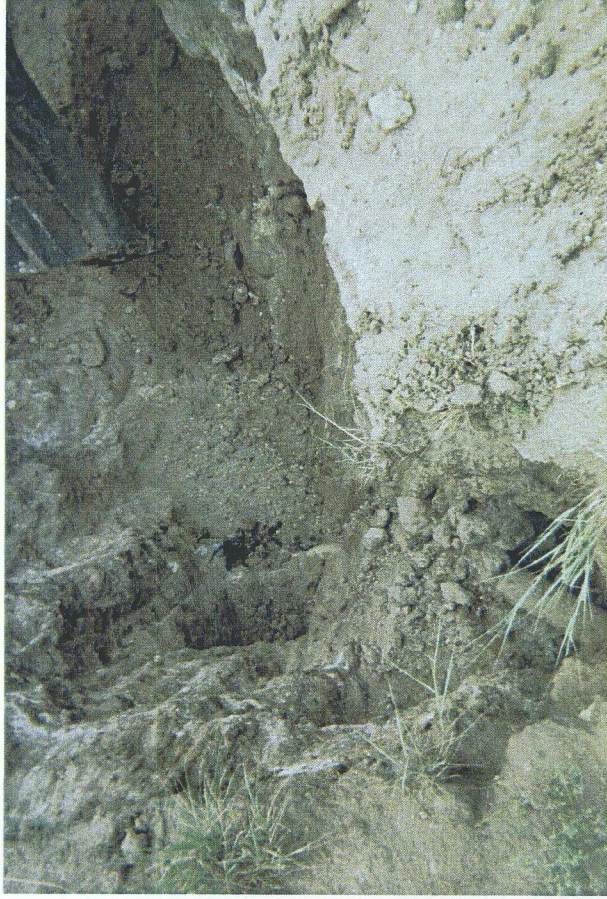
9/17/2010

Site prior to excavating

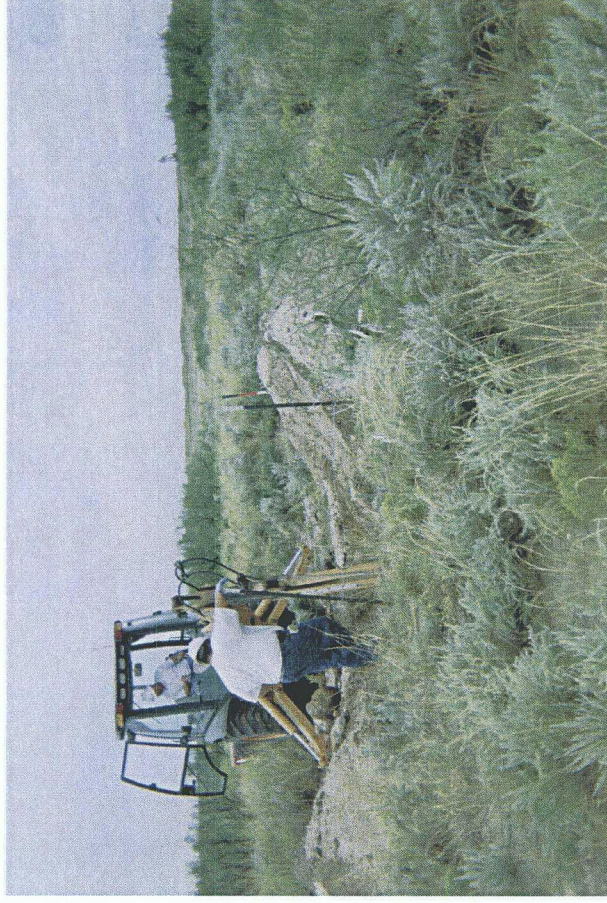
9/17/2010

Delineation trench being excavated

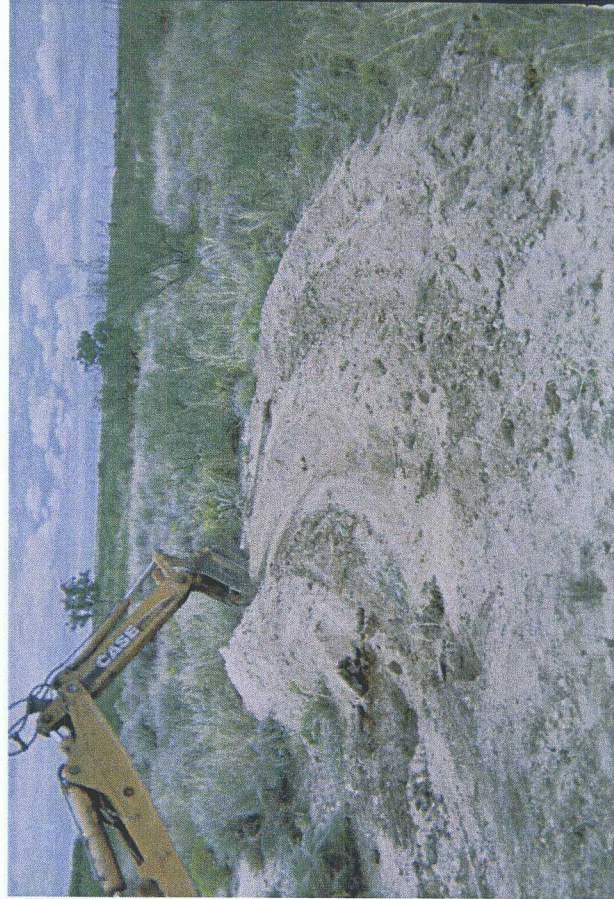
9/17/2010

Backfilling excavation

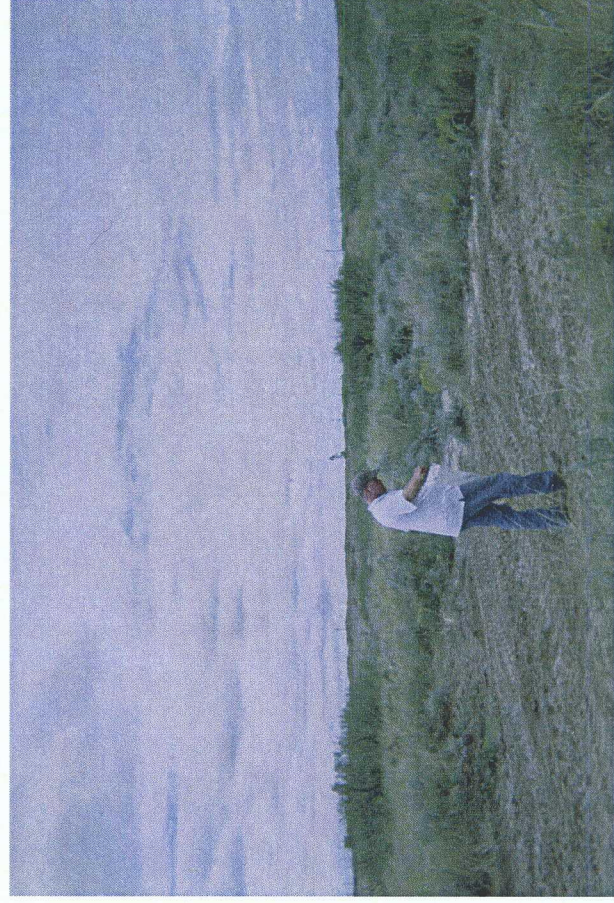
9/17/2010

Seeding excavation

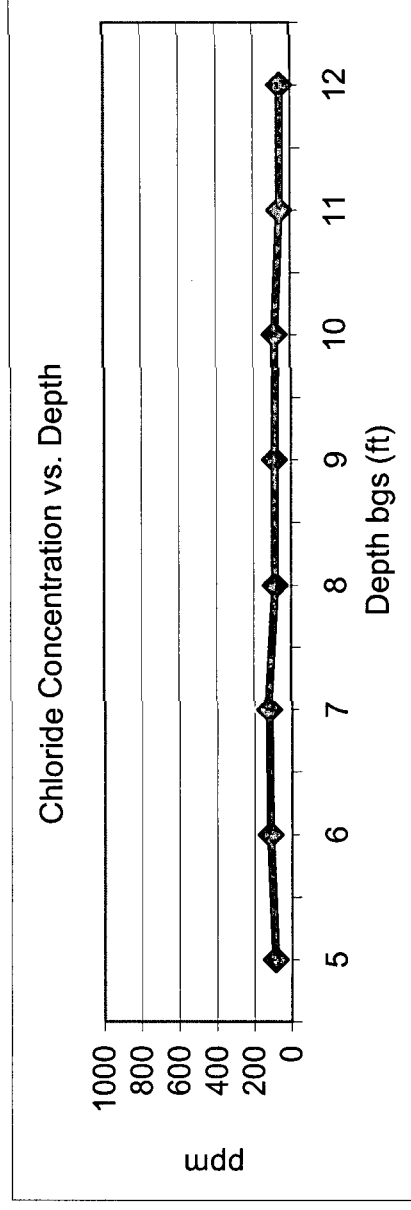
CHLORIDE CONCENTRATION CURVE

Backhoe samples at the junction (source)

Depth bgs (ft)	Cl ⁻ ppm
5	86
6	114
7	120
8	85
9	87
10	83
11	57
12	57

Groundwater = 26 ft.
