EME Jct. O-25

CLOSURE

**RICE OPERATING COMPANY
JUNCTION BOX FINAL REPORT**

Unit O, Section 25, T20S, R36E

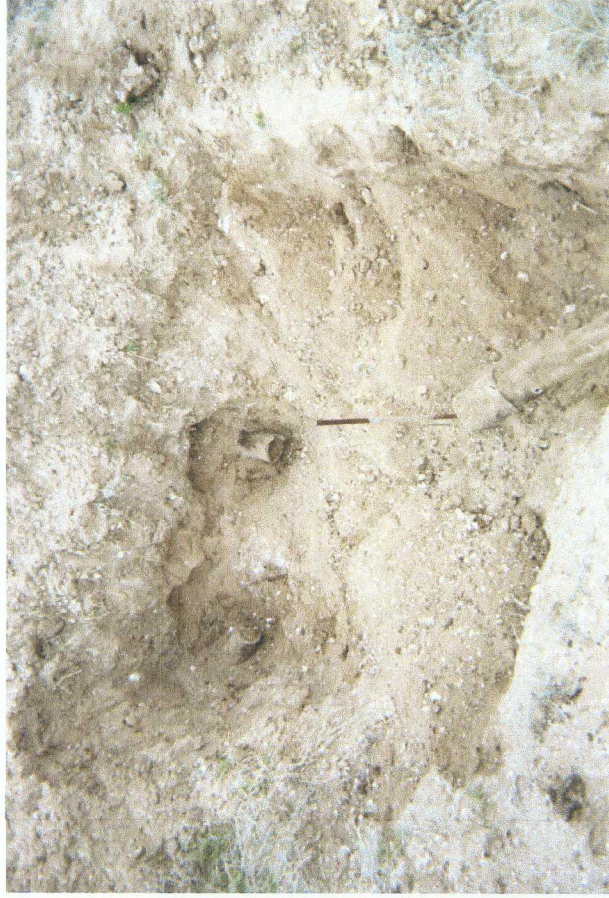
4/1/2010

Site prior to excavation

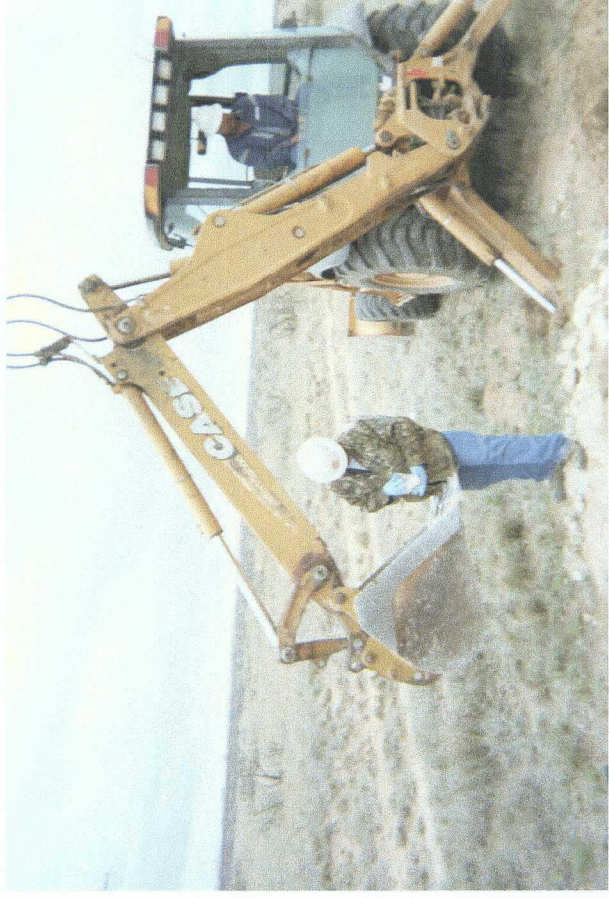
4/13/2010

Collecting a soil sample

removed, an investigation was conducted using a backhoe to collect soil samples at

regular intervals producing a 5x3x7-ft-deep excavation. Chloride field tests performed on

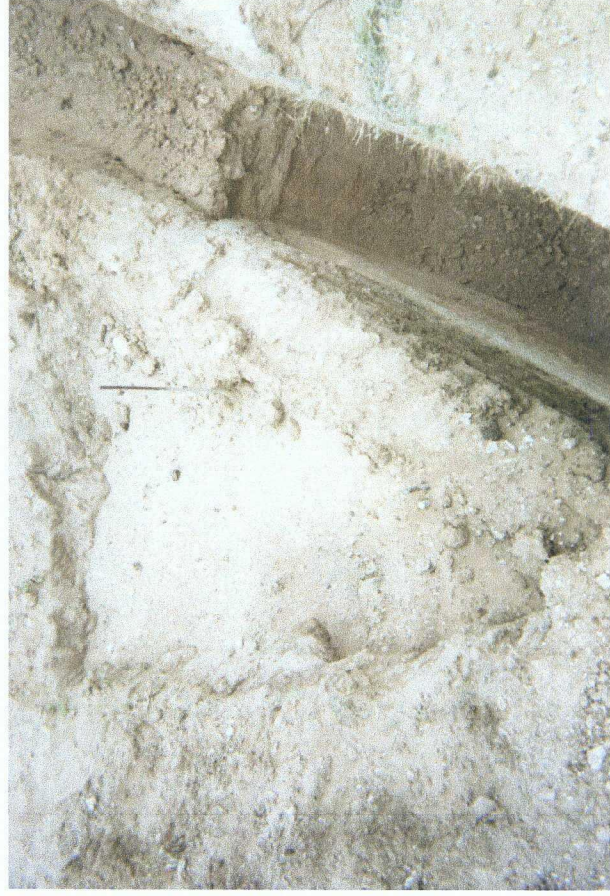
Final excavation 5x3x7 4/13/2010

each sample yielded low concentrations similar to that of the background. Organic vapors were measured using a PID and also yielded

low concentrations. The deepest sample, 7 ft. BGS was analyzed by a commercial laboratory which confirmed low concentrations. The

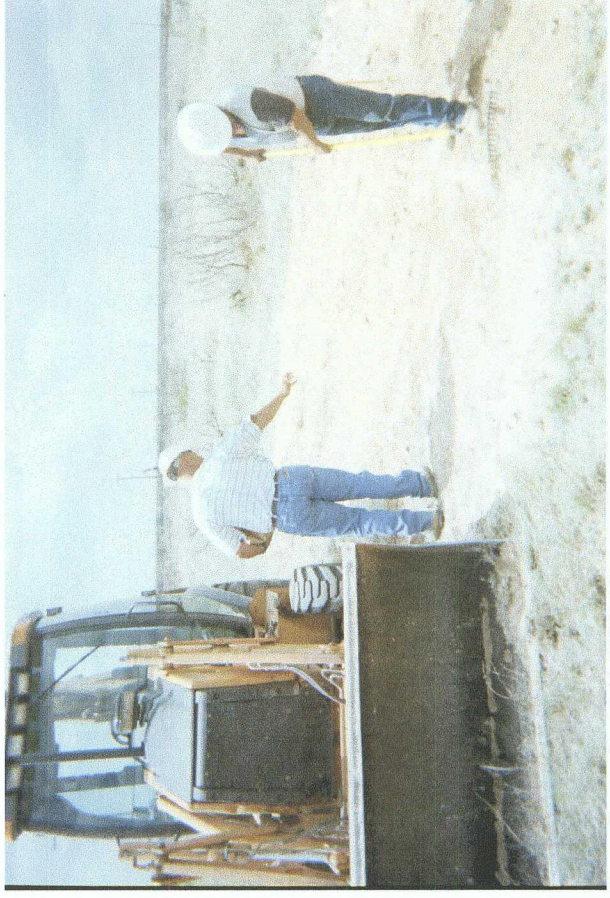
Seeding site 4/13/2010

excavated soil was returned to the excavation to ground surface and contoured to the surrounding area. On 4/13/2010, the site was

seeded with a blend of native vegetation and is expected to return to a productive capacity at a normal rate.
