BD D-18 EOL

CLOSURE

RICE OPERATING COMPANY
JUNCTION BOX FINAL REPORT

Unit D, section 18, T22S, R37E

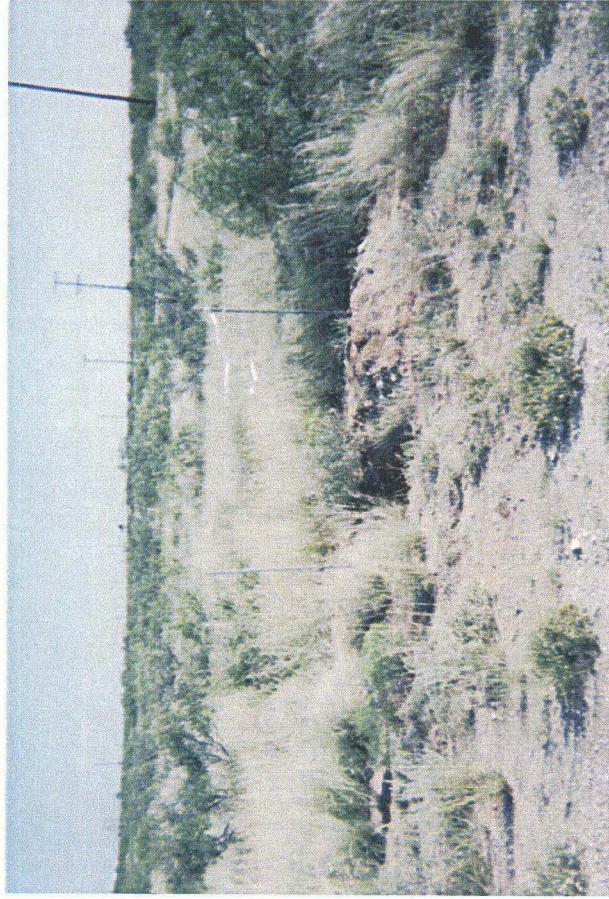
Site prior to excavation

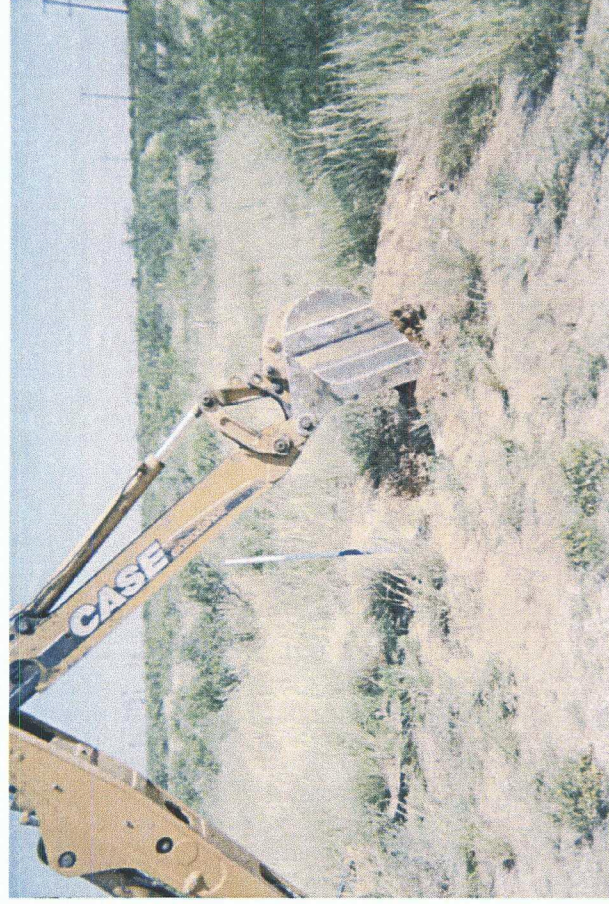
Delineation trench being excavated

General Description of Remedial Action: This junction and line were eliminated during the pipeline replacement/upgrade program. After the former junction box was removed, an investigation was conducted using a backhoe to collect soil samples at regular intervals creating a 6x2x12-ft deep excavation. Chloride field tests yielded low concentrations similar to that of the background. Organic vapors were measured using a PID, which yielded low concentrations. The deepest sample, 12 ft. bgs, was sent to a commercial laboratory for analysis of chloride and TPH, which confirmed low concentrations of each. The excavated soil was returned to the excavation to ground surface and contoured to the surrounding area. On 8/20/2010, the site was seeded with a blend of native vegetation and is expected to return to a productive capacity at a normal rate.

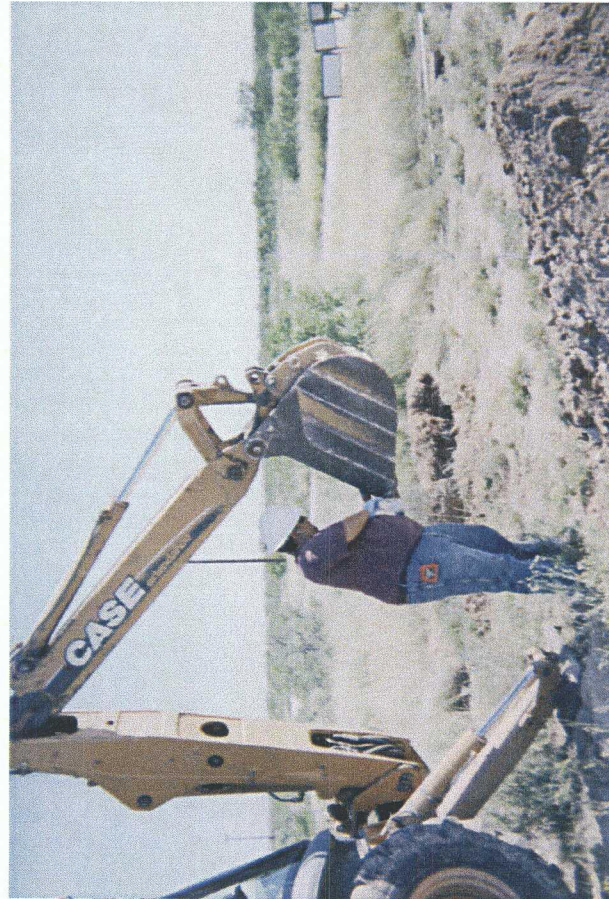
Sample being taken

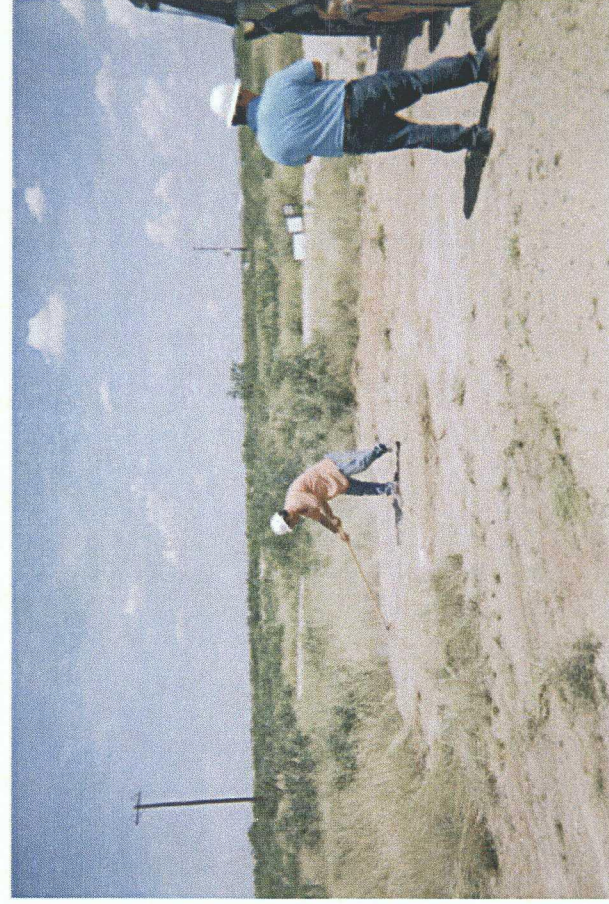
Site complete seeded and raked
