BD Jct. A-11-2

CLOSURE

**RICE OPERATING COMPANY
JUNCTION BOX FINAL REPORT**

Unit A, Section 11, T22S, R37E

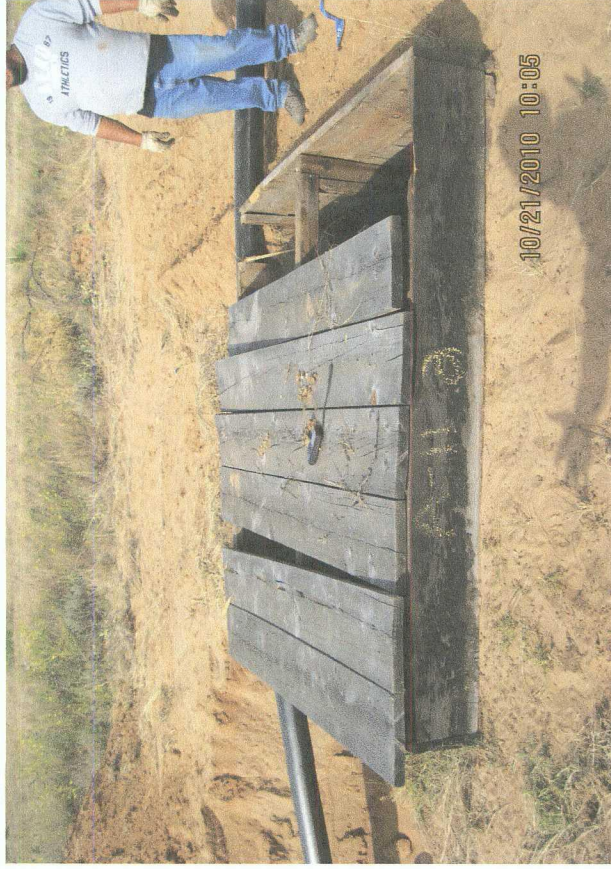
10/21/2010

Site prior to delineation

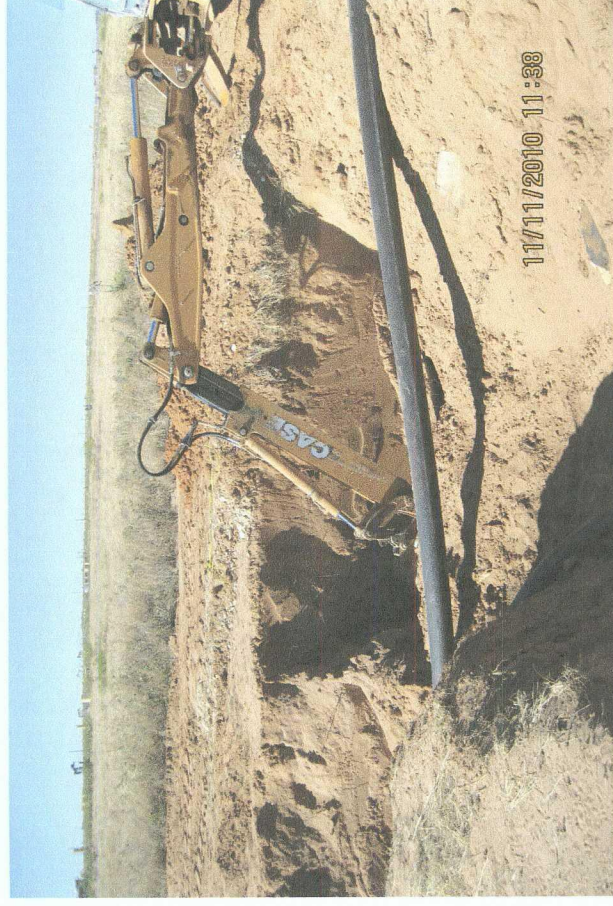
10/21/2010

the pipeline replacement/upgrade program. After the junction box was removed, an investigation was conducted using a backhoe to collect soil samples at regular intervals

creating a 30X15X14-ft. deep excavation. Chloride field tests performed on each

Delineation trench being excavated

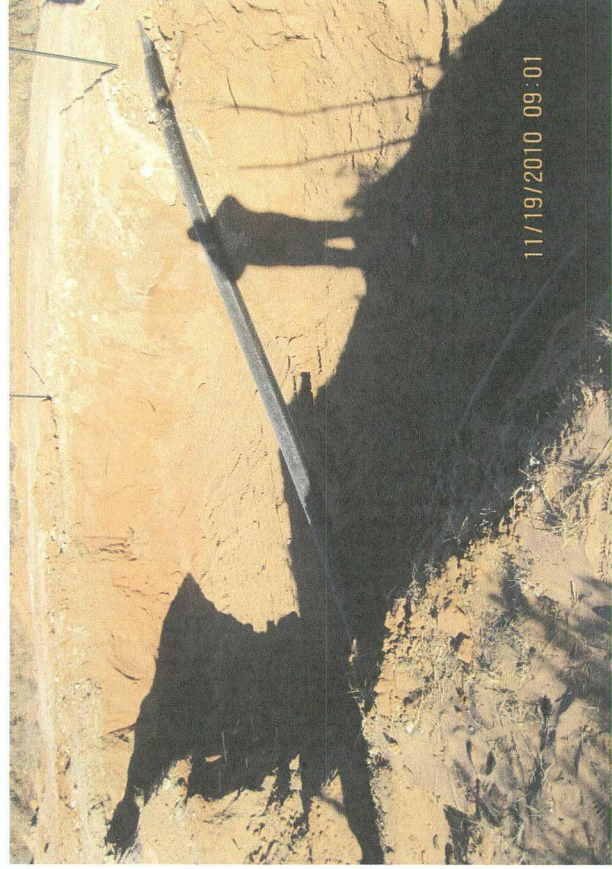
11/19/2010

Site backfilled

excavated soil was blended on site and representative samples were collected from the blended backfill, the bottom of the excavation,

confirmed low concentrations of each. The excavation was backfill to 5 ft. below ground surface (BGS). A new water tight junction box was built in the same location.

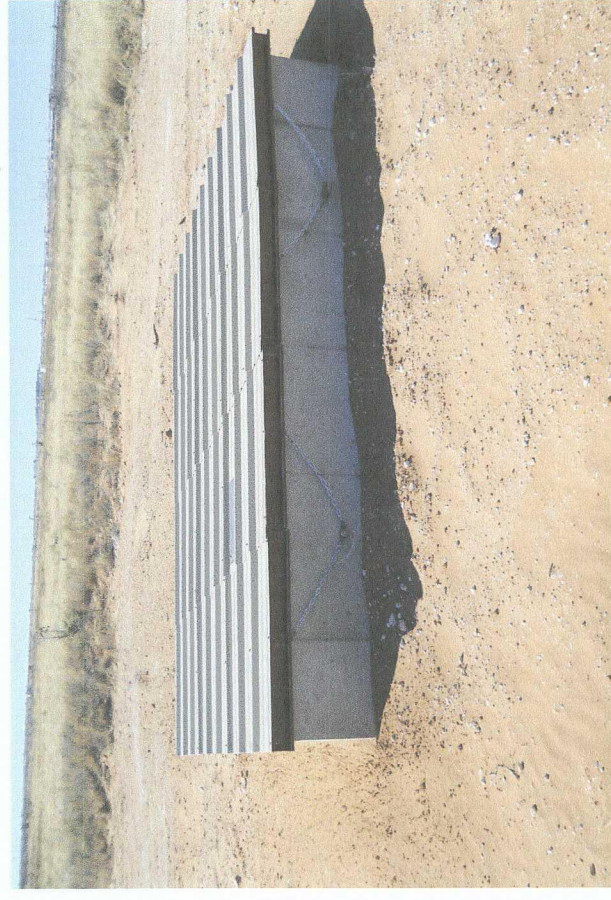
2/23/2011

New water tight junction box

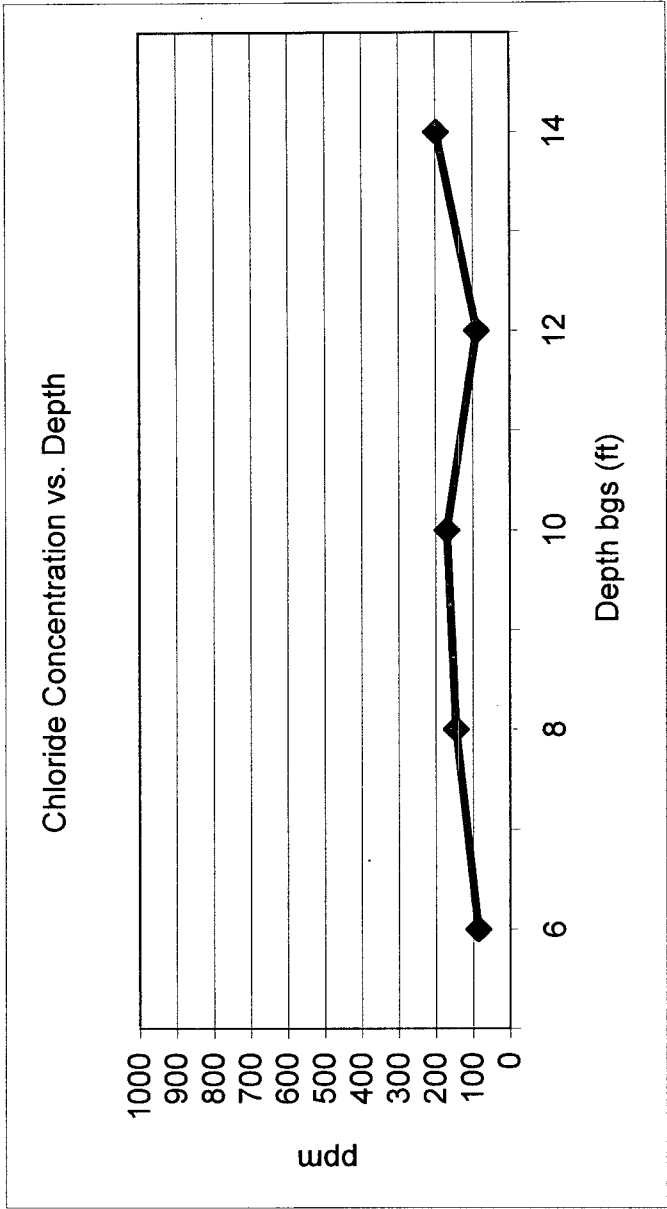
BD Jct. A-11-2

Backhoe samples 5 ft. south of the junction (source)

Depth bgs (ft)	[Cl ⁻] ppm
6	86
8	146
10	170
12	89
14	198

Groundwater = 59 ft.

LOCATION	DEPTH	mg/kg
4-wall comp.	n/a	265
bottom comp.	12'	513
backfill comp.	n/a	357
background	6"	144
vertical delineation at 5 ft. south of junction (source)	6'	86
	8'	146
	10'	170
	12'	89
	14'	198
