**BD H-7 EOL**

**RICE OPERATING COMPANY  
JUNCTION BOX FINAL REPORT**

Unit H, Section 7, T22S, R38E

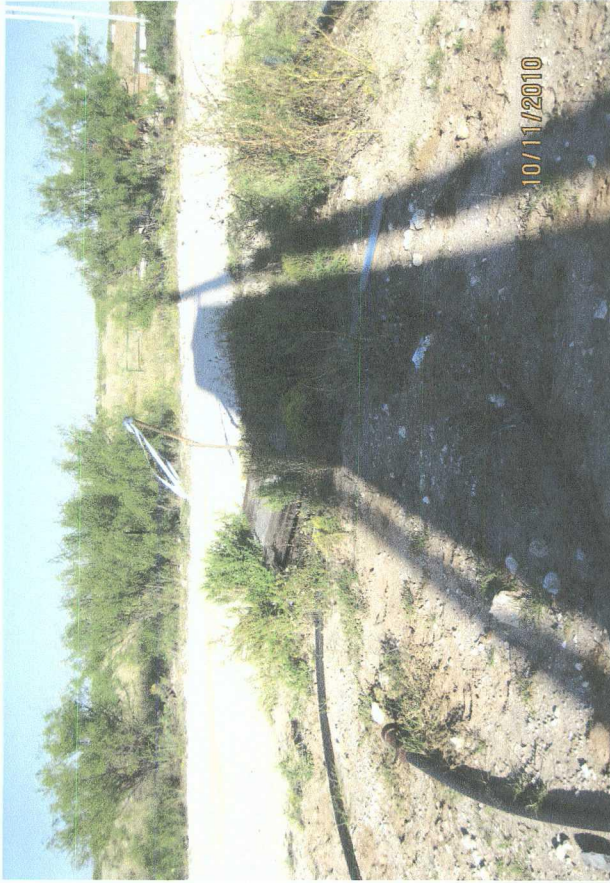
10/11/2010

Site prior to excavation

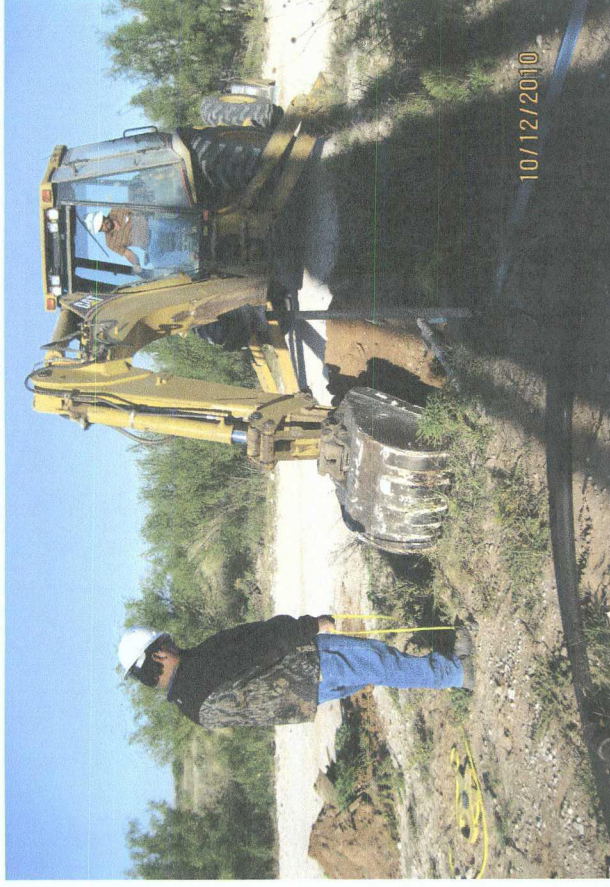
10/12/2010

Delineation trench being excavated

**General Description of Remedial Action:** This junction was eliminated during the pipeline replacement/upgrade program. After the former junction box was removed, an investigation was conducted using a backhoe to collect samples at regular intervals producing a 7X2X12-ft. deep excavation. Chloride field test performed on each sample yielded low concentrations. Organic vapors were measured using a PID, which yielded low concentrations. The deepest sample, 12 ft. BGS, was sent to a commercial laboratory for analysis of chloride and TPH, which confirmed low concentrations of each. The excavated soil was returned to the excavation to ground surface and contoured to the surrounding area. On 3/04/2011, the site was seeded with a blend of native vegetation and is expected to return to a productive capacity at a normal rate.

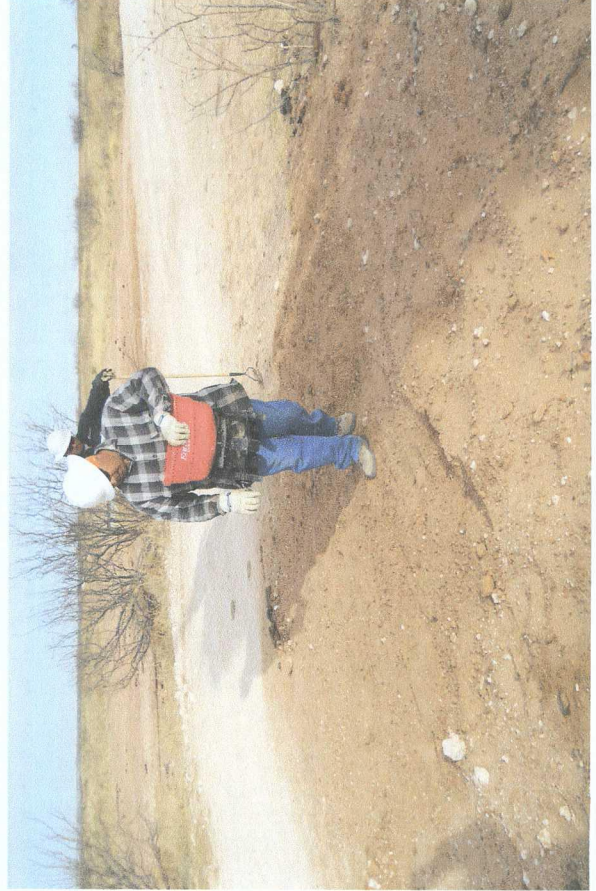
3/04/2011

Seeding excavation

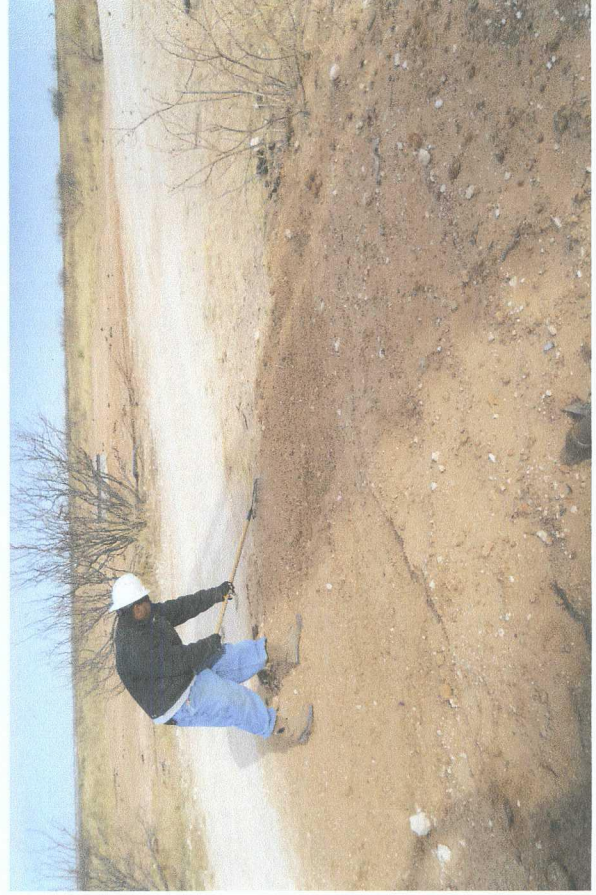
3/04/2010

Raking in seed
