**RICE OPERATING COMPANY
JUNCTION BOX FINAL REPORT**

SWD SYSTEM	JUNCTION	UNIT	SECTION	TOWNSHIP	RANGE	COUNTY	BOX DIMENSIONS - FEET		
Blaineby-Drinkard (BD)	E-25-EOL	E	25	22S	37E	Lea	Length 6 ft.	Width 4 ft.	Depth 3 ft.
							Eliminated

BD E-25 EOL

Unit E, Section 25, T22S, R37E

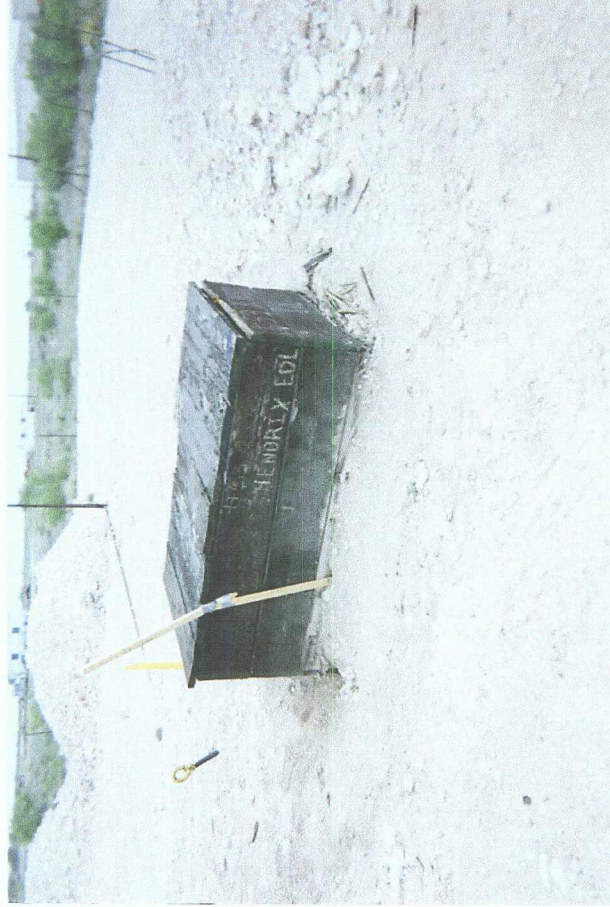
Site prior to excavation

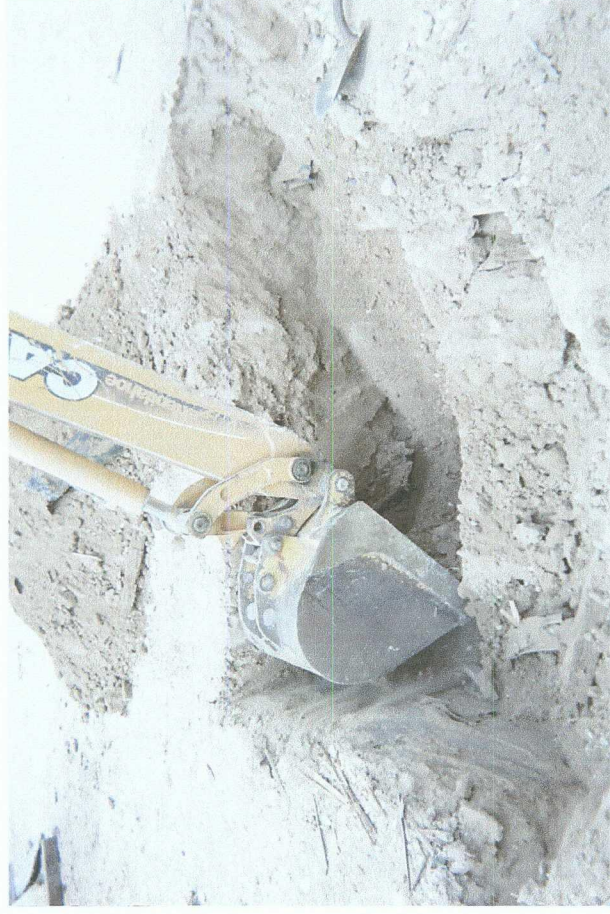
Delineation trench being excavated

General Description of Remedial Action: This junction and line were eliminated during the pipeline replacement/upgrade program. After the former junction box was removed, an investigation was conducted using a backhoe to collect soil samples at regular intervals creating a 5x3x8-ft deep excavation. Chloride field tests yielded low concentrations similar to that of the background. Organic vapors were measured using a PID, which yielded low concentrations. The deepest sample, 8 ft. bgs, was sent to a commercial laboratory for analysis of chloride and TPH, which confirmed low concentrations. The excavated soil was returned to the excavation to ground surface and contoured to the surrounding area. This site was not seeded due to location on caliche pad.

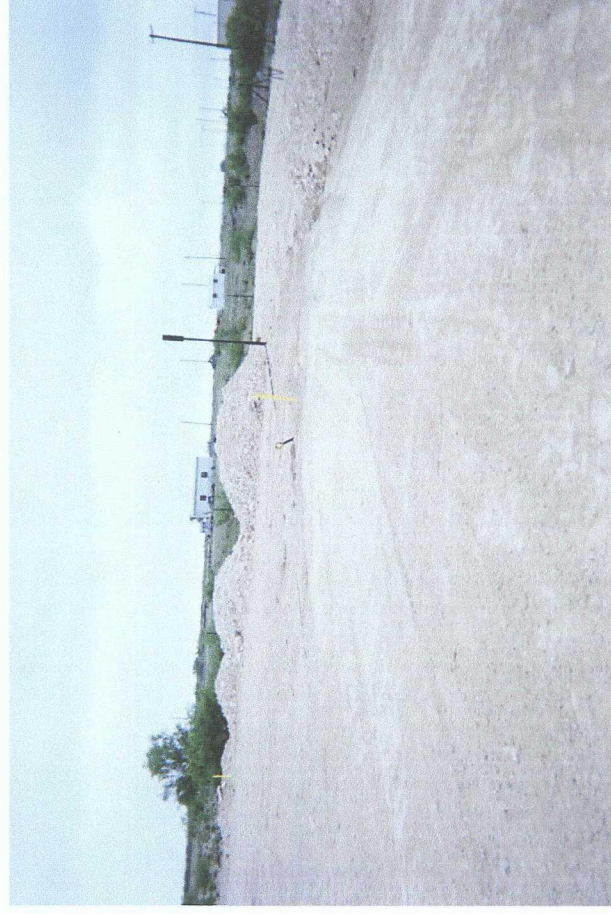
Site complete

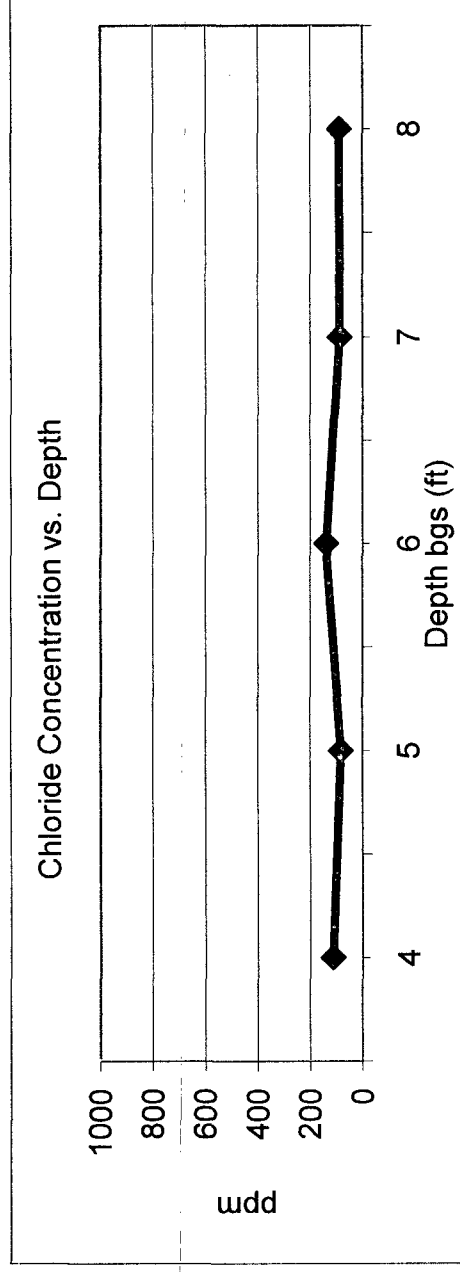
Backhoe samples at the junction (source)

Depth bgs (ft)	[Cl ⁻] ppm
4	114
5	83
6	141
7	88
8	91

Groundwater = 49 ft.
