BD L-7 Vent

CLOSURE

**RICE OPERATING COMPANY
JUNCTION BOX FINAL REPORT**

Unit L, Section 7, T21S, R38E

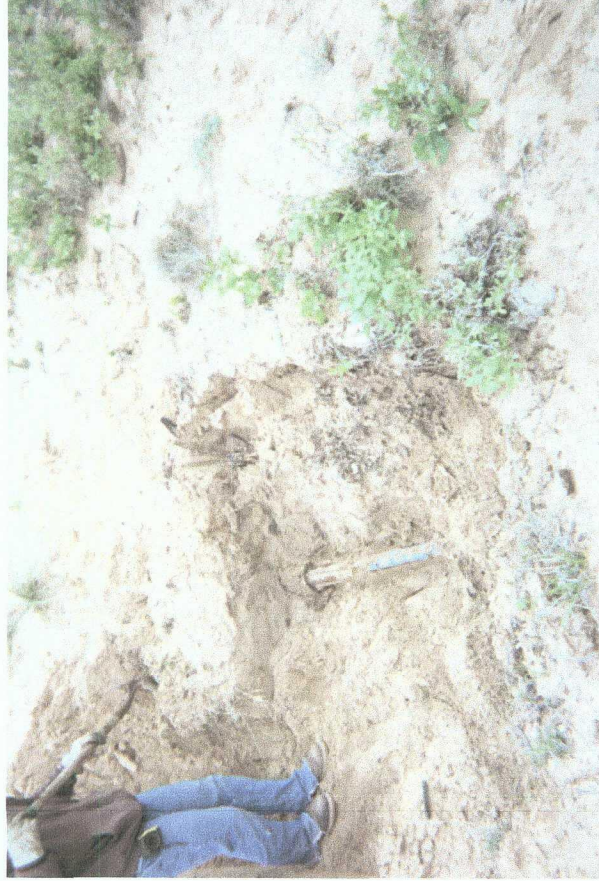
4/19/2010

Site prior to excavation

General Description of Remedial Action: This junction was eliminated during the pipeline replacement/upgrade program. After the former junction box was removed, an investigation was conducted using a backhoe to collect samples at regular intervals producing a 5X3X12-ft. deep excavation. Chloride field tests were performed on each sample which yielded low concentrations similar to that of the background sample. Organic vapors were measured using a PID, which also yielded low concentrations. The deepest sample, 12 ft. BGS was sent to a commercial laboratory for analysis of chloride and TPH, which confirmed low concentrations of each. The excavated soil was returned to the excavation to ground surface and contoured to the surrounding area. The site was seeded by operations with a blend of native vegetation and is expected to return to a productive capacity at a normal rate.

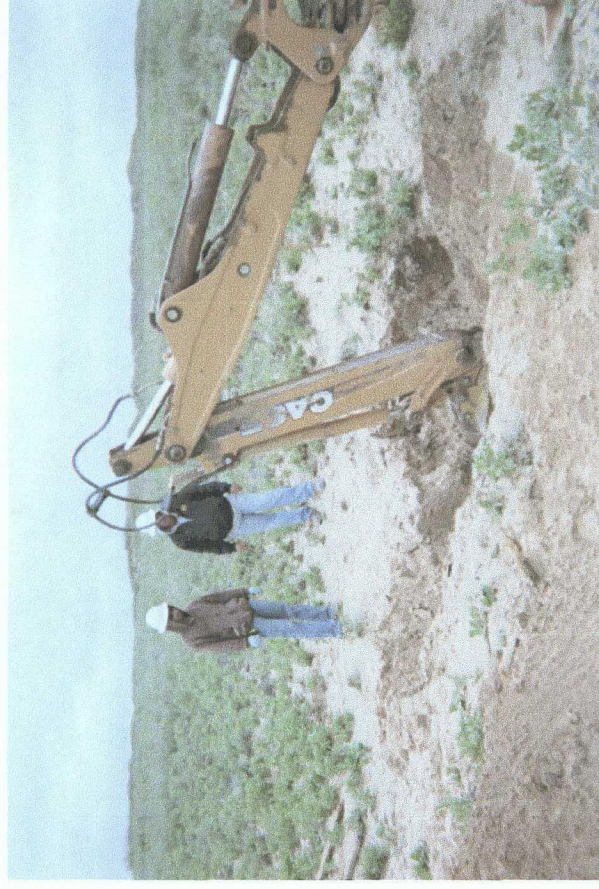
4/19/2010

Delineation trench being excavated

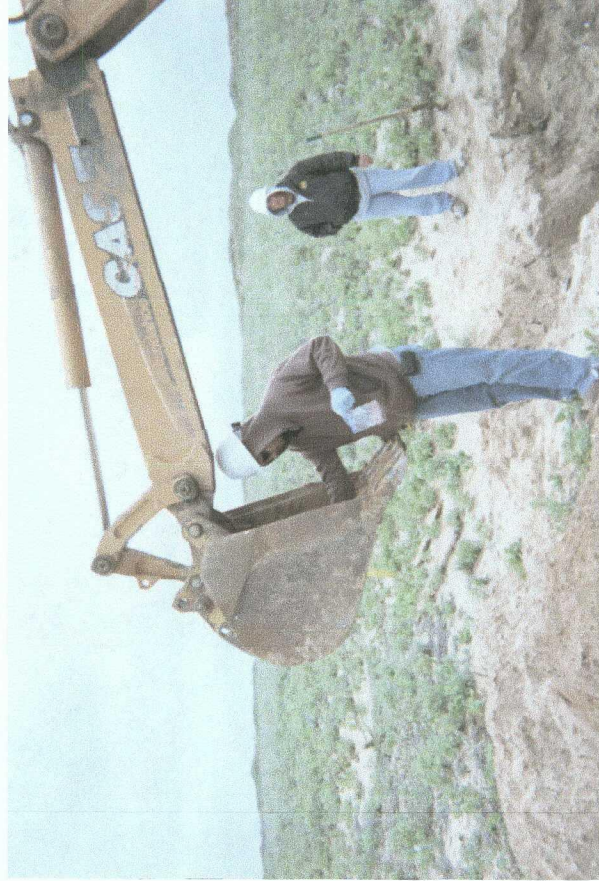
4/19/2010

Sample being collected

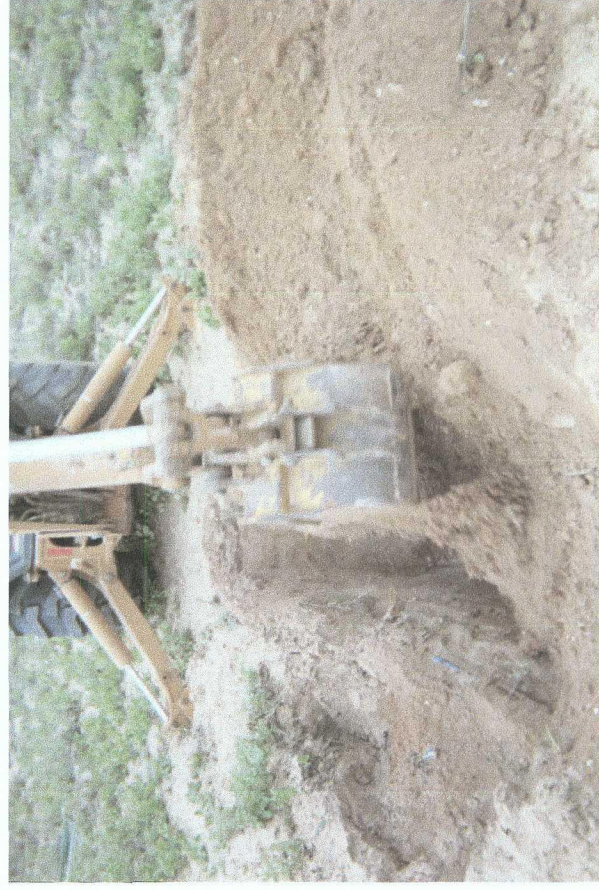
4/19/2010

Backfilling excavation
