BD Jct. A-11-1

CLOSURE

**RICE OPERATING COMPANY
JUNCTION BOX FINAL REPORT**

Unit A, Section 11, T22S, R37E

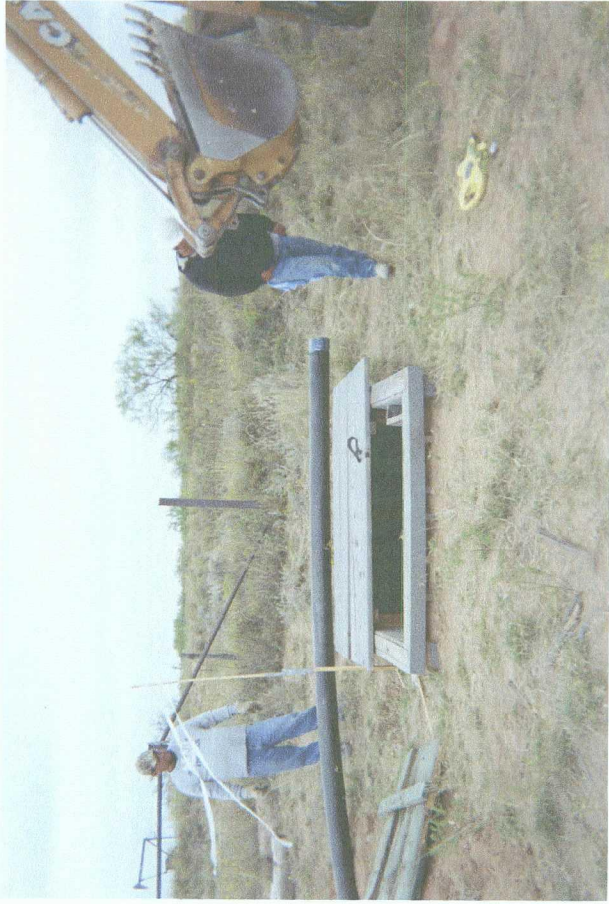
10/21/2010

Site prior to excavation

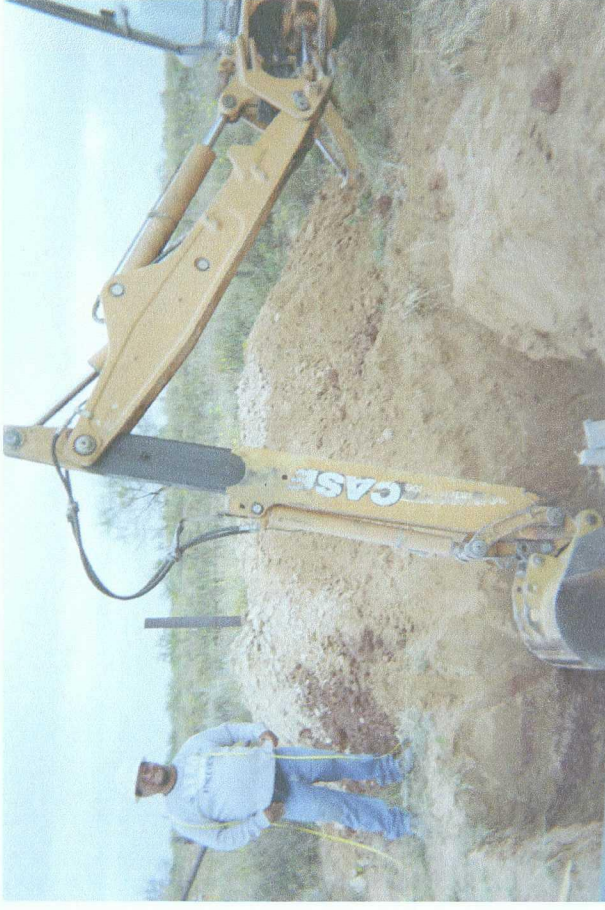
10/21/2010

Delineation trench being excavated

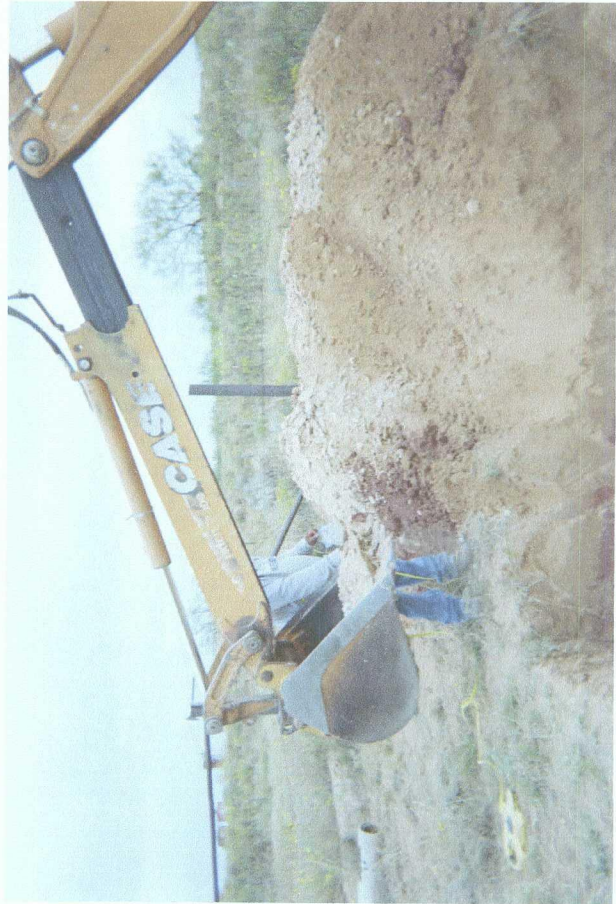
10/21/2010

Collecting sample

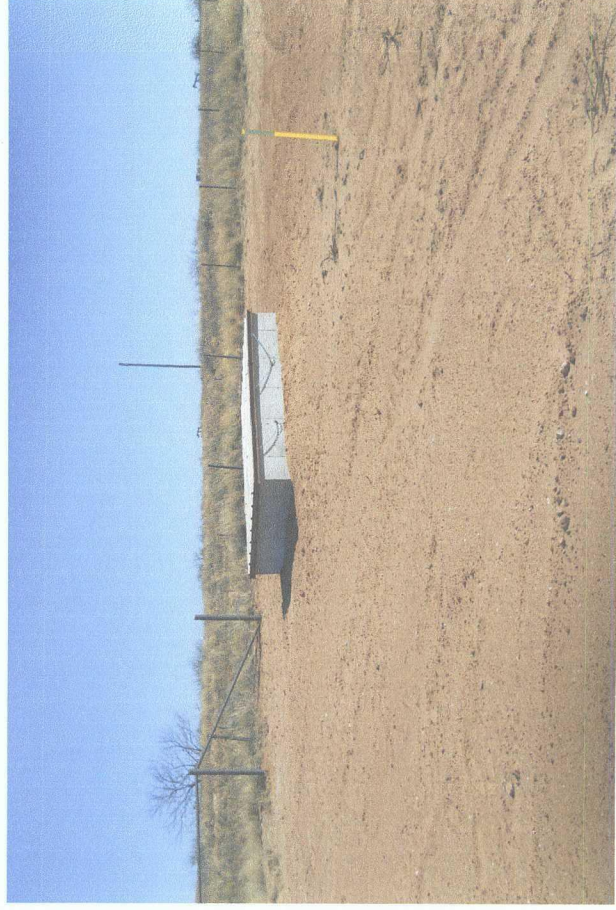
2/23/2011

New water tight junction box

General Description of Remedial Action: This junction and line was addressed during the pipeline replacement/upgrade program. After the former junction box was removed, an investigation was conducted using a backhoe to collect soil samples at regular intervals creating a 7x2x12-ft deep excavation. Chloride field tests performed on each sample yielded low concentrations similar to that of the background. Organic vapors were measured using a PID, which yielded low concentrations. The deepest sample, 12 ft. bgs, was sent to a commercial laboratory for analysis of chloride and TPH, which confirmed low concentrations. The excavated soil was returned to 7 ft. below ground surface (BGS). A new water tight box was built in the same location.

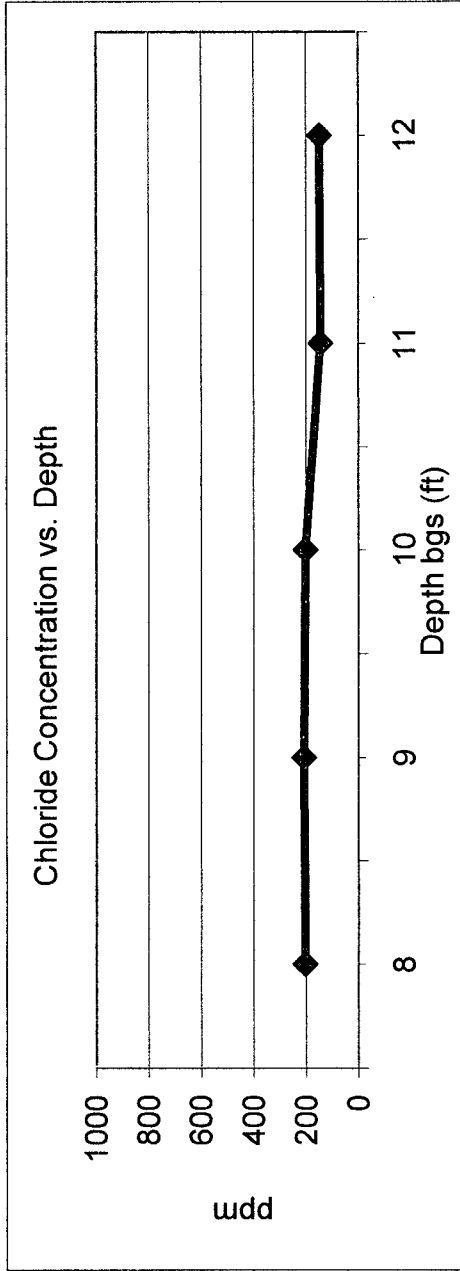
BD JCT A -11-1

Backhoe samples at the junction (source)

Depth bgs. (ft)	[Cl ⁻] ppm
8	204
9	209
10	203
11	145
12	149

Groundwater = 59 ft.
