Vacuum I-3 EOL

CLOSURE

Vacuum Jct. I-3 EOL

Unit I, Section 3, T18S, R35E

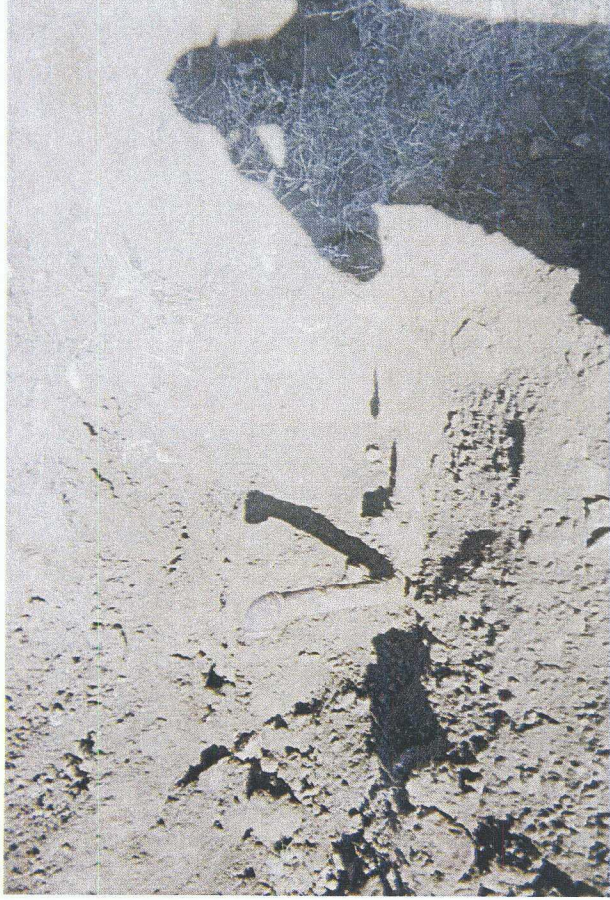
Site prior to delineation

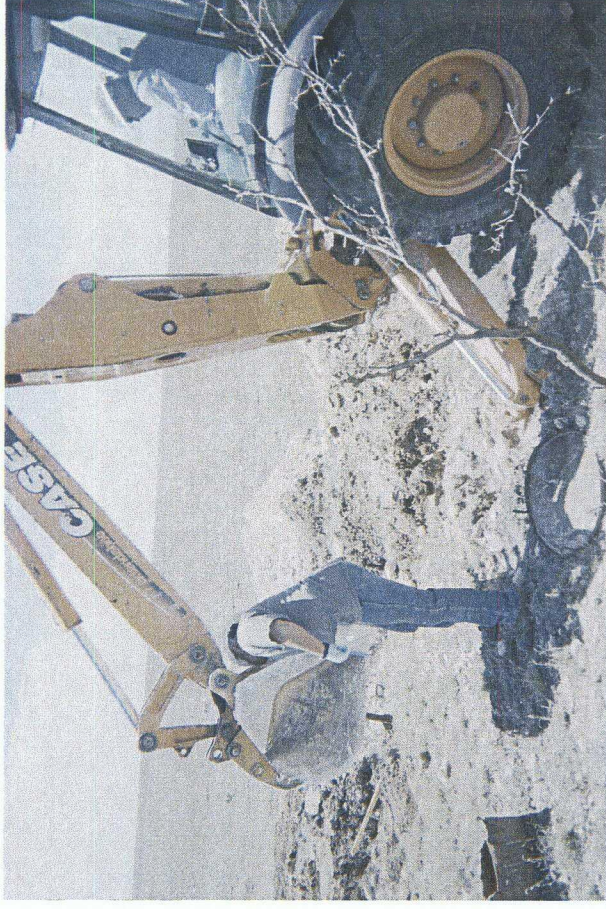
Collecting sample

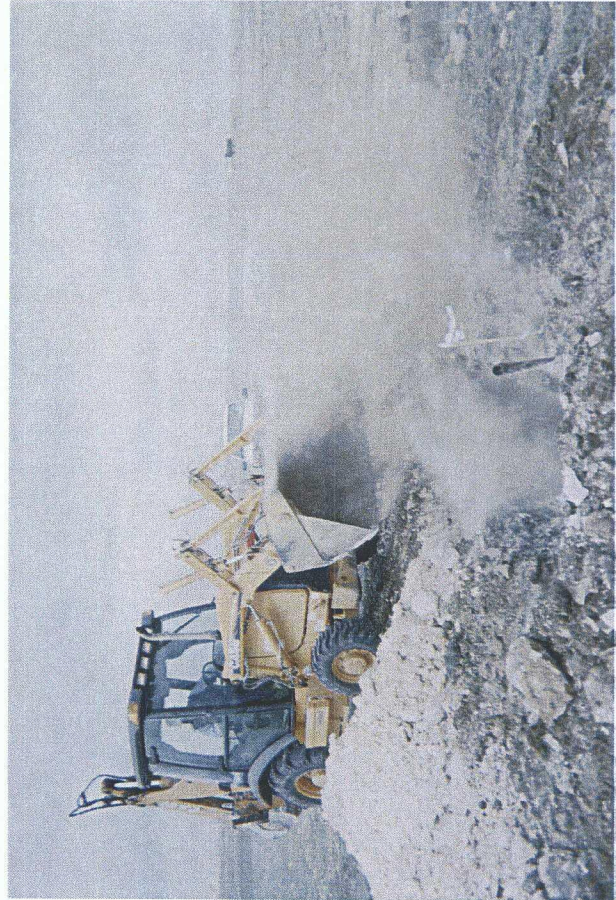
Backfilling excavation

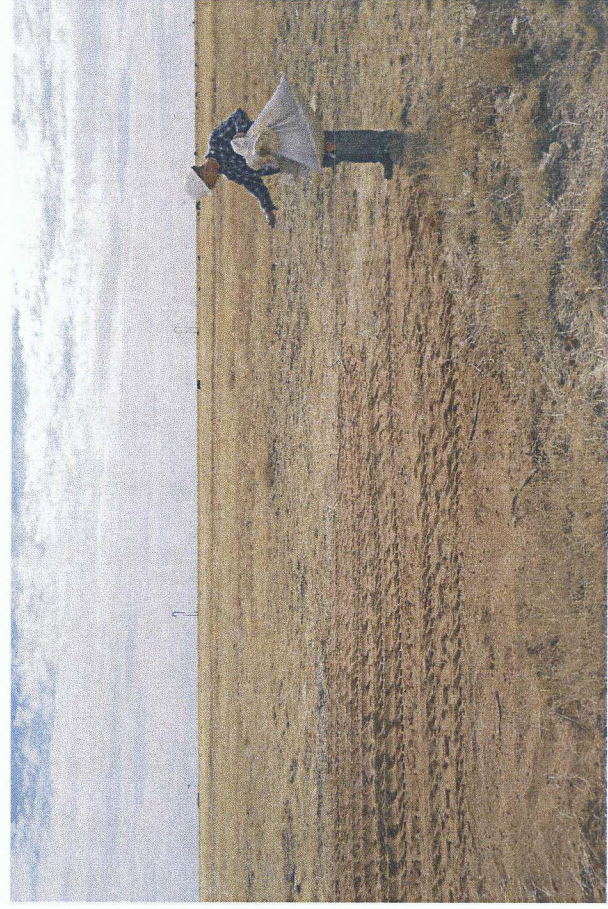
Seeding excavation

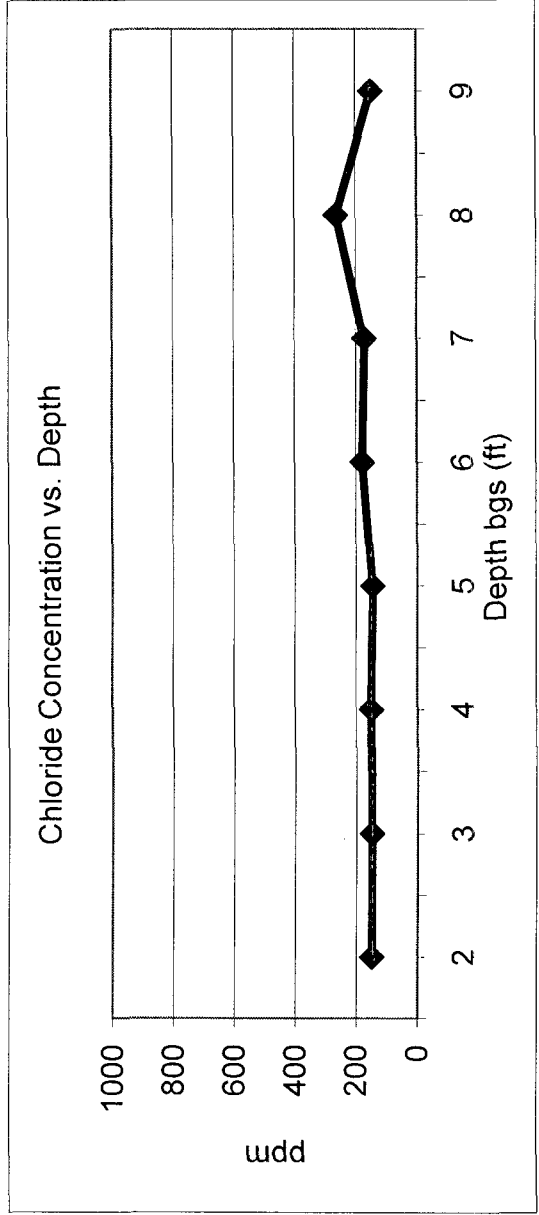
Vacuum I-3 EOL

Backhoe samples at the junction (source)

Depth bgs (ft)	[Cl ⁻] ppm
2	149
3	148
4	150
5	145
6	178
7	171
8	264
9	149

Groundwater = 56 ft
