MARALO SITE

SECTION 36, TWS. 25 S., RNG. 36 E.

JAL, NM

MARCH 2003

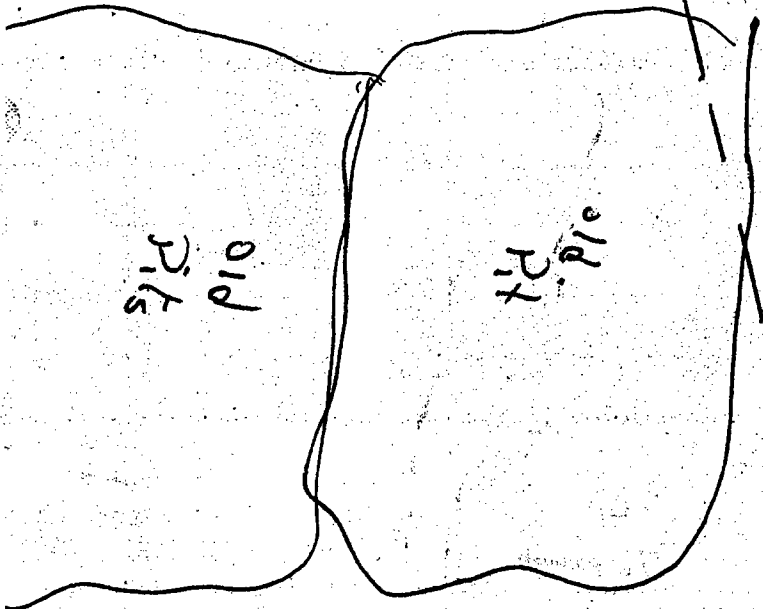
Tank Battery Area

MA #2

water well

MA #1

old pit

old pits

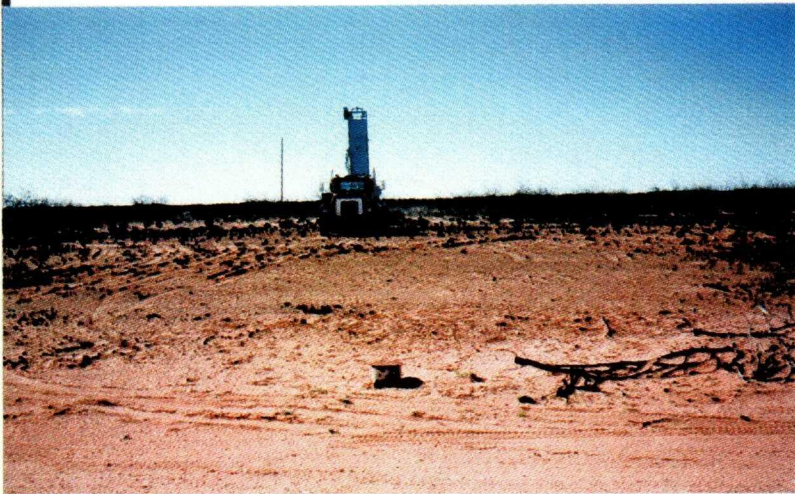
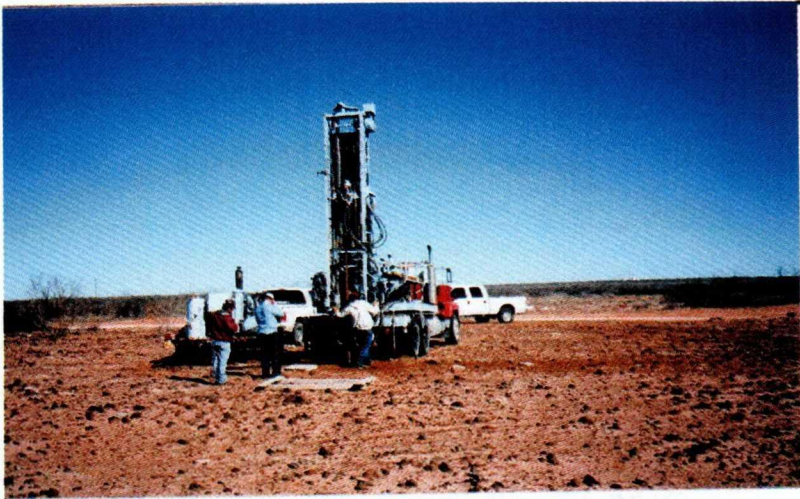
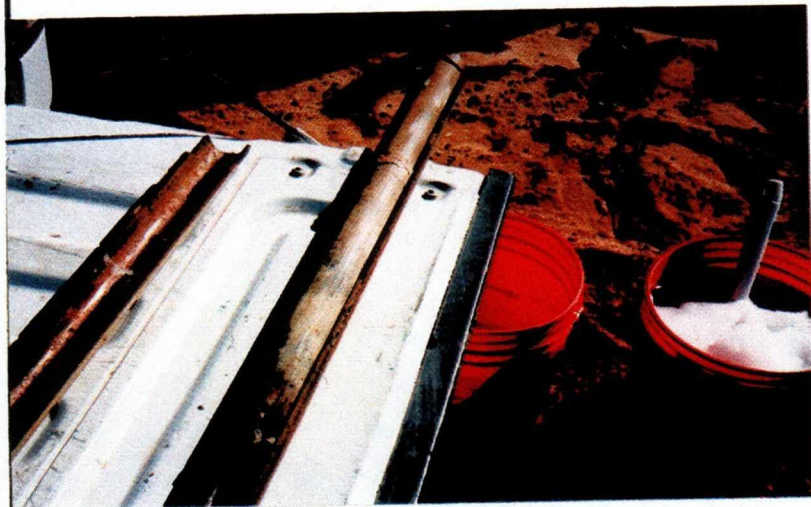
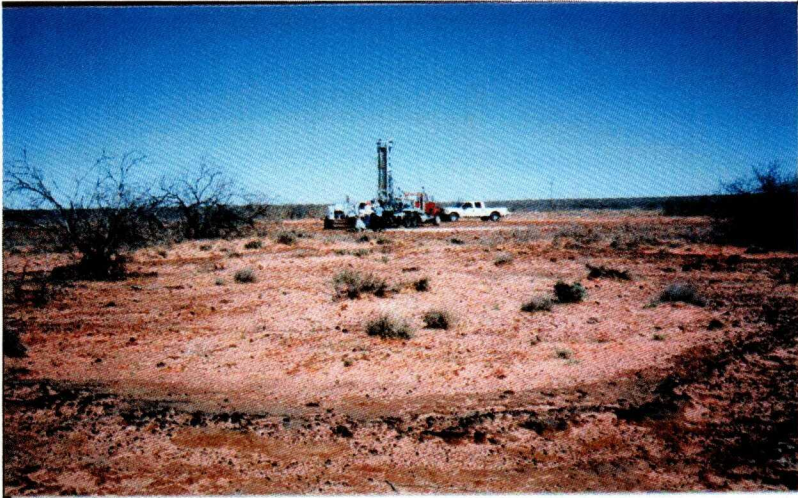
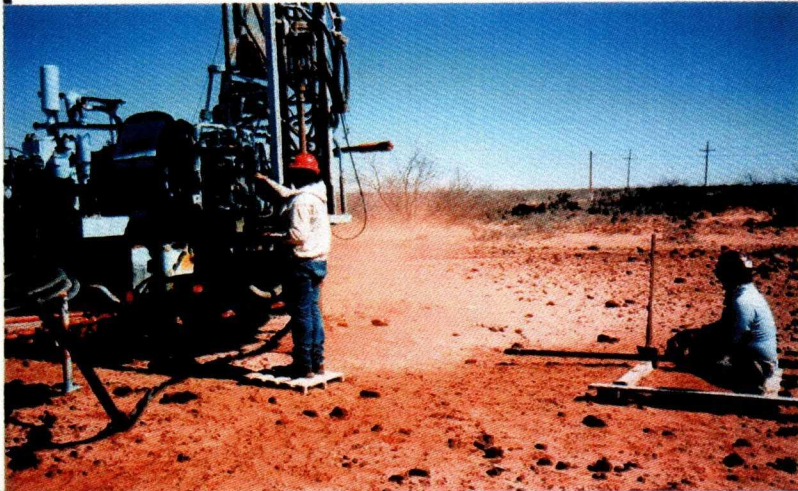
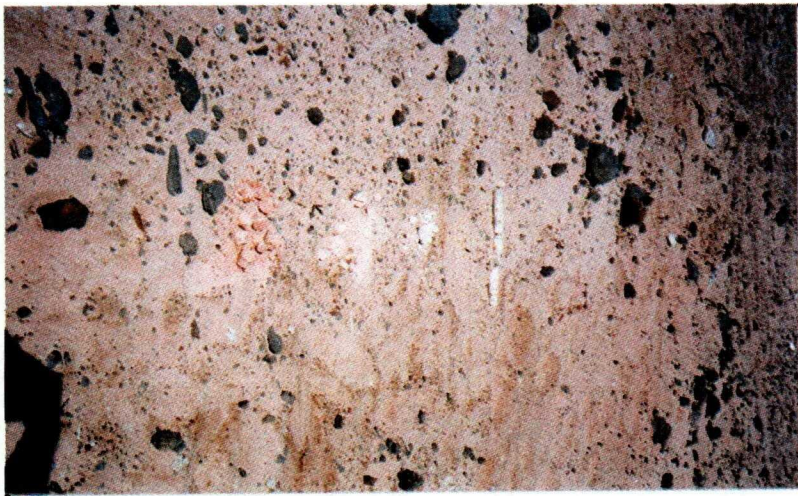
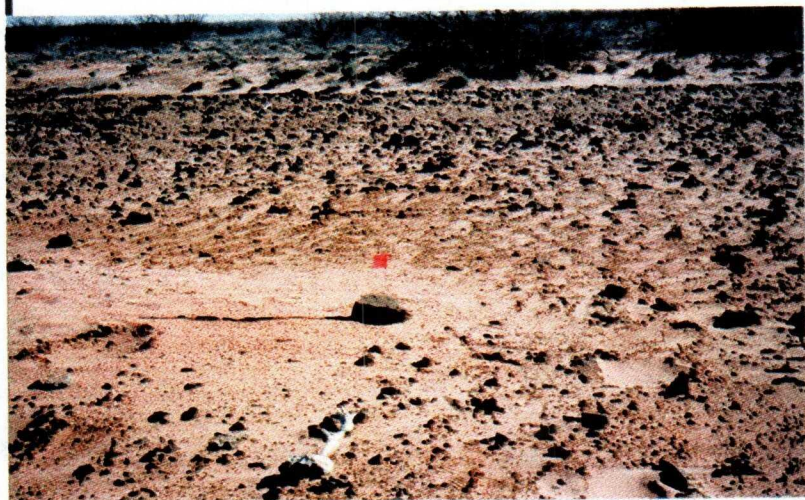
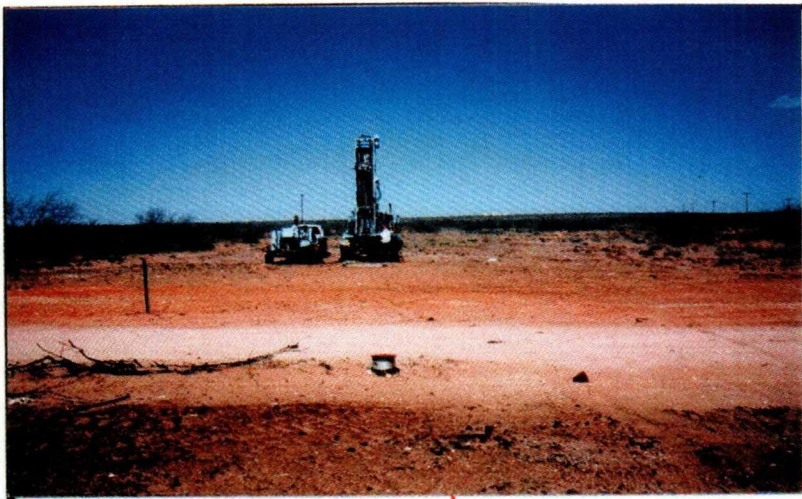
MA #1

MA 1-1	8 to 10 ft. oily strong odor
MA 1-2	20 ft. oily strong odor
MA 1-3	40 ft. strong odor, discolored caliche
MA 1-4	60 ft. slight odor, staining
MA 1-5	80 ft. slight odor

0'-10' top soil rock, very oily
10'-35' sand, rock, oily
35'-50' caliche, rock, oil stained
50'-65' sand, small gravel
65'-80' sand, clay

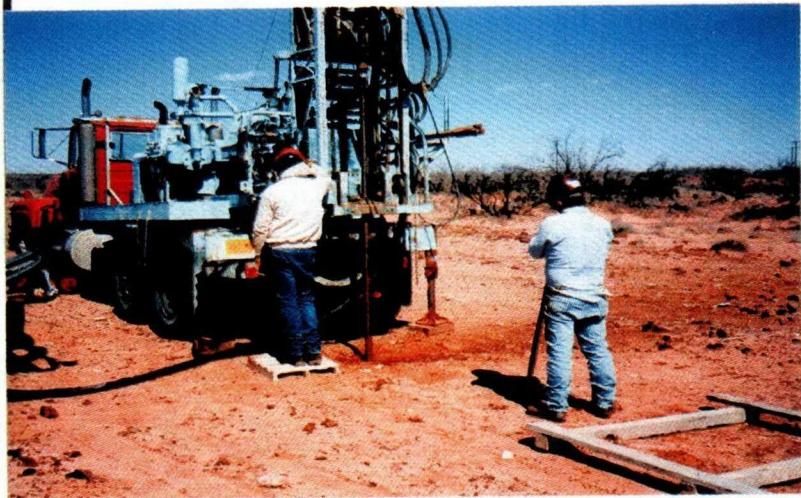
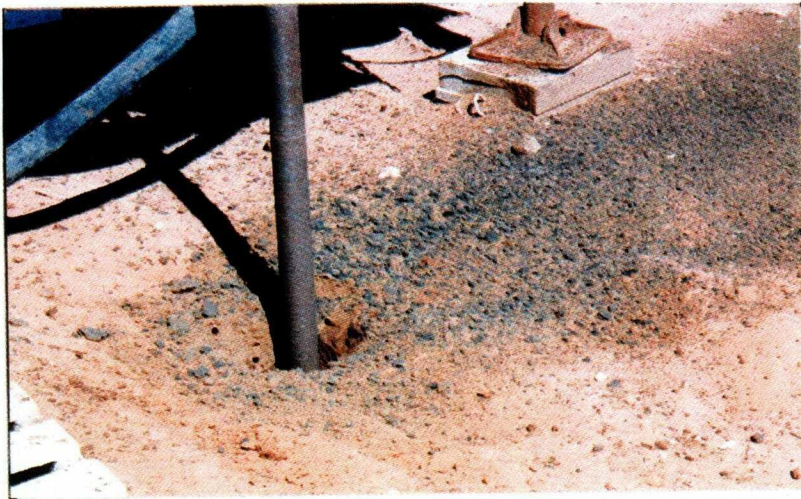
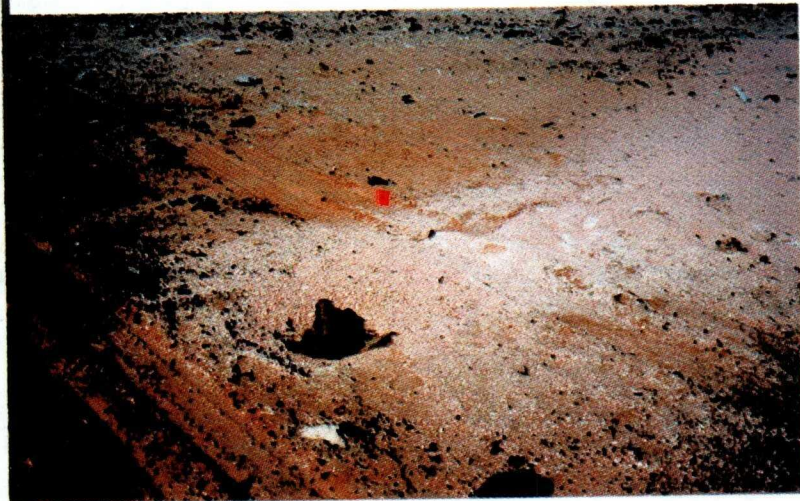
↑
MA #2
↓

MA 2-1	8' to 10' black oily, strong odor
MA 2-2	20' oily, strong odor
MA 2-3	40' stained caliche, slight odor
MA 2-4	60' slight odor
MA 2-5	80' slight odor

0'-15' black very oily top soil
15'-26' sand, rock, oily, strong odor
26'-32' caliche, charcoal gray, strong odor
32'-38' caliche white in color, odor
38'-48' caliche, sand, rock, odor
48'-57' sand, caliche, rock
57'-80' sand, clay, rock
TD 80 ft.
