EXHIBIT NO. 32

CASE NO. 11956

# Chaco 1, Fracture Dimensions

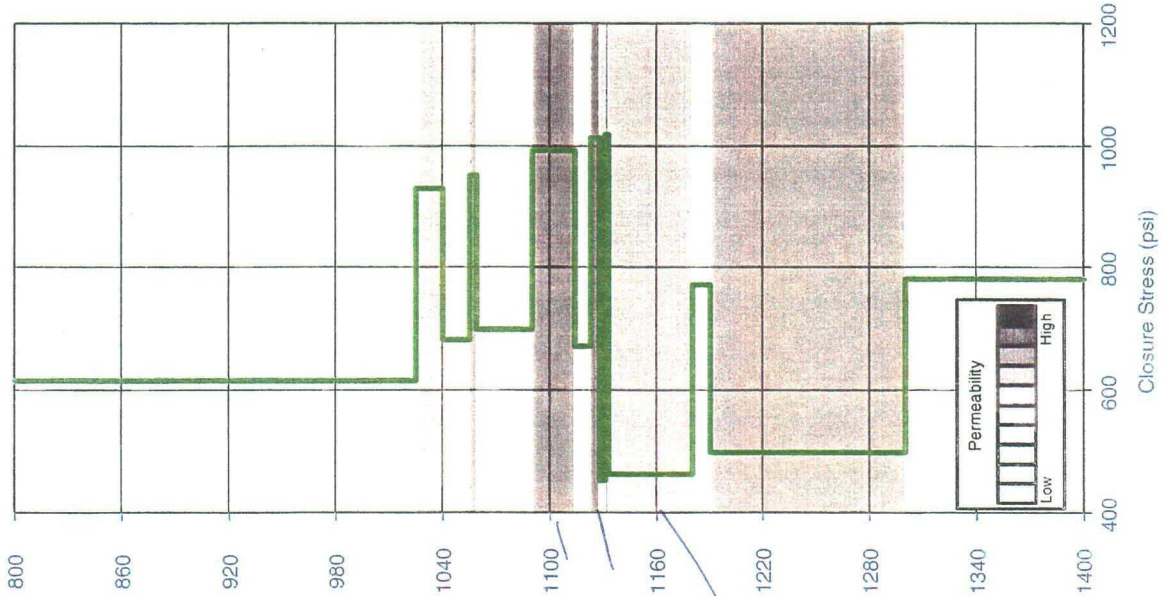
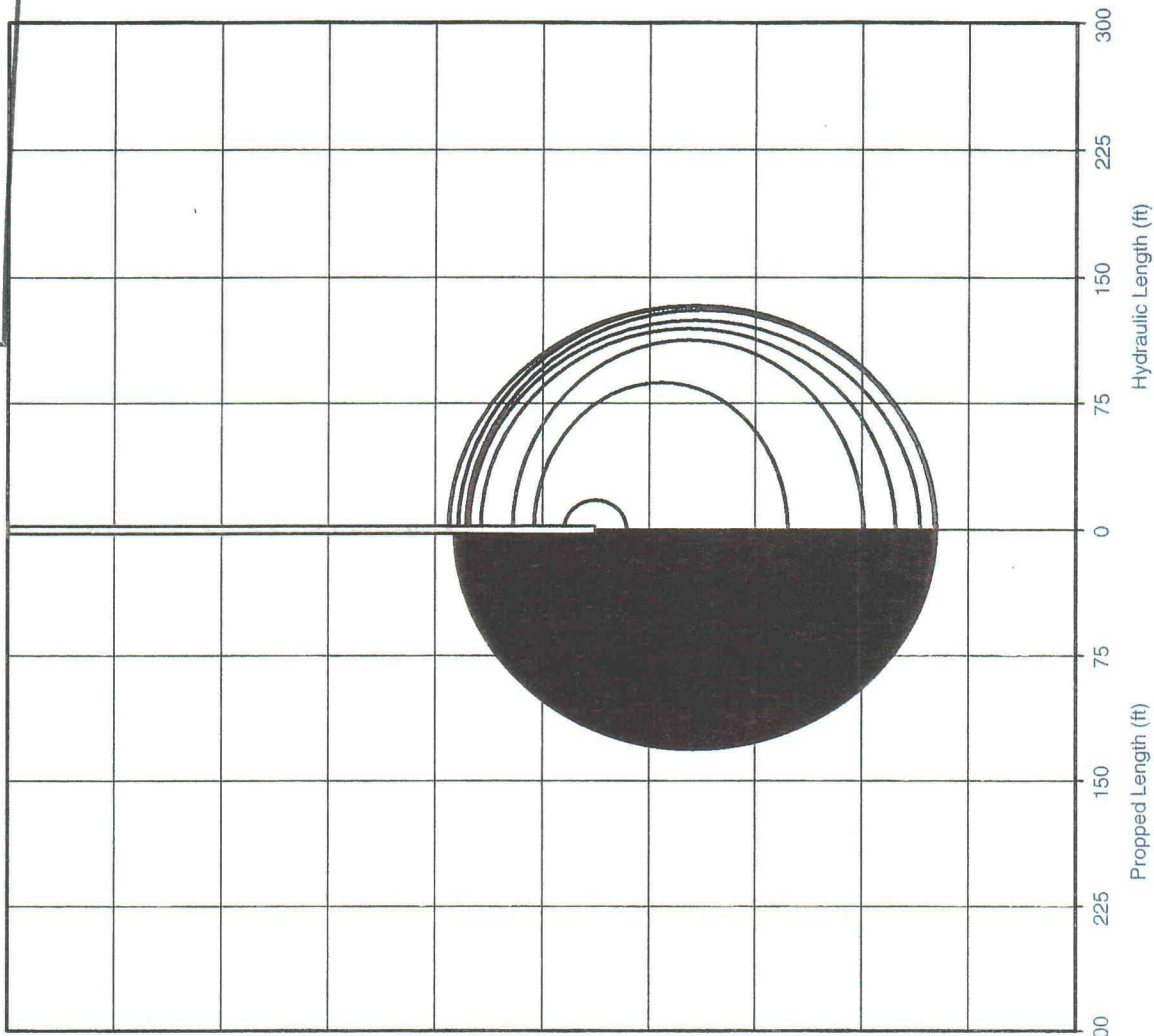
Stress Profile

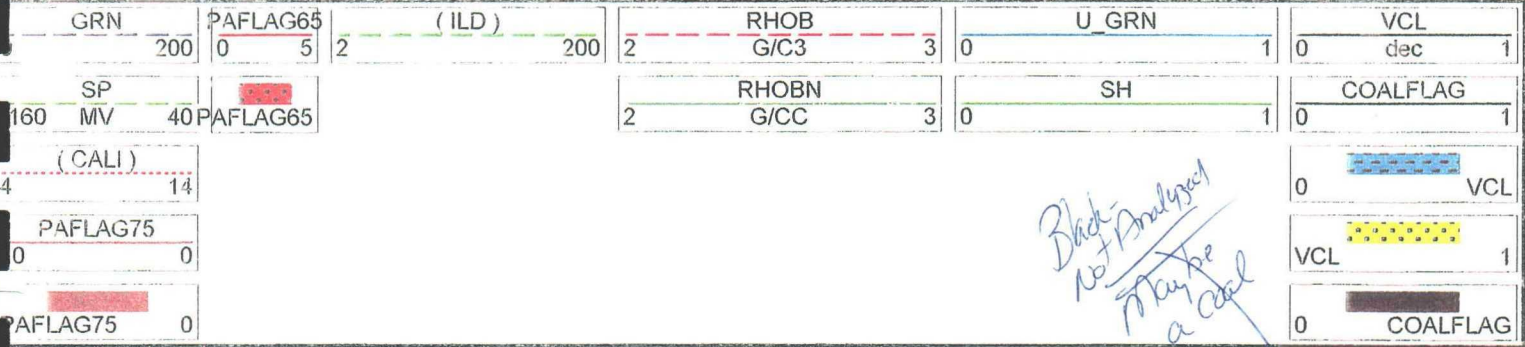
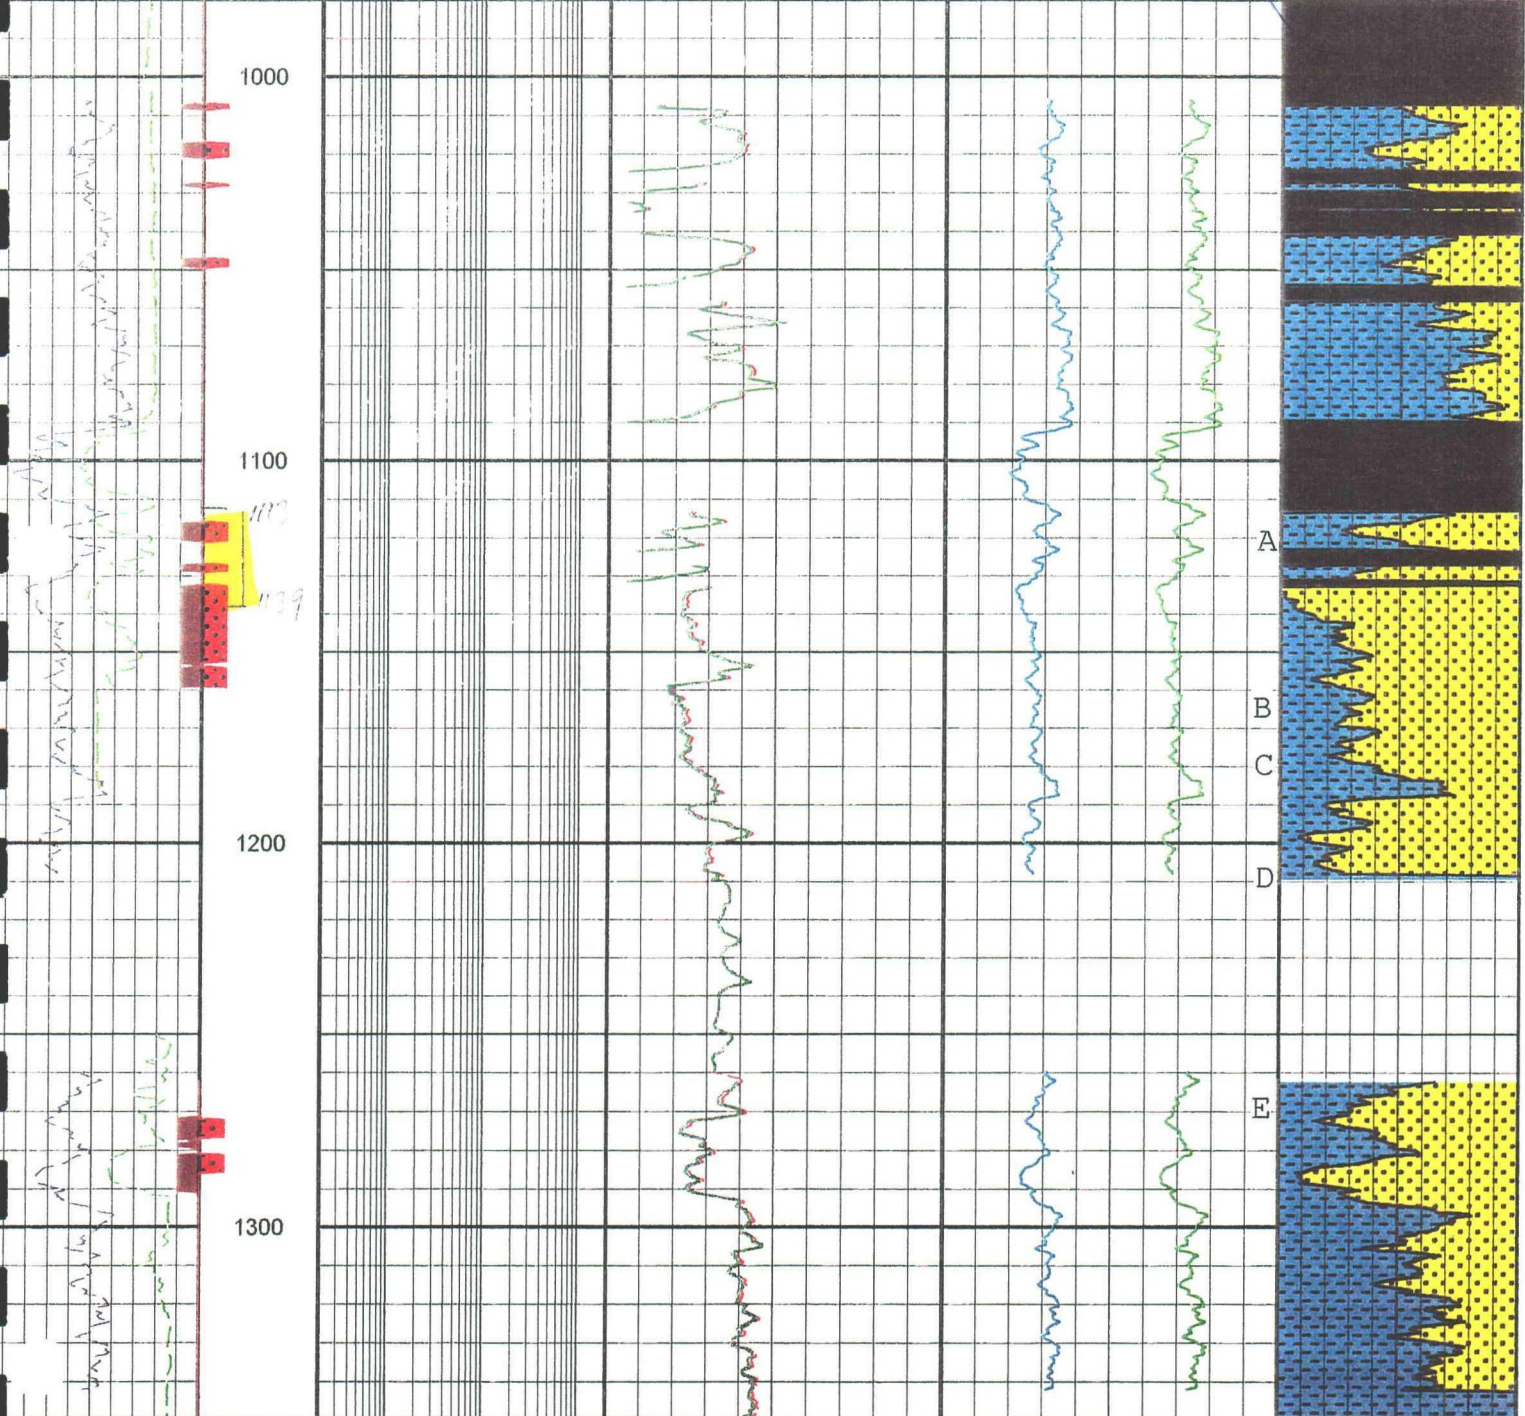
# CHACO #1 PETCOM 13

DEPTH (FT)

*Black-  
No + Analyzed  
May be  
a coal*
