**PART 36  
PERMIT  
APPLICATION**

**Industrial Ecosystems Inc.  
Soil Reclamation Center**

Re: Request for Additional Information – Reply to Letter dated 11/22/11  
Permit Application Review for a Proposed Commercial SWMF  
Crowe Blanco Properties, LLC Operated by Industrial Ecosystems, Inc.

ON-SITE OFF-SITE TOPOGRAPHY  
 CROWE BLANCO PROPERTIES, LLC  
 OPERATED BY INDUSTRIAL ECOSYSTEMS  
 BLANCO, NEW MEXICO

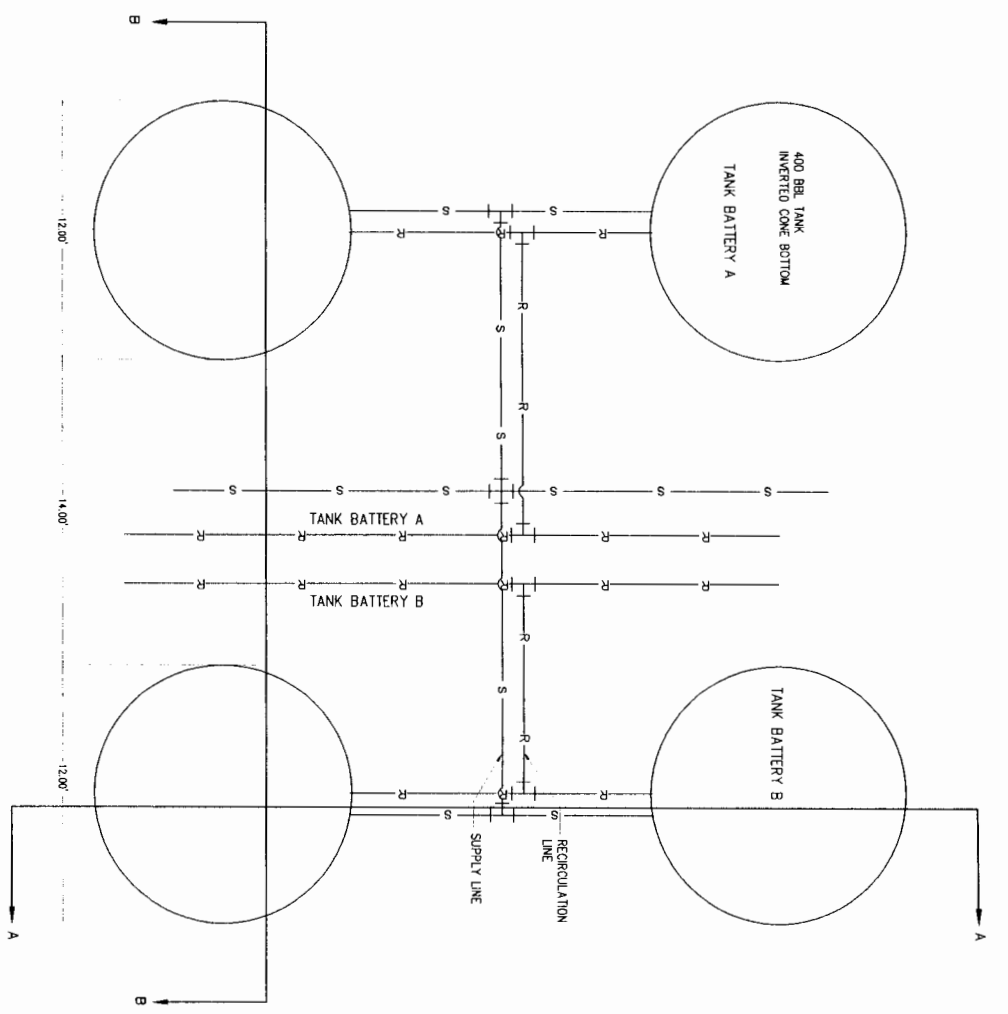
RECEIVING TANK TYPICAL PIPING  
NOT TO SCALE

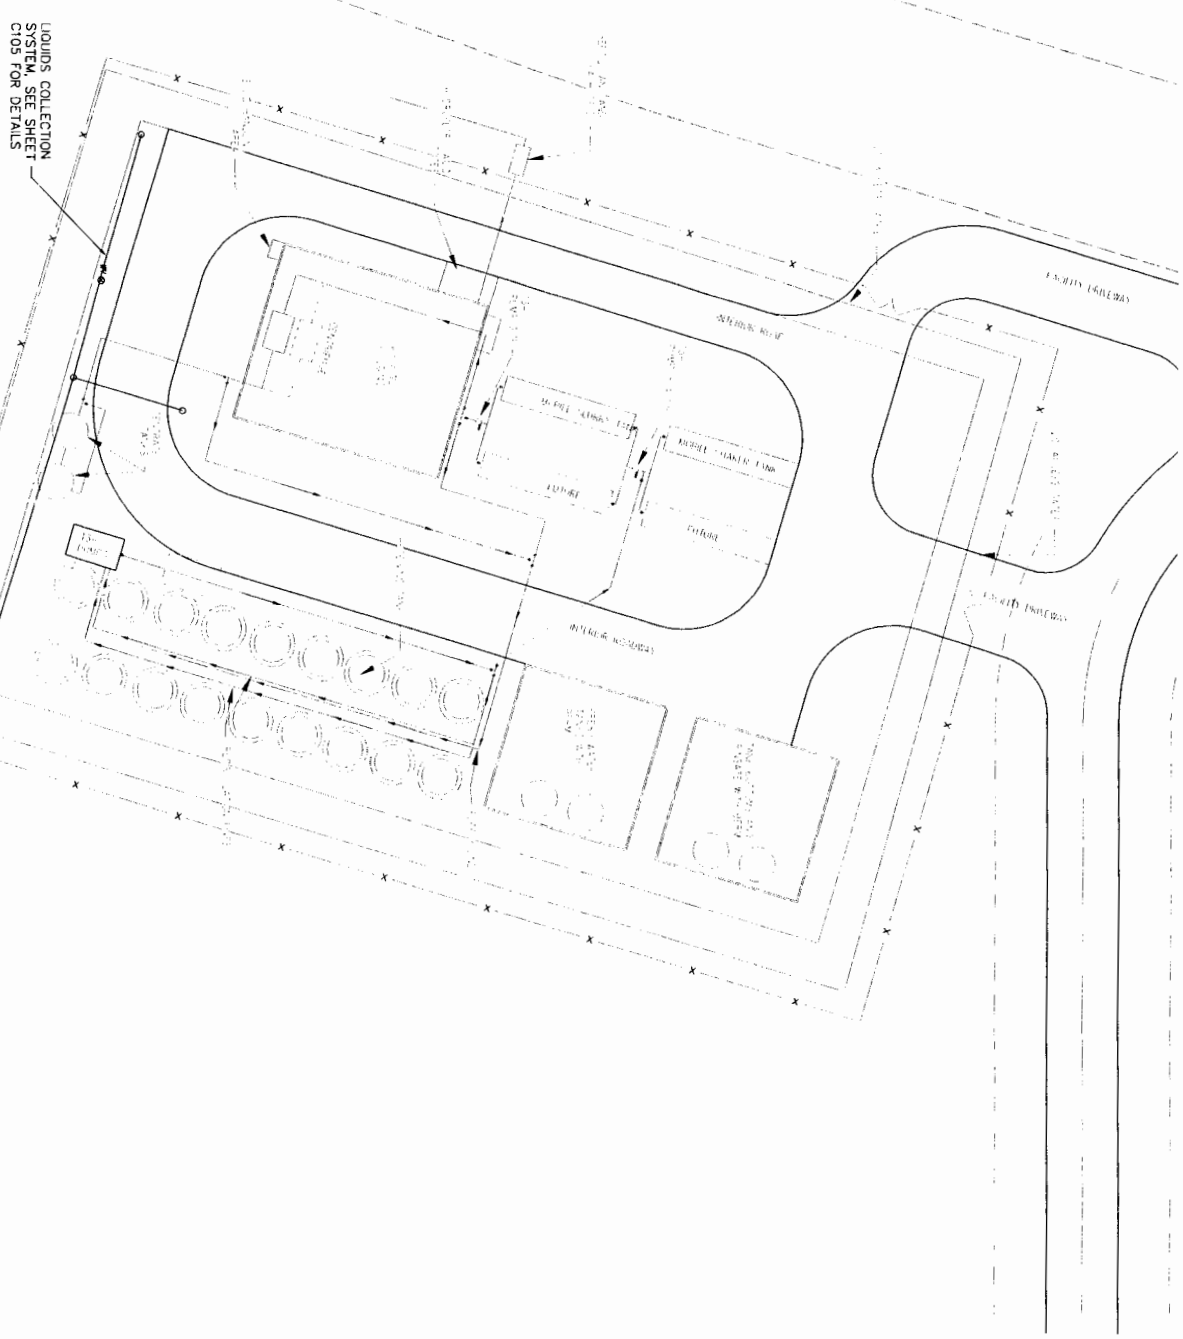
PLAN VIEW: PROCESS AND ENGINEER DESIGN  
SCALE: 1" = 30'

HUTCHINSON-HAYES MODEL 1448 1 1/4" DIAMETER, 48" LENGTH NORMAL CENTRIFUGAL FORCE 2118 G'S AT 3250 RPM, MAXIMUM 3180 G'S AT 4000 RPM. THE BASIC PURPOSE OF CENTRIFUGE IS TO SEPARATE THE LIQUID AND SOLIDS FROM THE FEED SLURRY (IE. STAINLESS STEEL SCREEN CONVEYORS, THESE SOLIDS HARD TILES) TEST SCREEN CONVEYORS THESE SOLIDS TO A CENTRAL DISCHARGE AREA. THE CONVEYOR IS DRIVEN AT A SLIGHTLY SLOWER RPM THRU A PLANETARY GEAR REDUCER. THE LIQUIDS MIGRATE TO THE FRONT END OF THE MACHINE AND ARE DISPELLED THRU FOUR (4) ADJUSTABLE PLATE DAM OPENINGS, TO A CENTRAL DISCHARGE AREA THEN PUMPED TO A LIQUID STORAGE TANK TO BE DISPOSED OF.

CENTRIFUGAL TANK - THE CENTRIFUGAL TANK SHALL BE A 20' DIAMETER X 16' TALL STEEL TANK OF APPROXIMATELY 900 BARRELS.

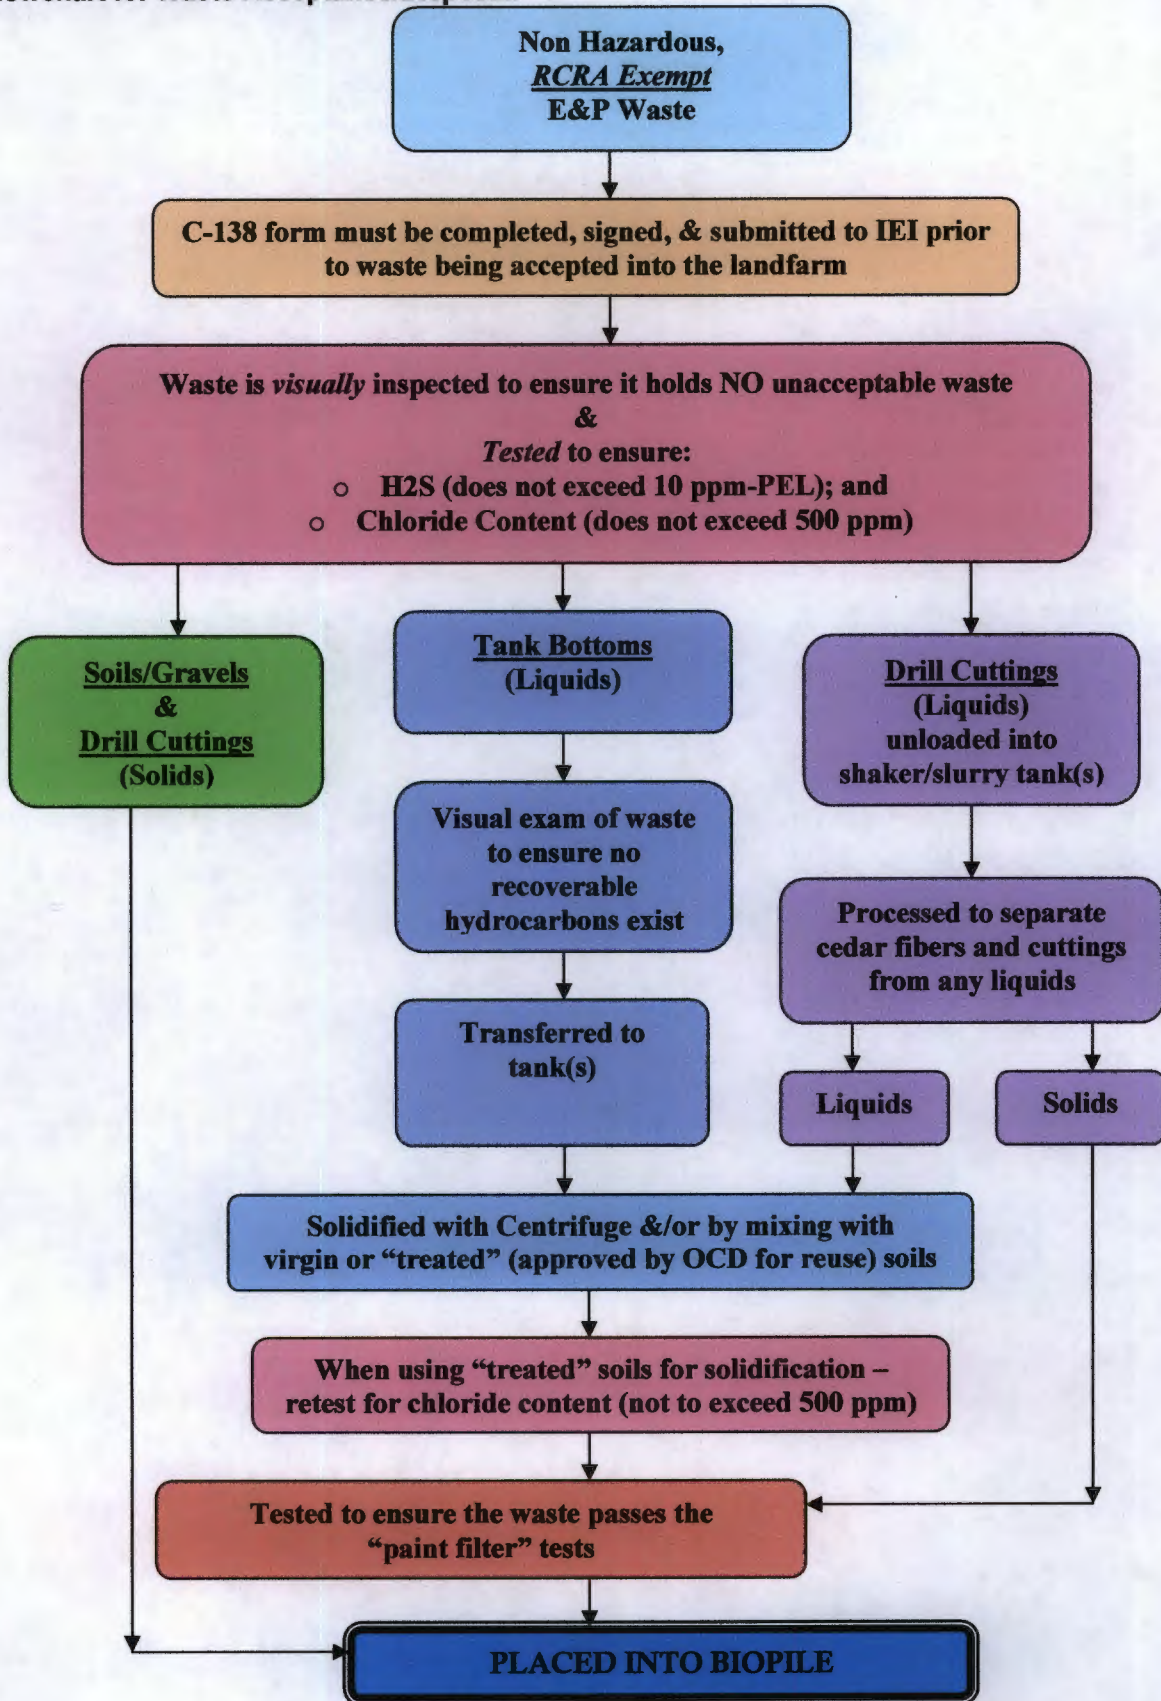
**4.1 Flowchart for Waste Acceptance/Disposal:**
