**Re: NMOCD Case No. 3R-173, 2013 Annual Groundwater Monitoring Report**

# 2013 Annual Groundwater Monitoring Report

ConocoPhillips Flora Vista No. 1  
San Juan County, New Mexico  
API# 30-045-20073  
NMOCD# 3R-173

September 2014 • 074926 • Report No. 5

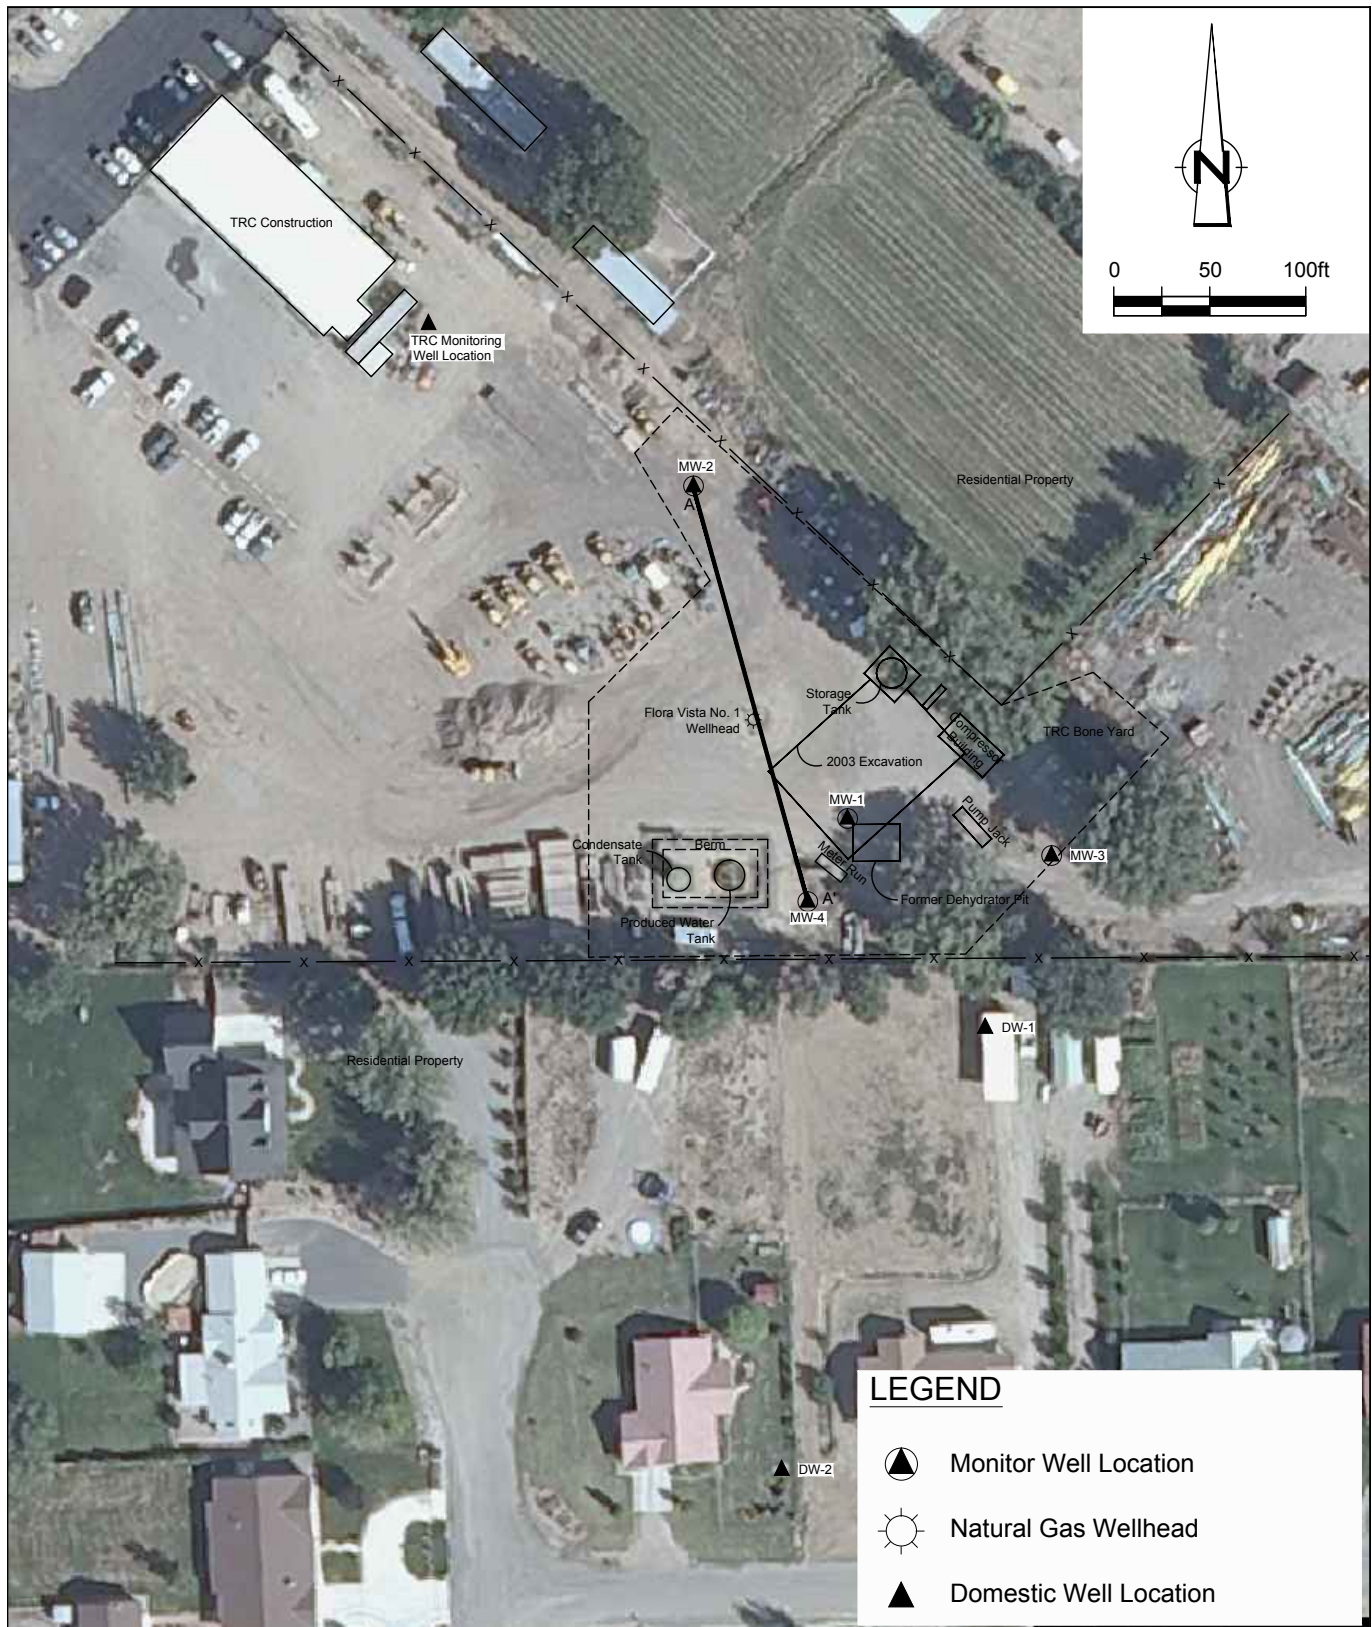
Figure 2

This annual report presents the results of the quarterly groundwater monitoring events conducted by Conestoga-Rovers & Associates (CRA) during 2013 at the Flora Vista No. 1 natural gas well site (Site), operated by Burlington Resources Oil & Gas Company LP (Burlington), a wholly owned subsidiary of ConocoPhillips Company (ConocoPhillips) (**Figure 1**). The Site is located on private property in Unit Letter F, Section 22, Township 30N, Range 12W, of San Juan County, New Mexico. The Site consists of a gas well and associated equipment and installations. A detailed Site layout map is provided as **Figure 2**.

In September 2003, Envirotech installed a groundwater monitor well (MW-1) slightly downgradient from the center of the excavation (**Figure 2**). Subsequent monitoring during September 2003 included analyses for benzene, toluene, ethylbenzene, and total xylenes (BTEX), as well as total petroleum hydrocarbons (TPH). Groundwater analyses indicated the presence of benzene and total xylenes above regulatory standards. Monitor Wells MW-2, MW-3, and MW-4 were installed at the Site in August 2008 in response to an April 2008 request from NMOCD for Site characterization and enhanced laboratory analyses.

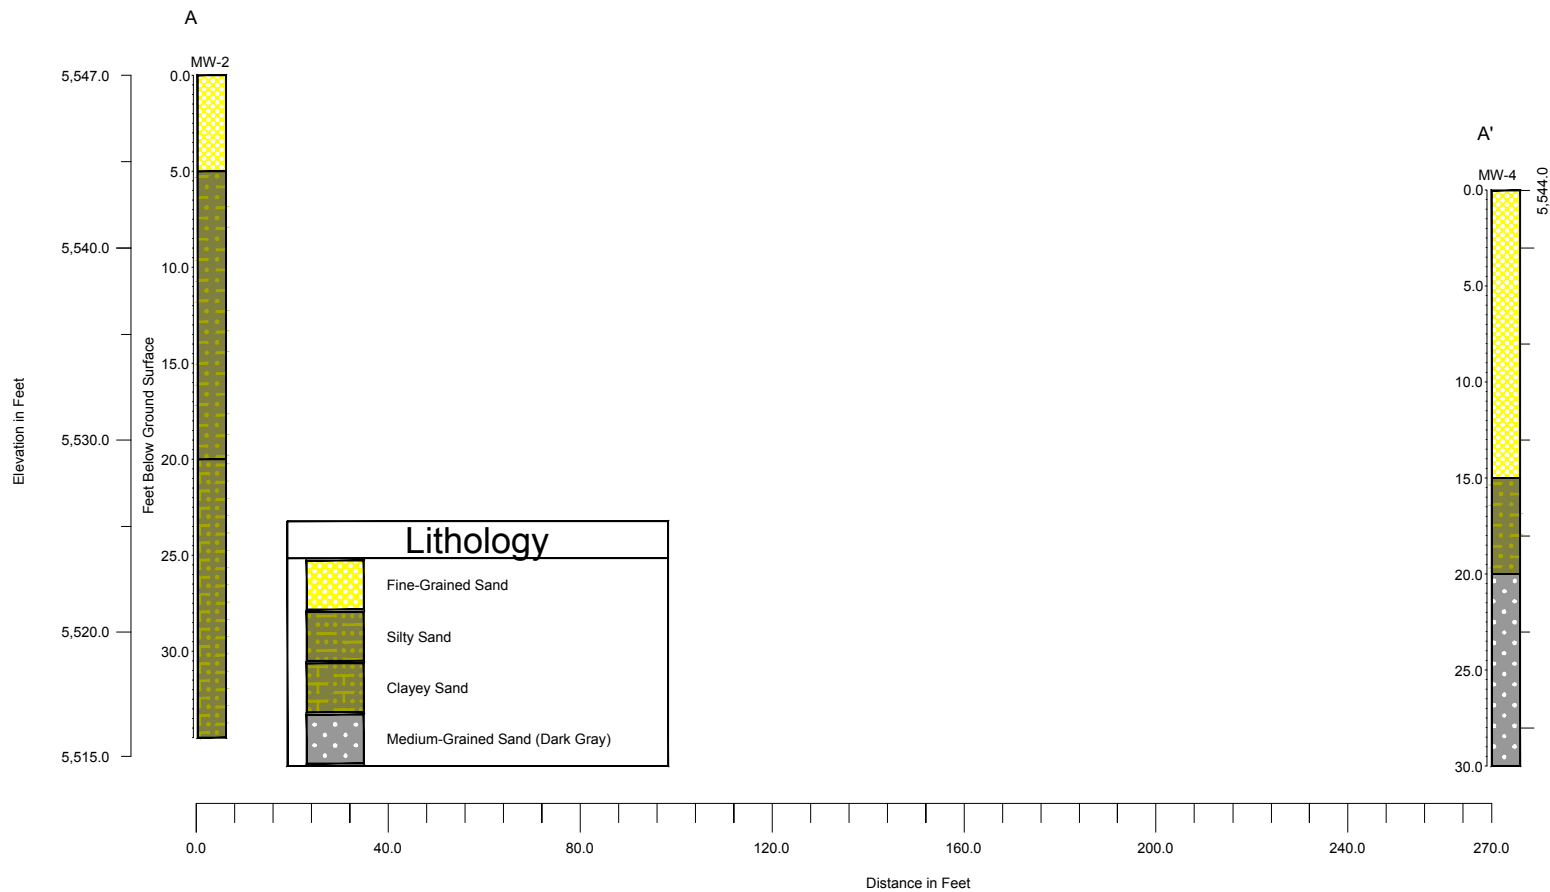
Figure 3

A generalized geologic cross section was prepared using boring logs from the August 2008 monitor well installation and is presented as **Figure 3**. In an attempt to actively remediate soil and groundwater at the Site, mobile dual phase extraction (MDPE) was conducted on August 21<sup>st</sup> and 22<sup>nd</sup>, 2013. A report detailing this event is included in **Appendix A**.

Flora Vista No. 1 - Cross-Section A-A'

GEOLOGICAL CROSS SECTION  
 FLORA VISTA NO. 1 NATURAL GAS WELL SITE  
 SECTION 22, T30N-R12W, SAN JUAN COUNTY, NEW MEXICO  
*ConocoPhillips Company*
