**Termination Request Approved for the
Hobbs SWD System
Hobbs Jct. E – 33 - 1 (1R428-67)
Unit Letter E Section 33, T18S, R38E, NMPM, Lea County, New Mexico**

**RE: Termination Request
Rice Operating Company – Hobbs SWD System
Hobbs Jct. E-33-1 (1R428-67): UL/E, Sec. 33, T18S, R38E**

Hobbs Jct. E-33-1

UL/E Sec.33 (T18S-R38E)

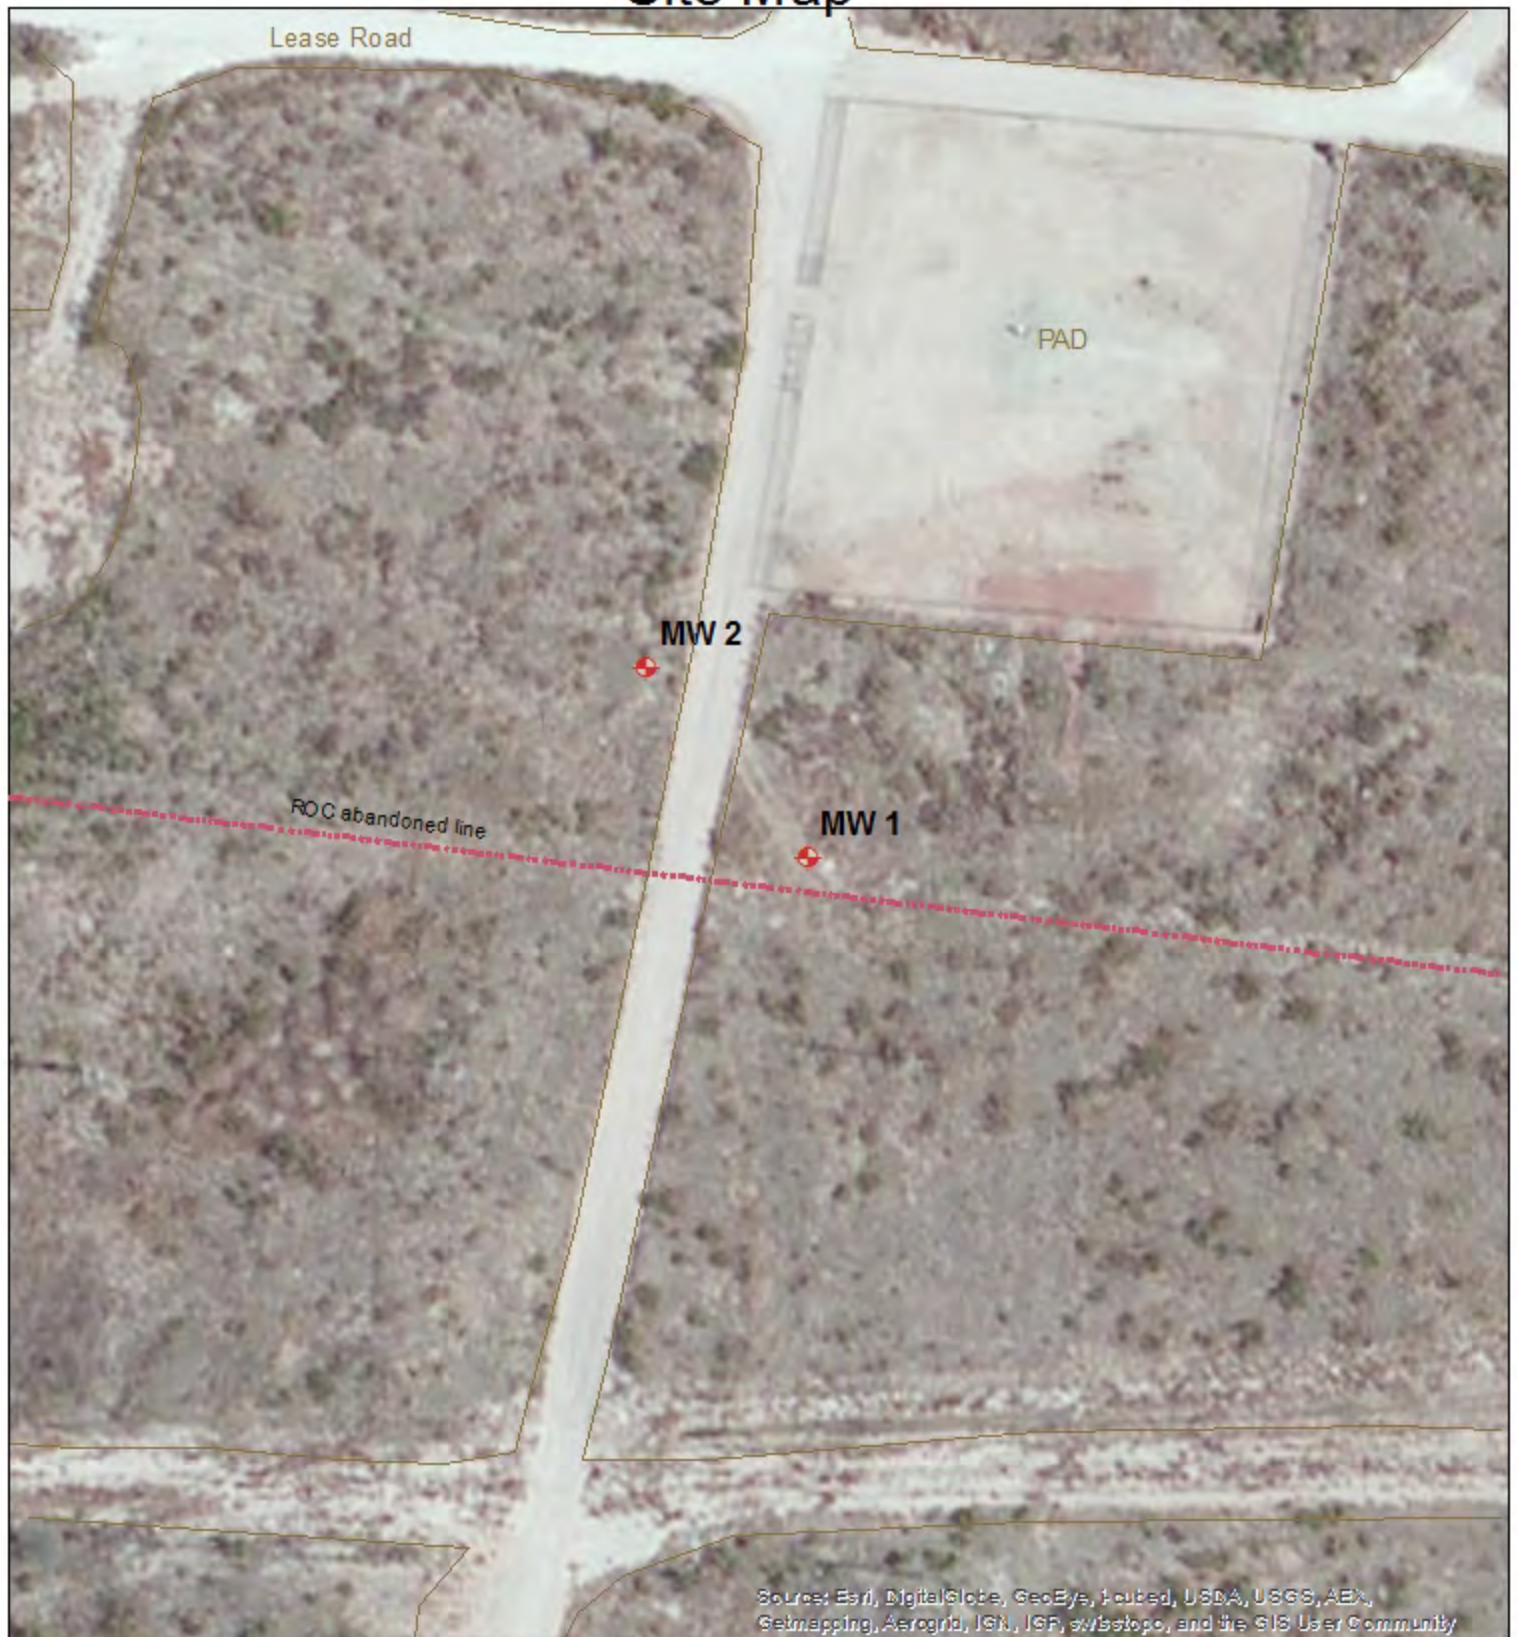
Figure 2

Site Map

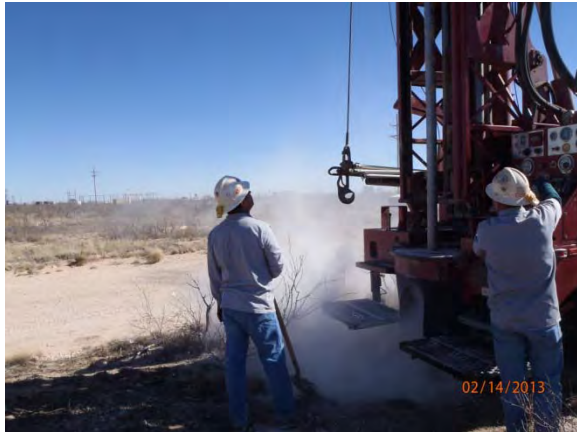
Installing MW-2, facing east 2/14/13

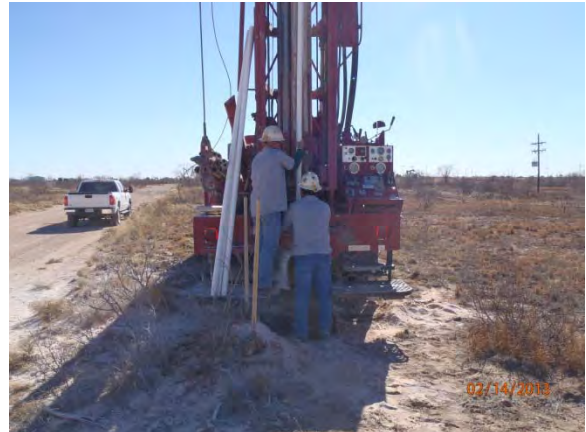
Installing the casing in MW-2, facing south
2/14/13

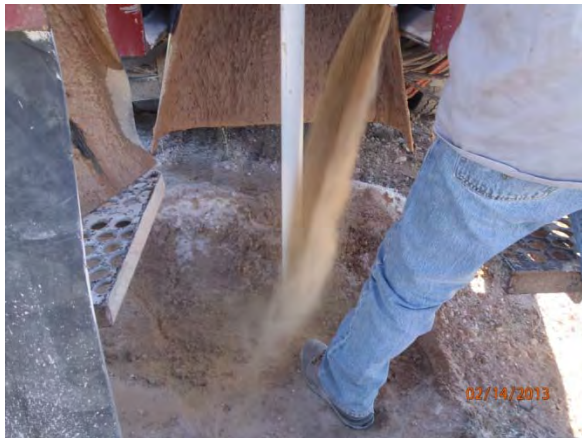
Installing the sand pack, facing south 2/14/13

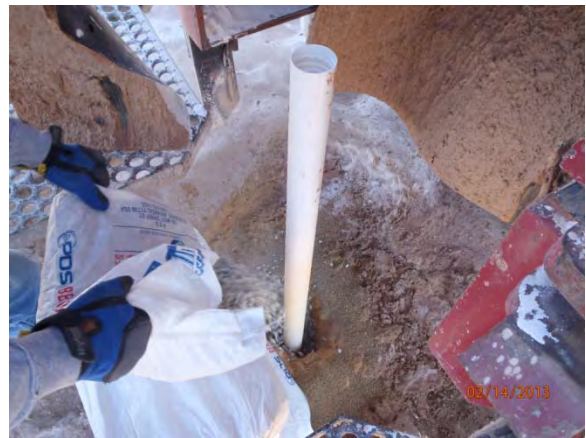
Installing the bentonite seal, facing south
2/14/13

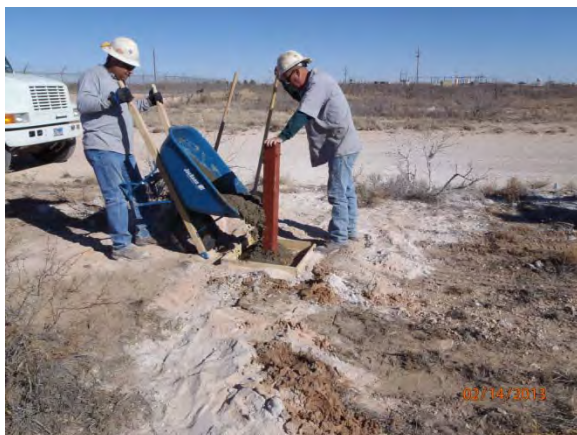
Concreting the well in, facing east 2/14/13

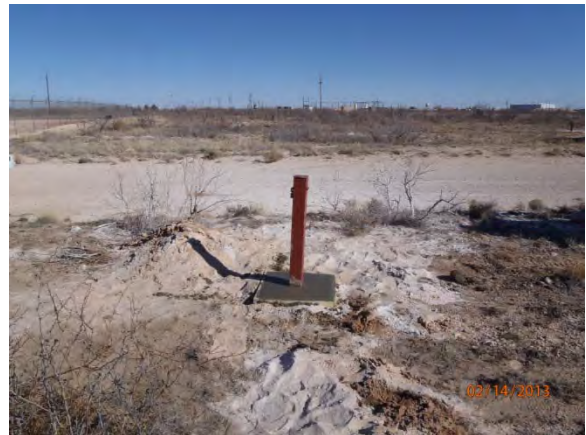
Completed MW-2, facing east 2/14/13

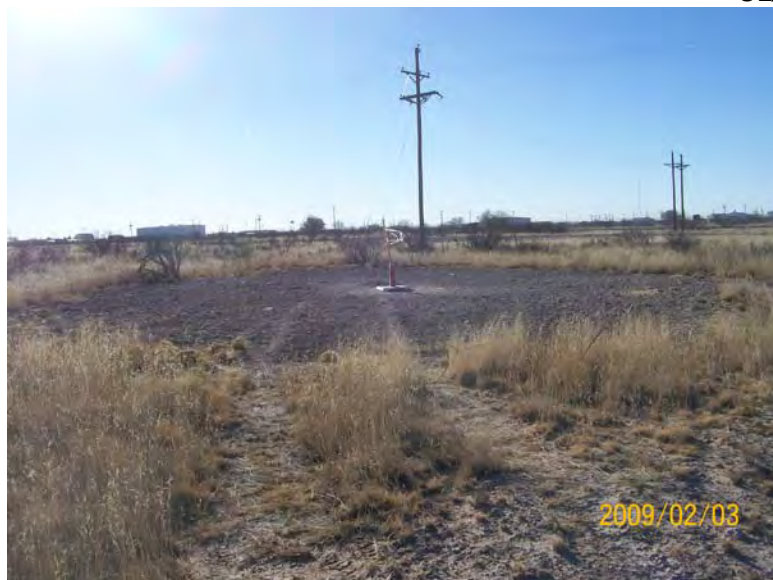
2/3/2009

Site prior to surface restoration,

On January 3rd, 2007, ROC submitted a Corrective Action Plan (CAP) to NMOCD, which was approved on August 8th, 2007. The report recommended that ROC restore the ground surface surrounding the former junction box. The surface surrounding the former junction box was restored and seeded on February 3rd, 2009. Since then, vegetation has recovered. Photographs of this are included in Appendix C.

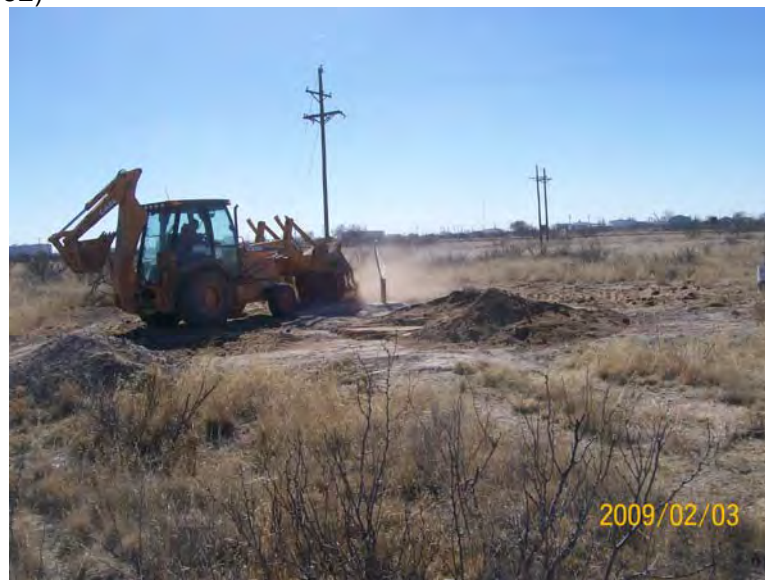
2/3/2009

Spreading imported topsoil

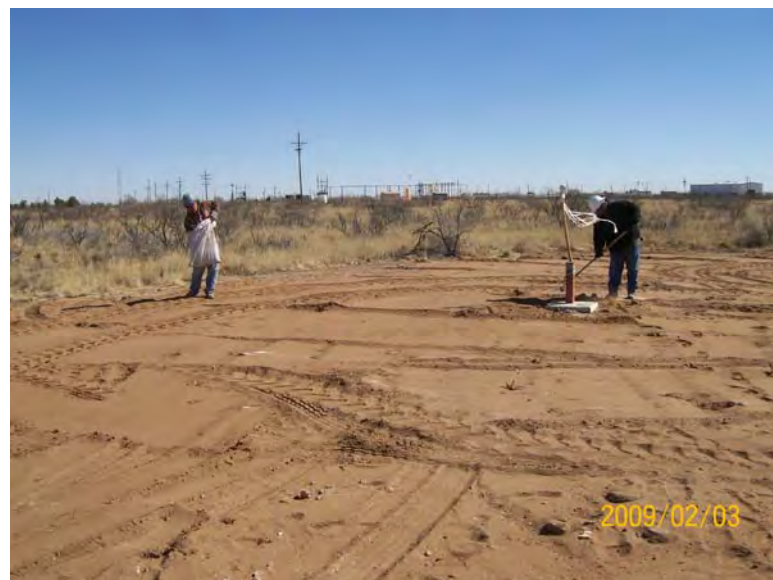
2/3/2009

Seeding remediated area,

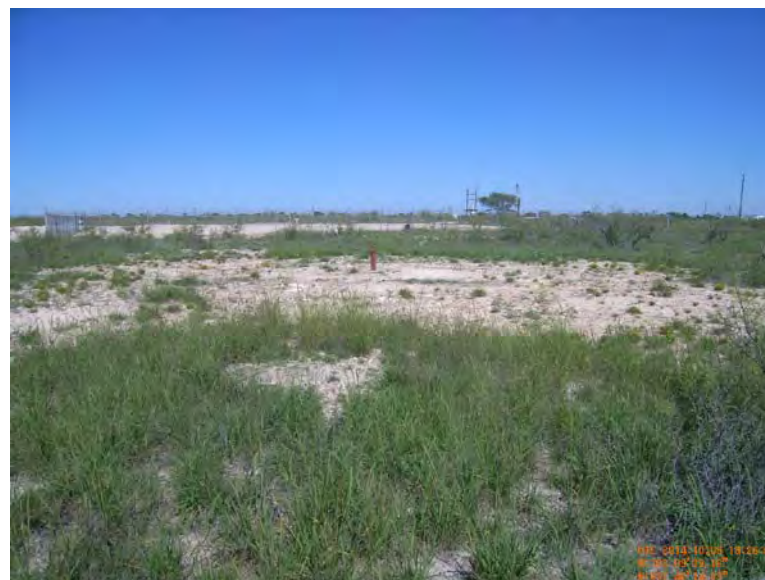
10/9/2014

Final photo, facing north

Given that the monitor well chloride concentrations have remained below regulatory standards for four consecutive quarters, and that vegetation surrounding the site has recover, ROC respectfully requests 'remediation termination' or similar closure status of the site.
