**REMEDIATION SUMMARY
AND SITE
CLOSURE STRATEGY**

**BOPCO, LP
G.H. Cobb Federal #1
Eddy County, New Mexico
UNIT LTR "M" (SW ¼ SW ¼), Section 23, Township 20 South, Range 31 East
Latitude 32° 33' 11.412" North, Longitude 103° 50' 44.304"
NMOCD Reference # 2RP-369**

December 2010

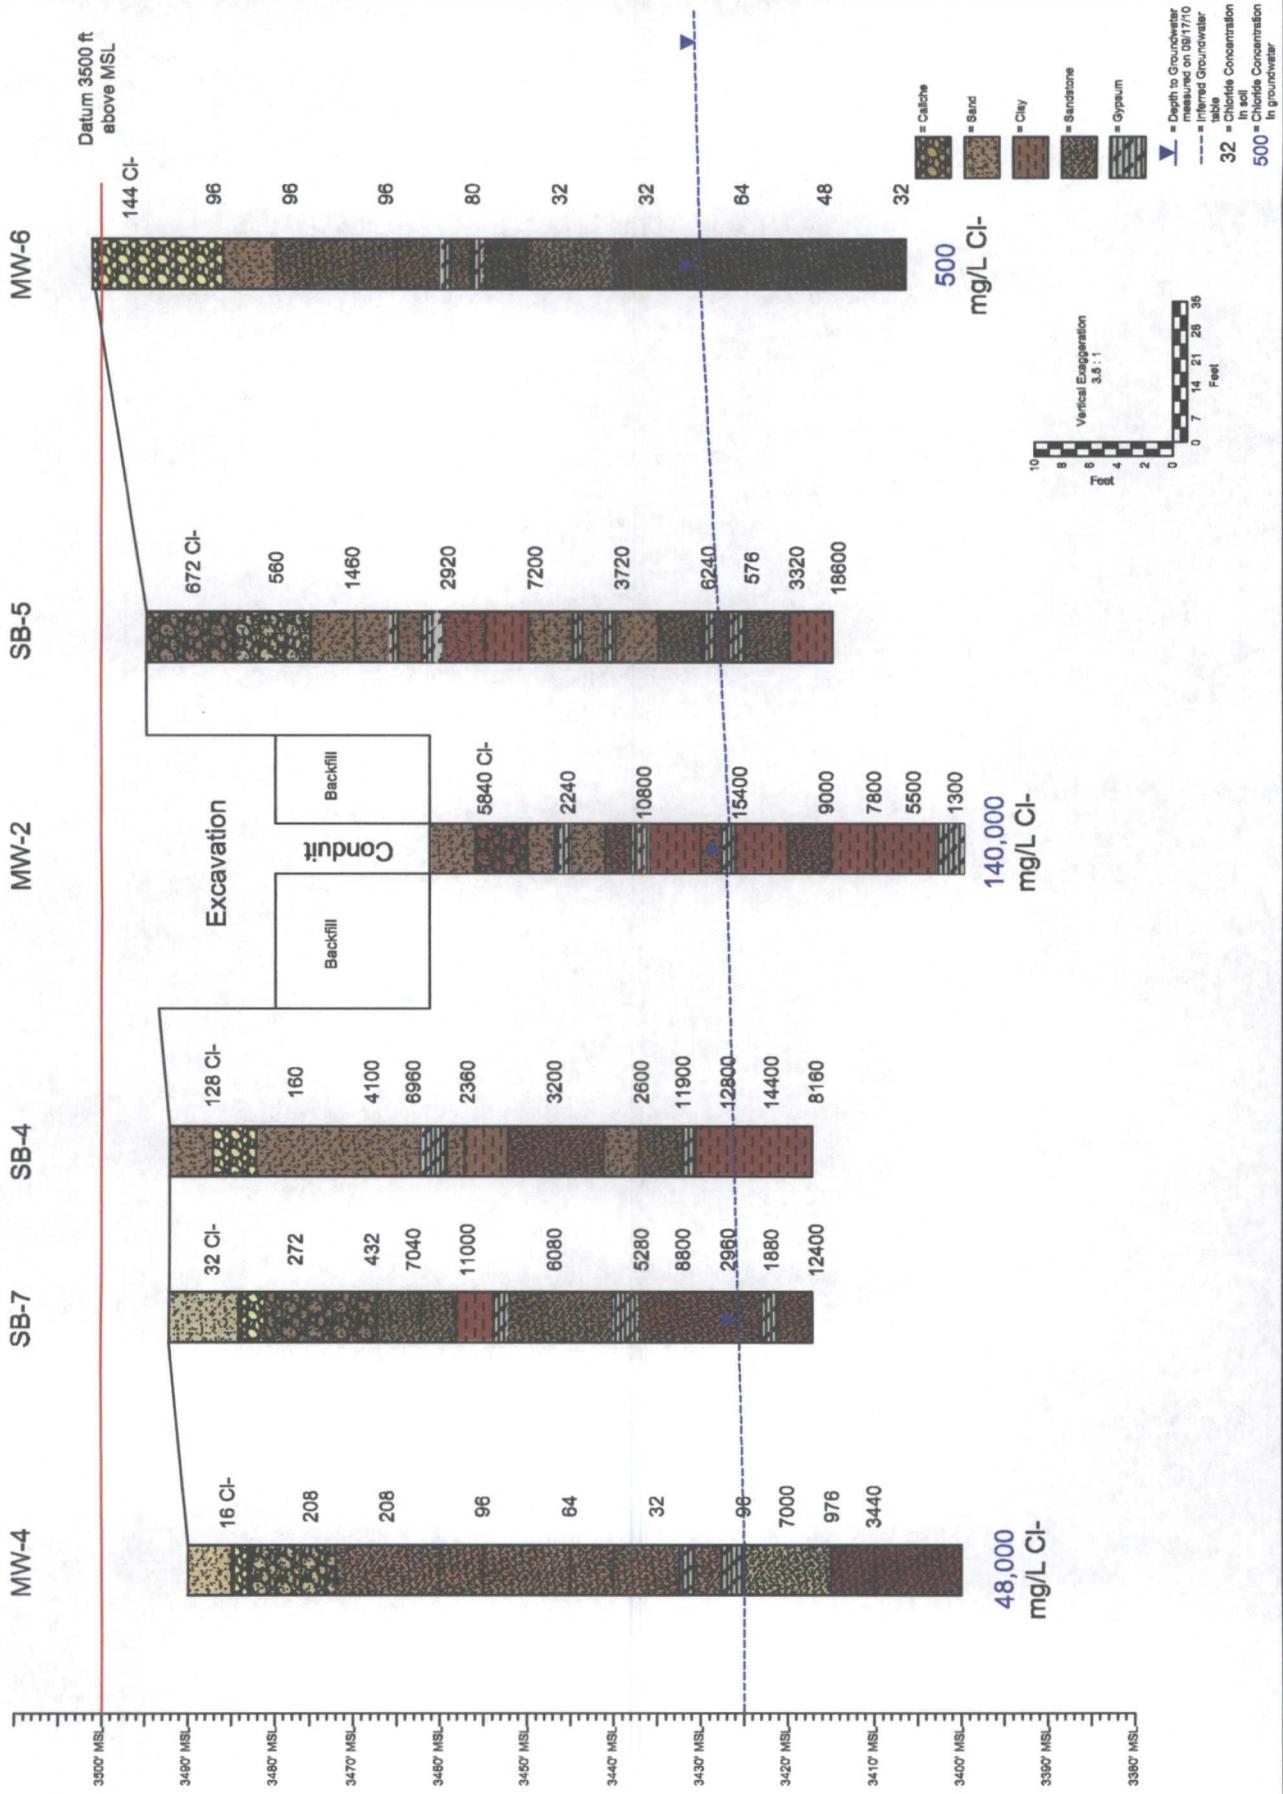
East - West Stratigraphic Cross Section B - B'
 G.H. Cobb Federal #1 (2RP-369) Eddy County, New Mexico
 BOPCO, L.P.

West
B

East
B'

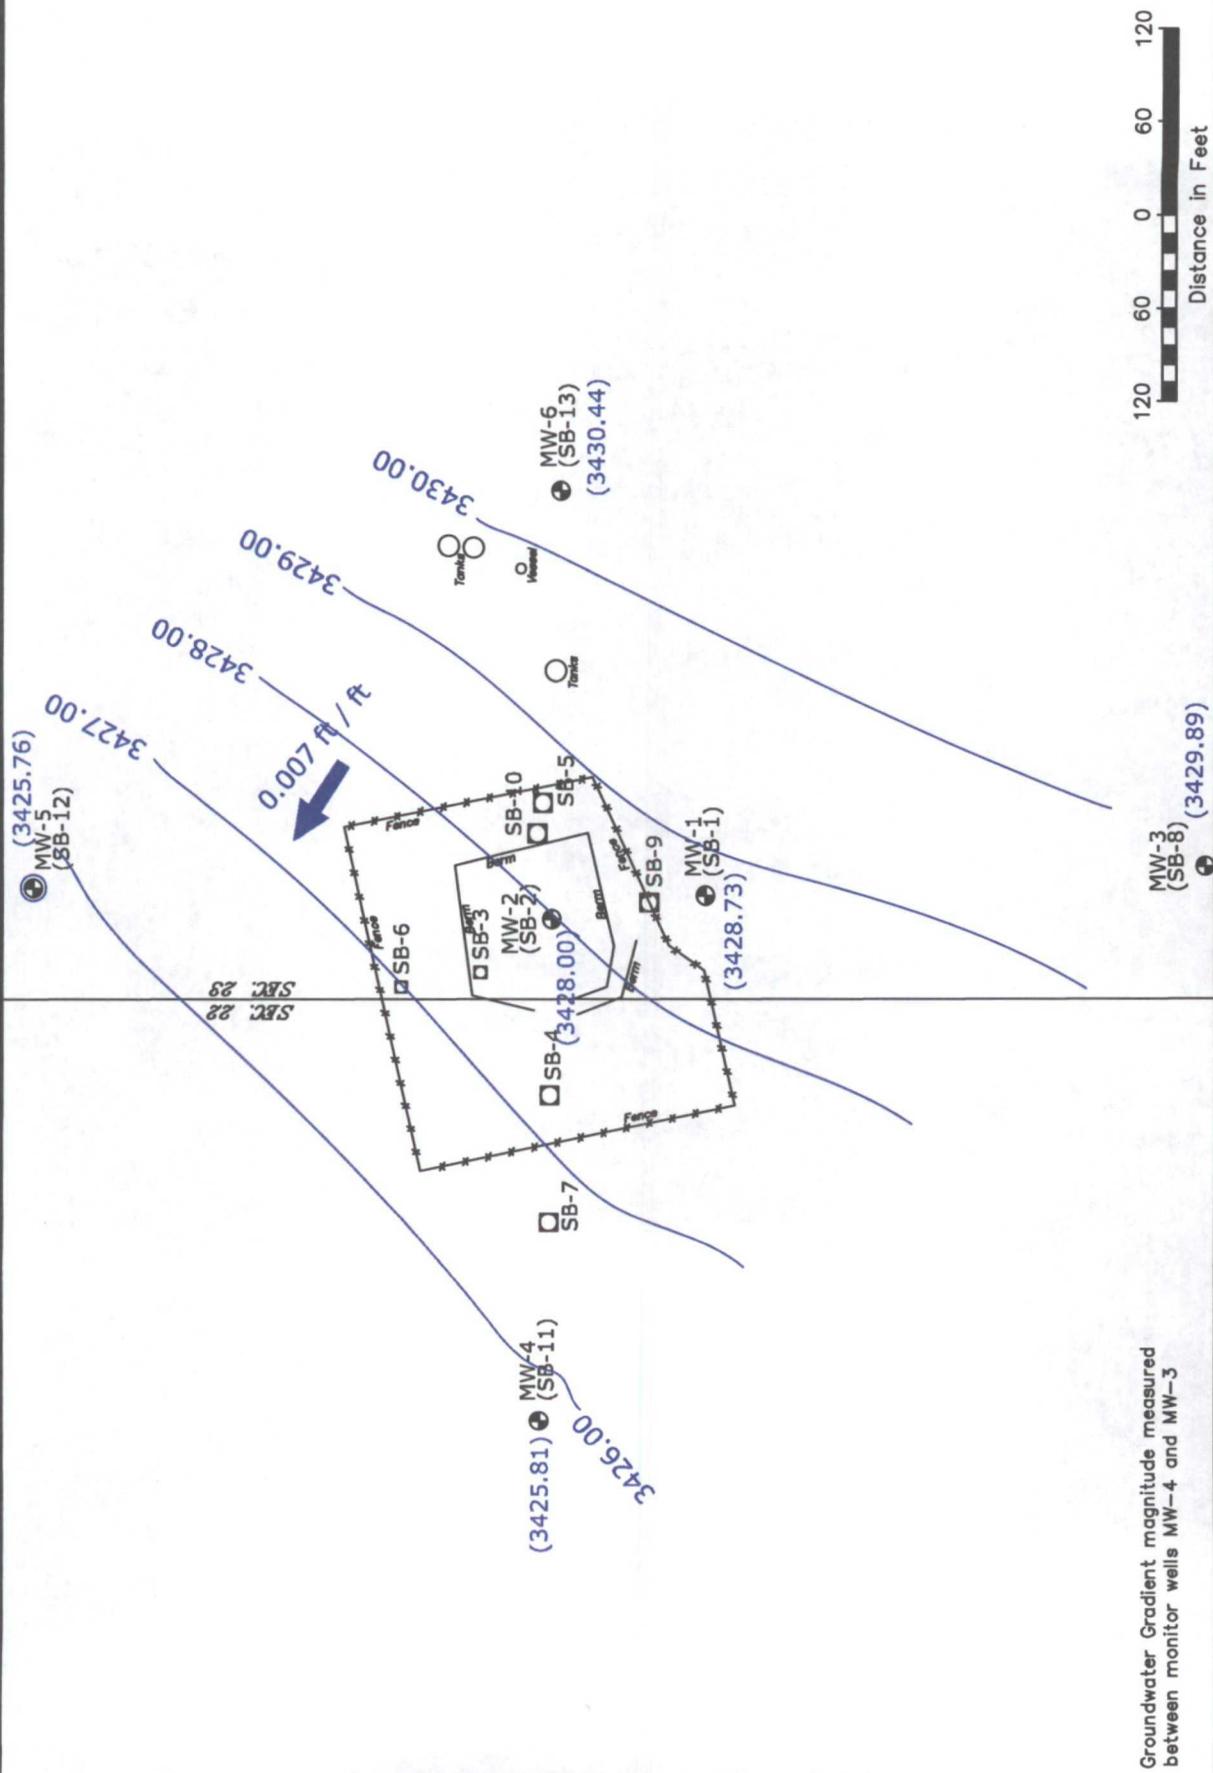
Groundwater Gradient magnitude measured between monitor wells MW-4 and MW-3

Groundwater was observed at depths ranging from 58 to 102 feet bgs in the on-site monitor wells. Groundwater elevation data collected during the September 19, 2010 sampling event indicated an inferred groundwater gradient of generally 0.007 feet/foot to the northwest. Locations of the groundwater monitor wells are depicted on Figure 2. Groundwater Elevation Data is provided as Table 2. Inferred Groundwater Gradient Maps are provided as Figures 4a and 4b.

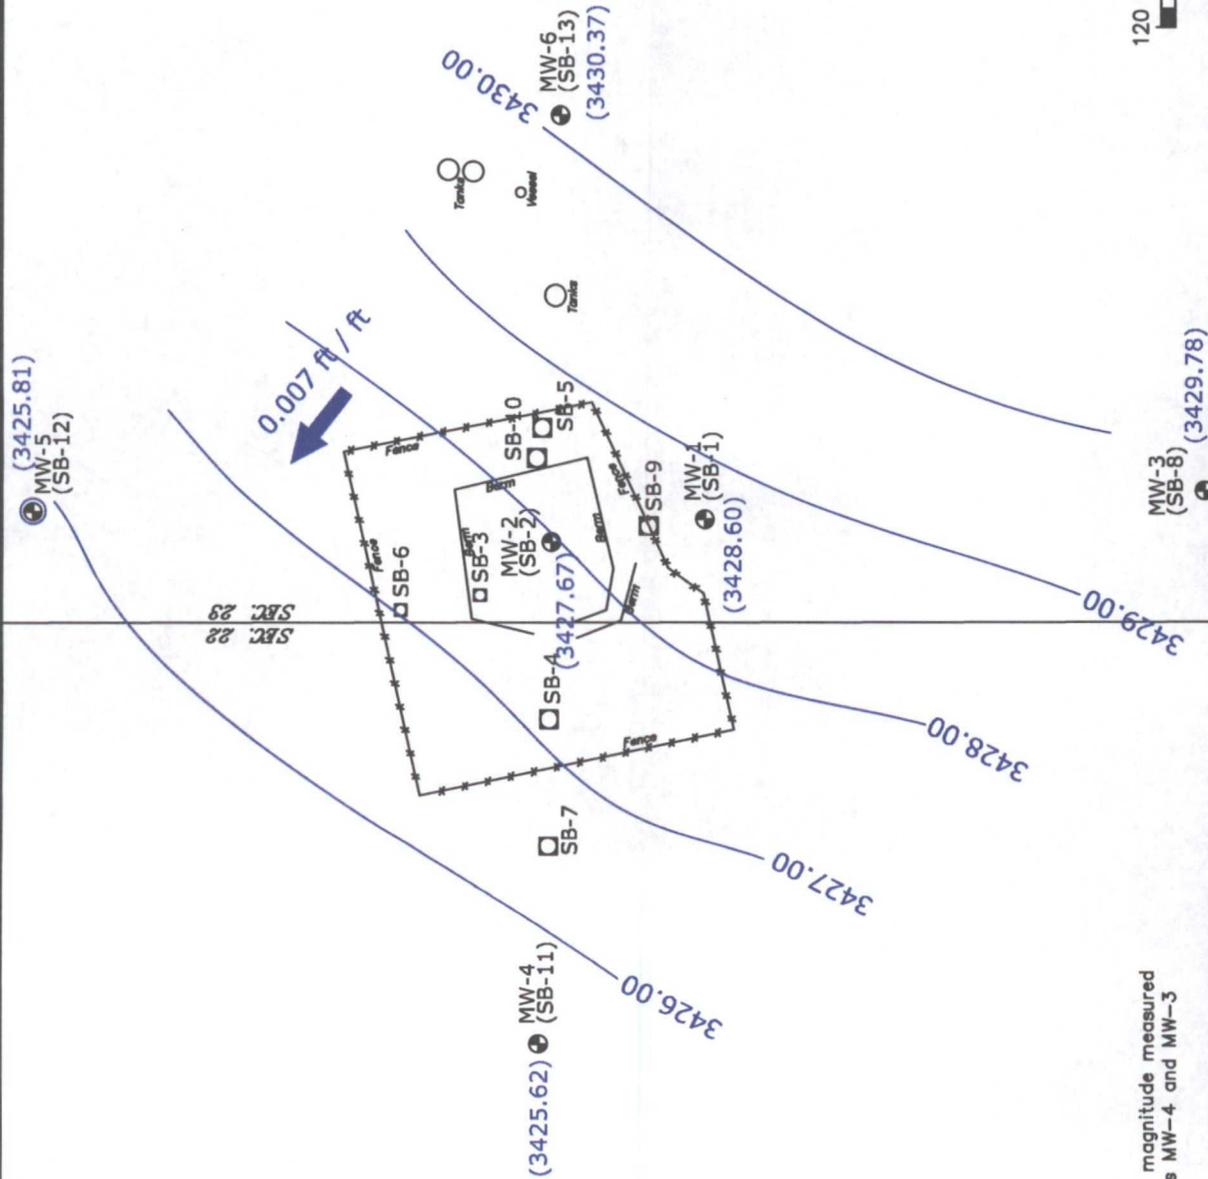
Groundwater Gradient magnitude measured between monitor wells MW-4 and MW-3

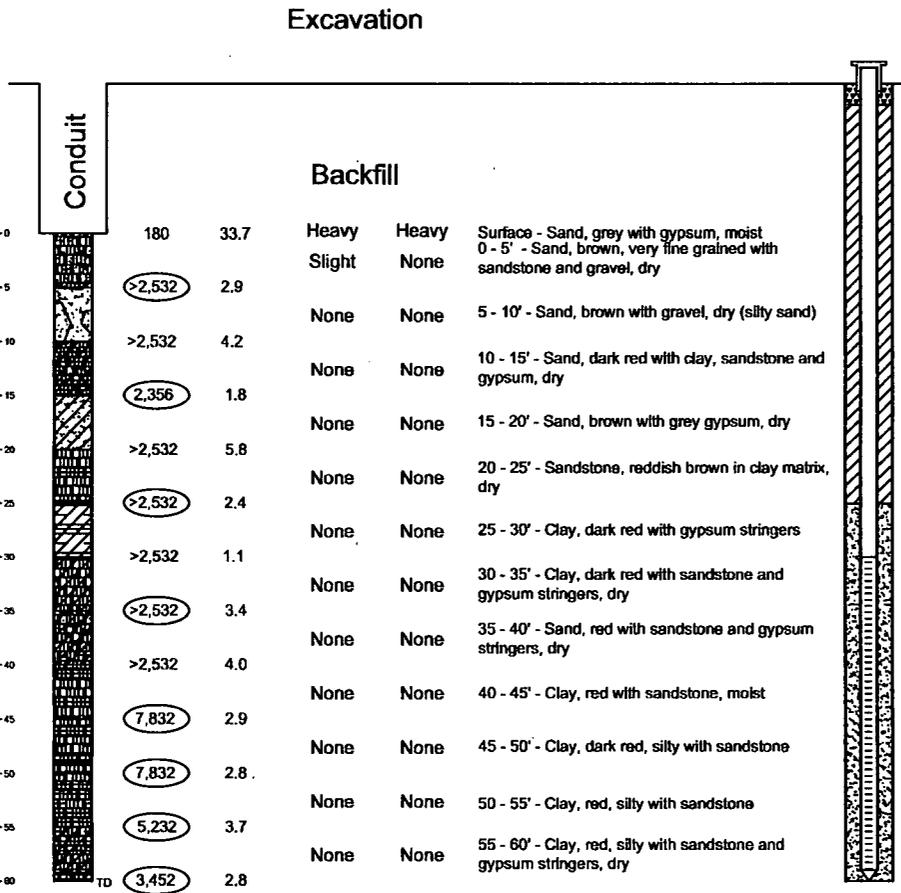
Monitor Well MW-2

Date Drilled December 30, 2009
 Thickness of Bentonite Seal 53 Ft
 Depth of Exploratory Boring 80 Ft bgs
 Depth to Groundwater _____
 Ground Water Elevation _____

▼ Indicates the PSH level measured on _____
 ▼ Indicates the groundwater level measured on _____
 ○ Indicates samples selected for Laboratory Analysis.
 PID Head-space reading in ppm obtained with a photo-ionization detector.

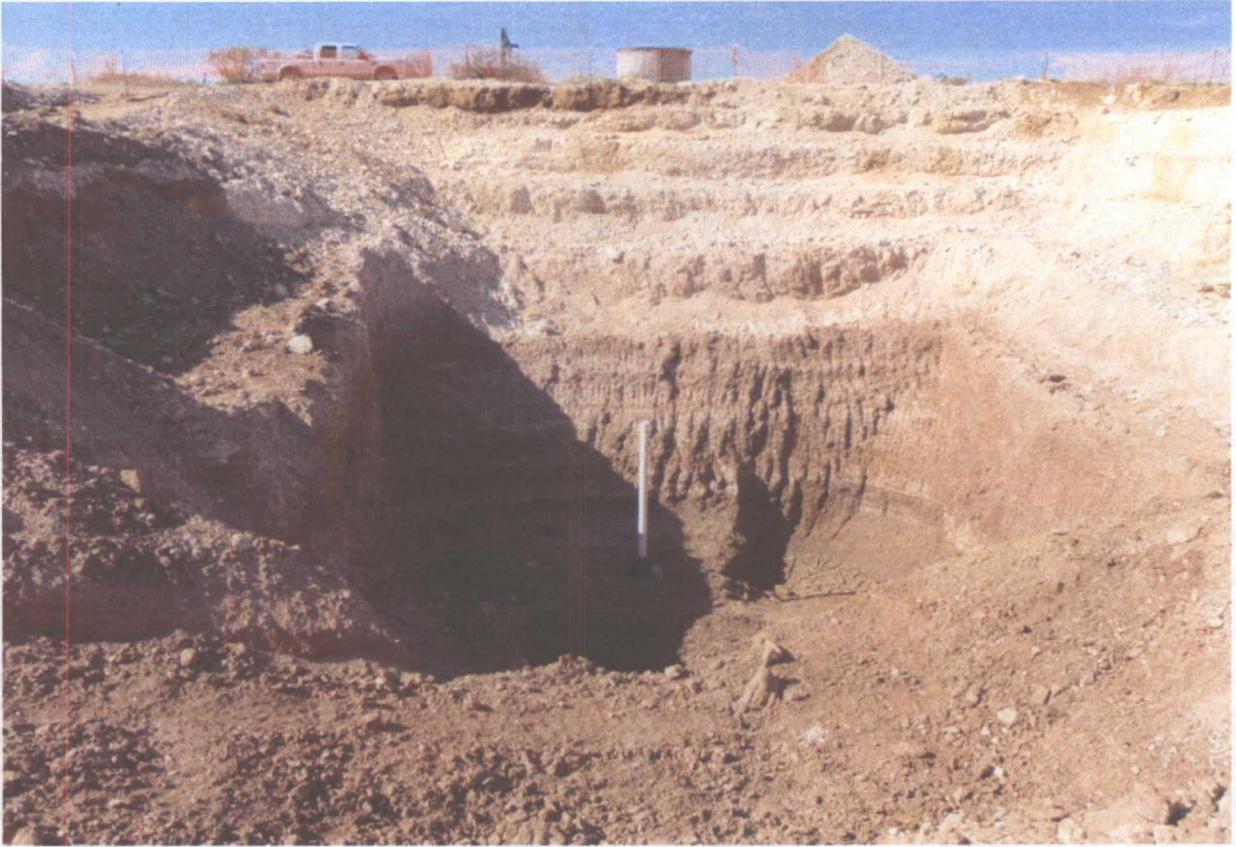
Photograph (looking East) of initial excavation with conduit riser at G.H. Cobb Federal #1.

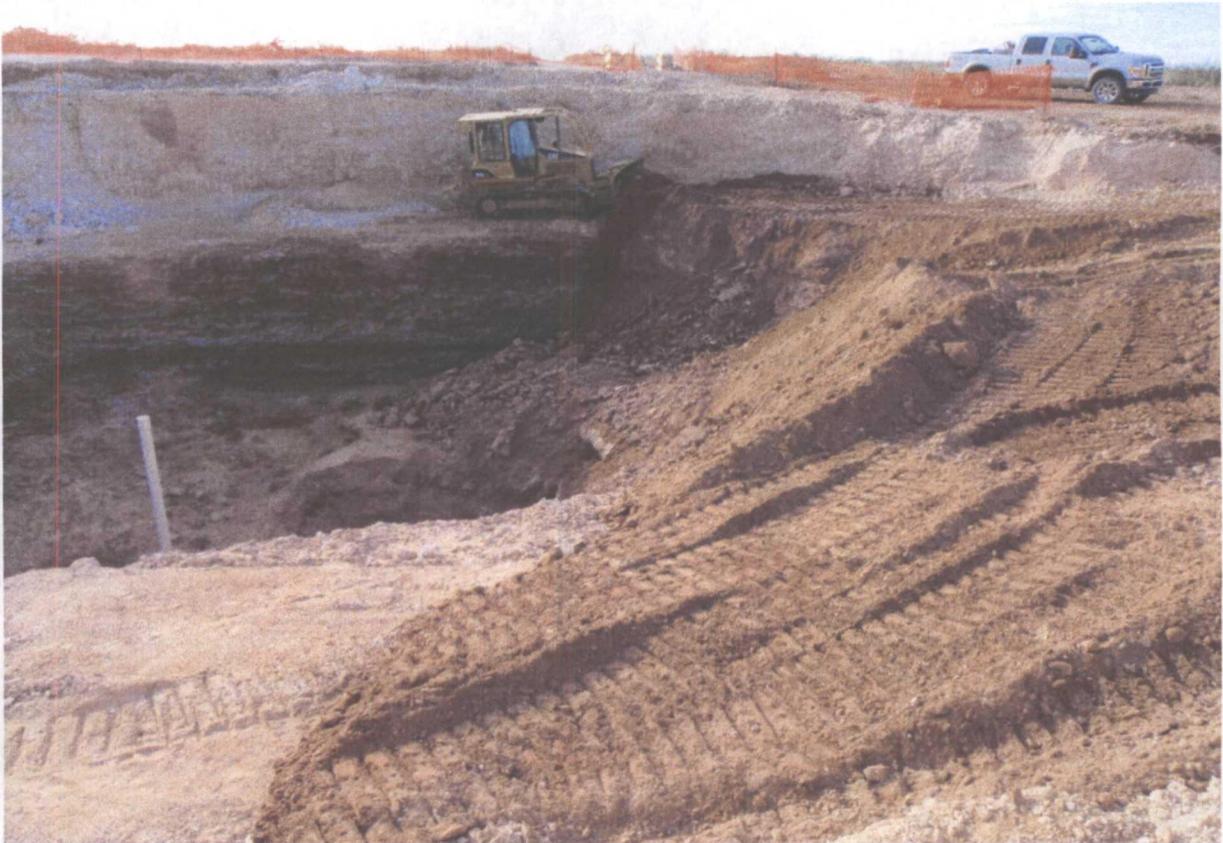
Photograph (looking East) of backfilling activities to allow for drilling at G.H. Cobb Federal #1.

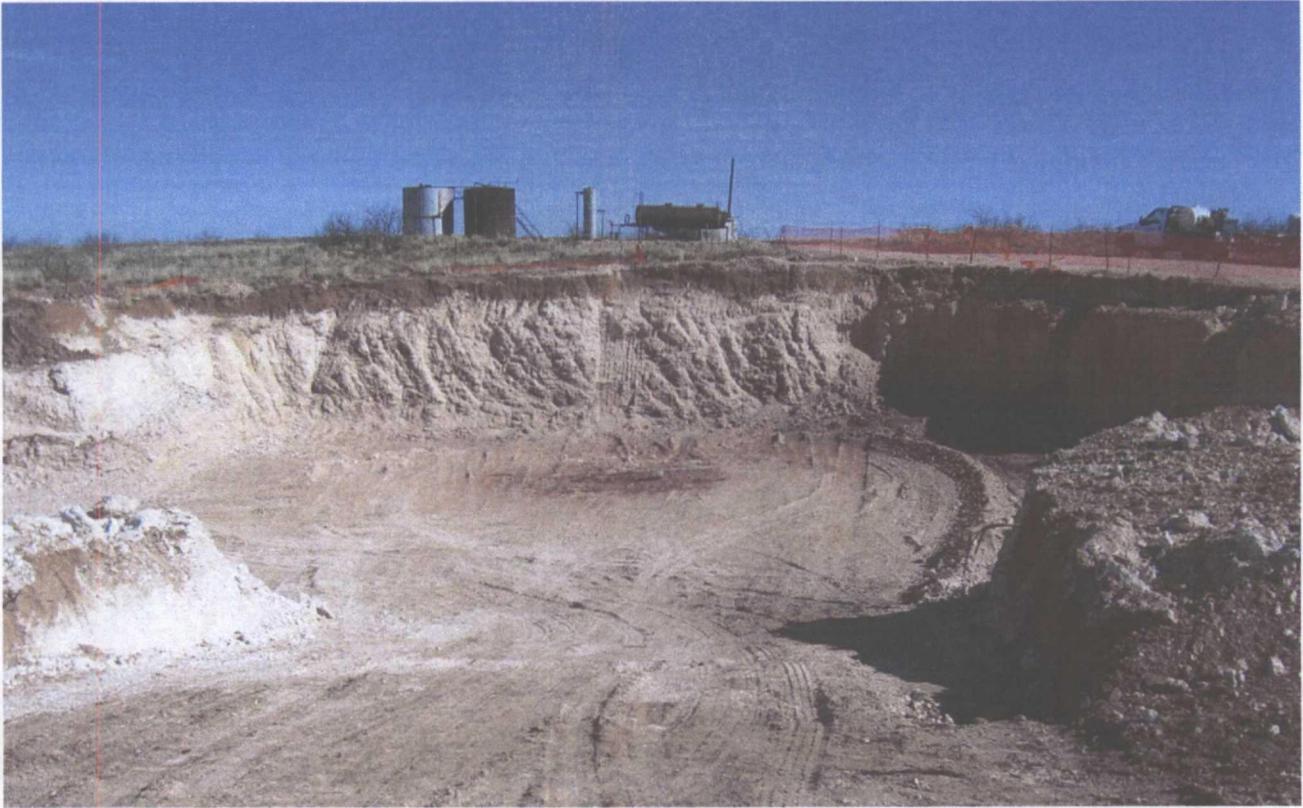
Photograph (looking East) of current excavation at G.H. Cobb Federal #1.

With NMOCD approval, BOPCO proposes to install a 20 mil polyurethane liner at approximately ten (10) to twelve (12) feet bgs in the existing excavation. Approximately one (1) foot of non-impacted cushion sand will be installed above and below the liner to protect the liner from damage during installation and backfilling activities. The excavation will be backfilled with locally purchased, non-impacted soil and compacted in twelve (12) inch lifts. Following backfilling activities, the site will be contoured to fit the surrounding topography and seeded with a BLM-approved seed mixture.

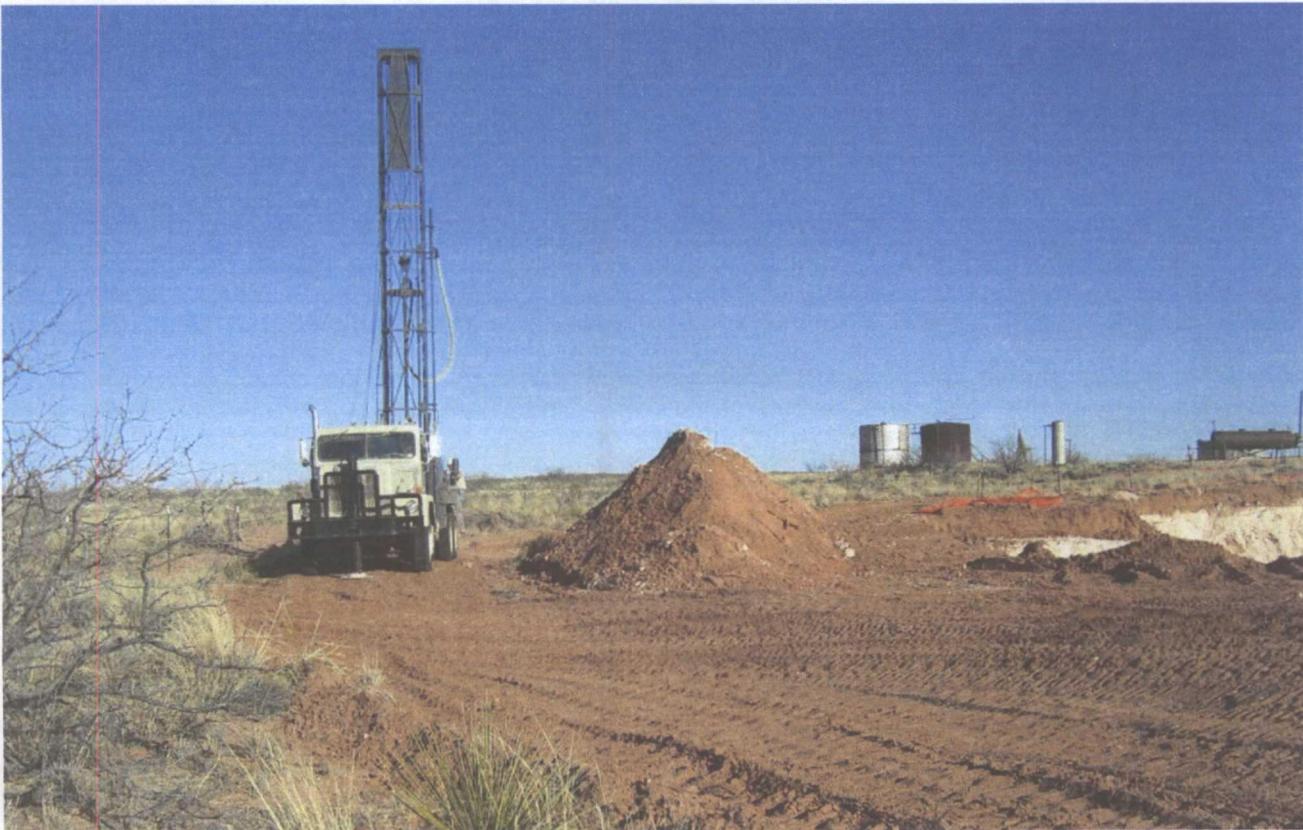
Photograph (looking Southeast) of drilling activities at G.H. Cobb Federal #1.
