Britt B Battery
(1RP-3004)

Termination Request

**RE: Termination Request
ConocoPhillips Britt B Battery (1RP-3004)
UL/E sec. 15 T20S R37E
API No. 30-025-06111**

CONOCOPHILLIPS BRITT B BATTERY

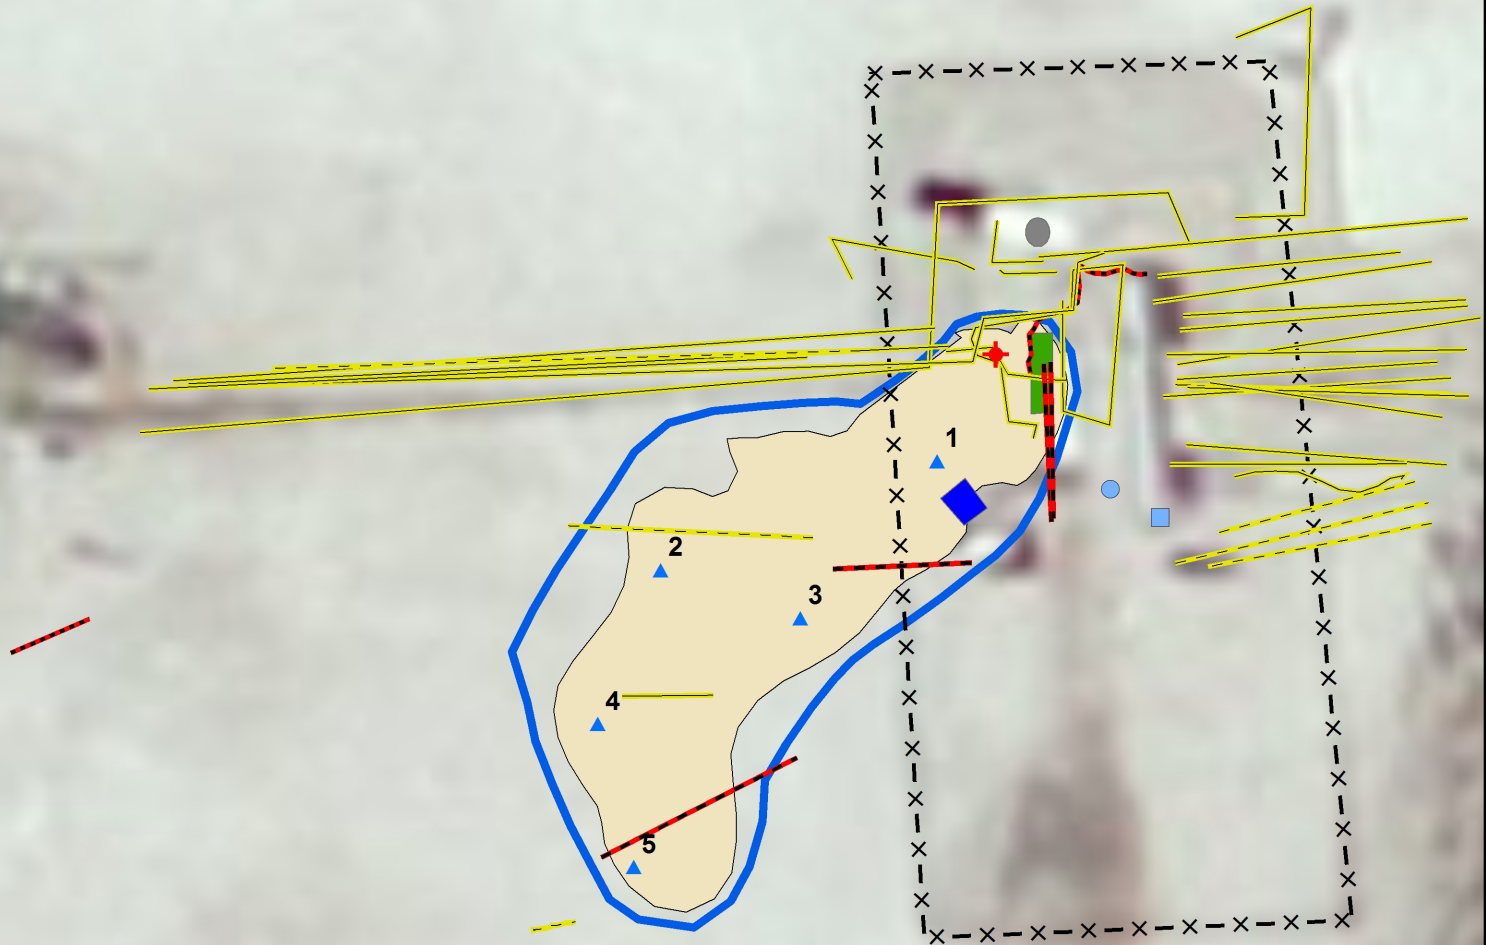
Figure 1

Excavation Data

Final Sampling Data

CI-	PID	GRO	DRO	B	T	E	X	BTEX
5 pt. comp at 6 in	256	0.1	<50	<50	<0.2	<0.2	<0.2	<0.6	<1.2

CAP activities began at the site on December 17th, 2014. The release area was scraped down to 6 inches, and a 5 point bottom composite was taken and field tested for chlorides and organic vapors (Figure 1). The 5 point bottom composite was then sent to a commercial laboratory for analysis. Laboratory analysis confirmed GRO, DRO and BTEX readings were below regulatory standards, while the chloride reading was slightly above regulatory standards, returning a value of 256 mg/kg (Appendix B). All excavated soil, a total of 60 cubic yards, was taken to a NMOCD approved facility for disposal. A total of 60 cubic yards of caliche was imported to the site to use as backfill. A composite sample of the imported caliche was taken to a commercial laboratory for analysis and returned a chloride value of 192 mg/kg. The site was backfilled according to a NMOCD notification sent January 8th, 2015 and NMOCD's response on January 9th, 2015 with the imported caliche and contoured to the surrounding location.

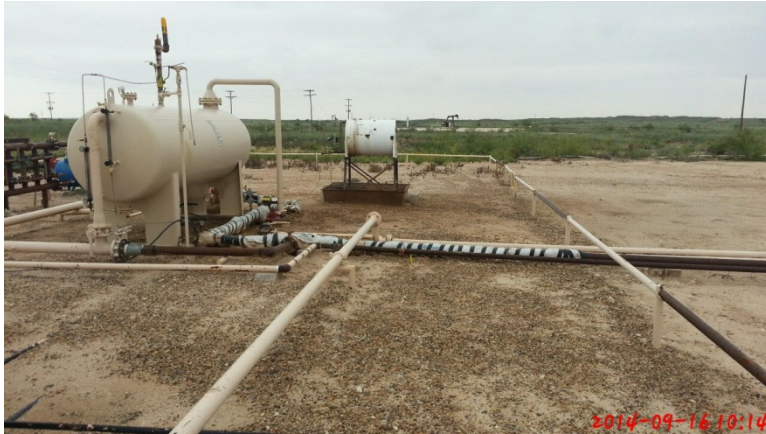
Source of the release, facing south

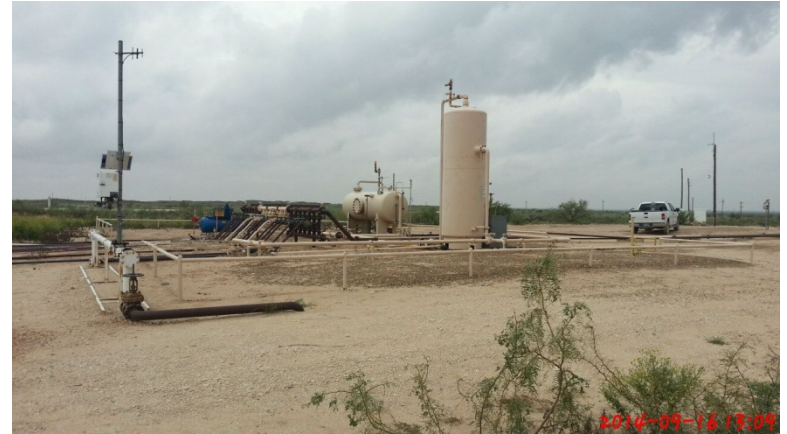
Initial site photo, facing southwest

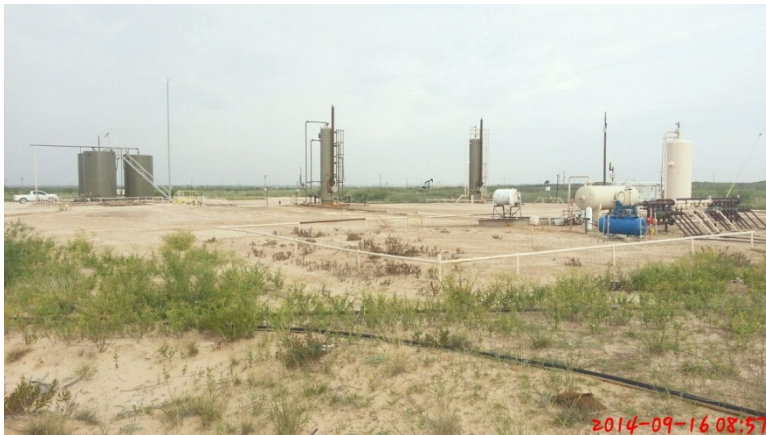
Initial site photo, facing northwest

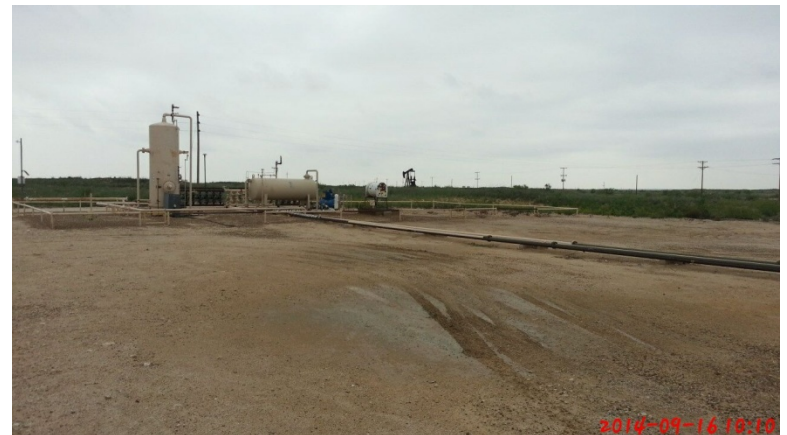
Initial site photo, facing southeast

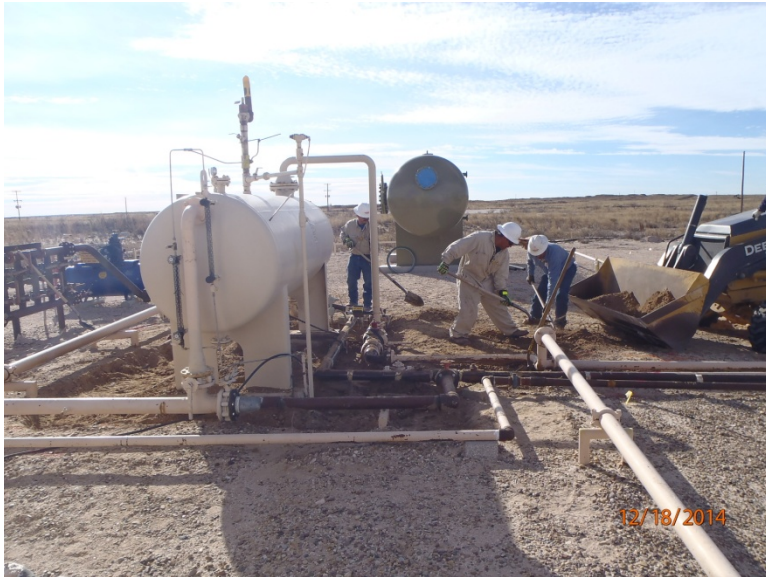
Shoveling release area, facing south 12/18/14

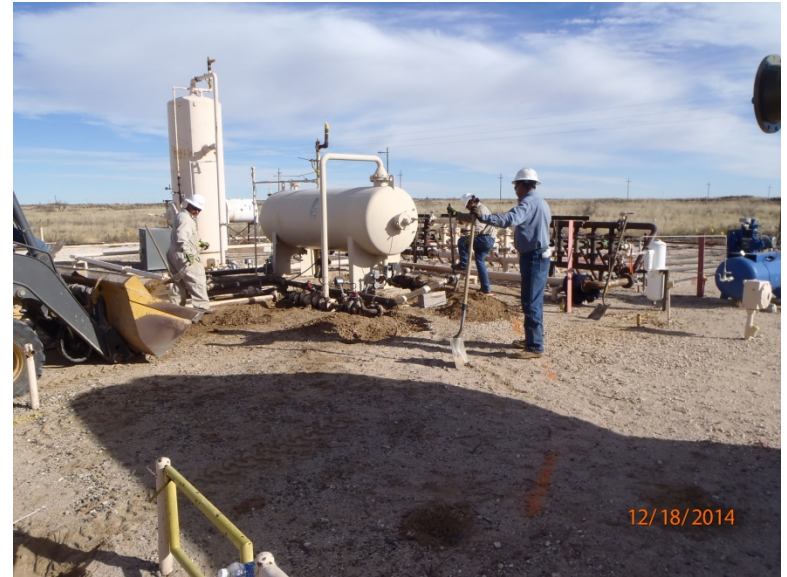
Shoveling release area, facing northeast 12/18/14

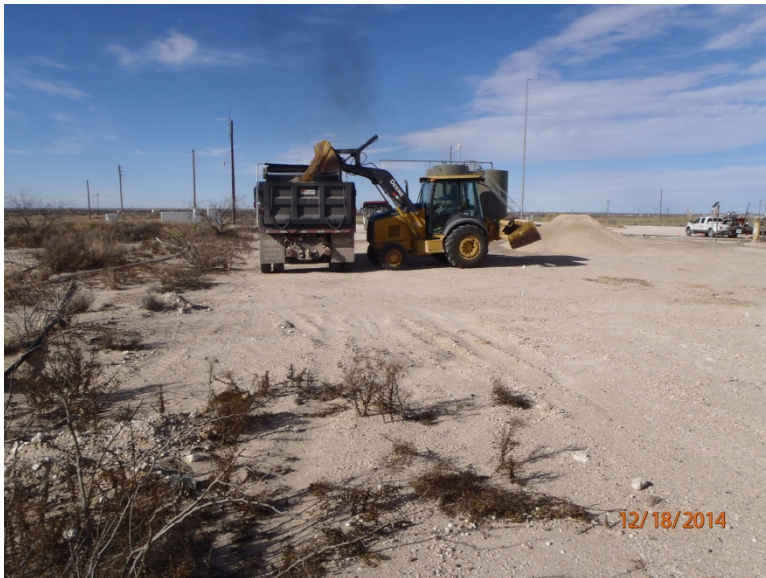
Exporting soil, facing west 12/18/14

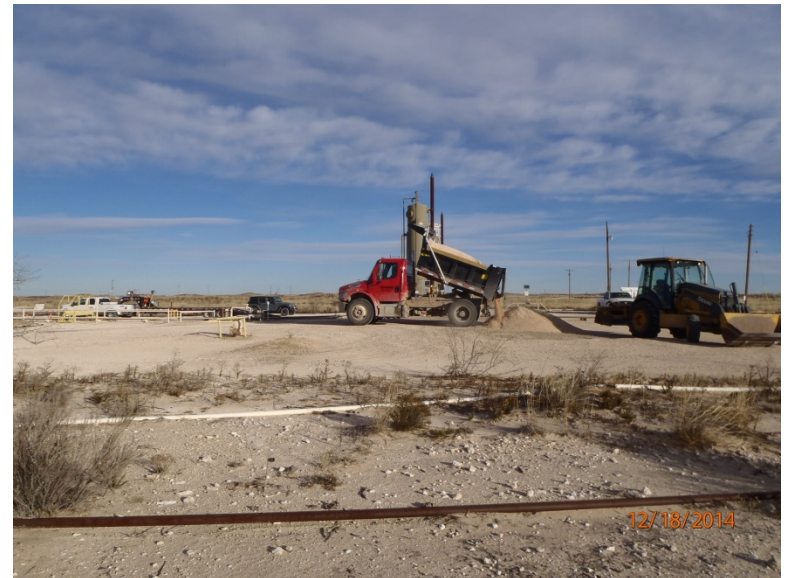
Importing soil, facing north 12/18/14

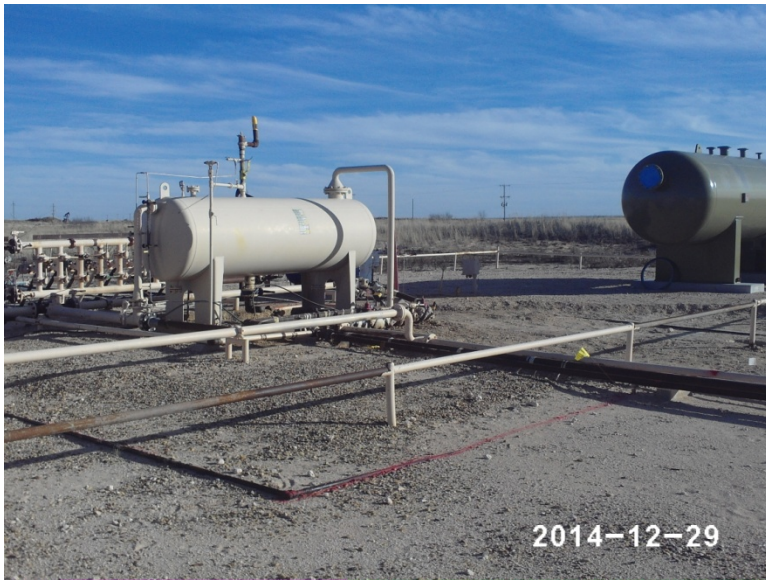
Completed 6 in scrape, facing southeast 12/29/14

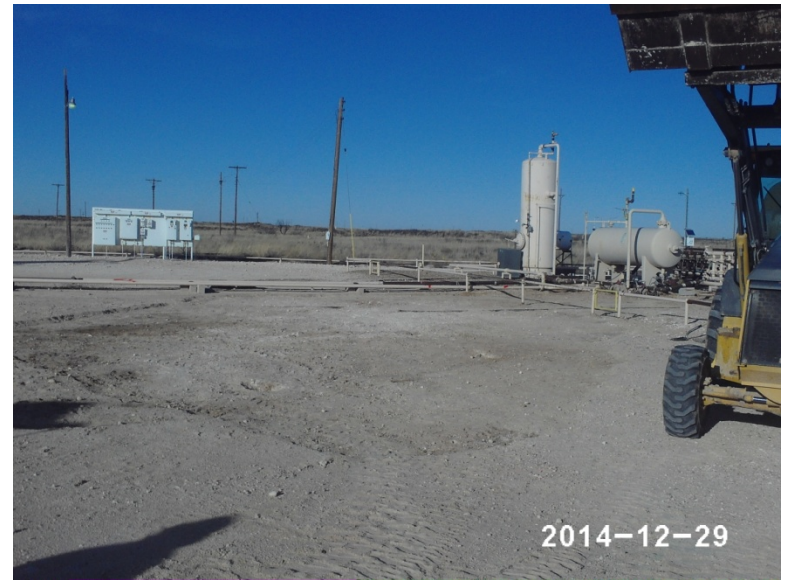
Completed 6 in scrape, facing north 12/29/14

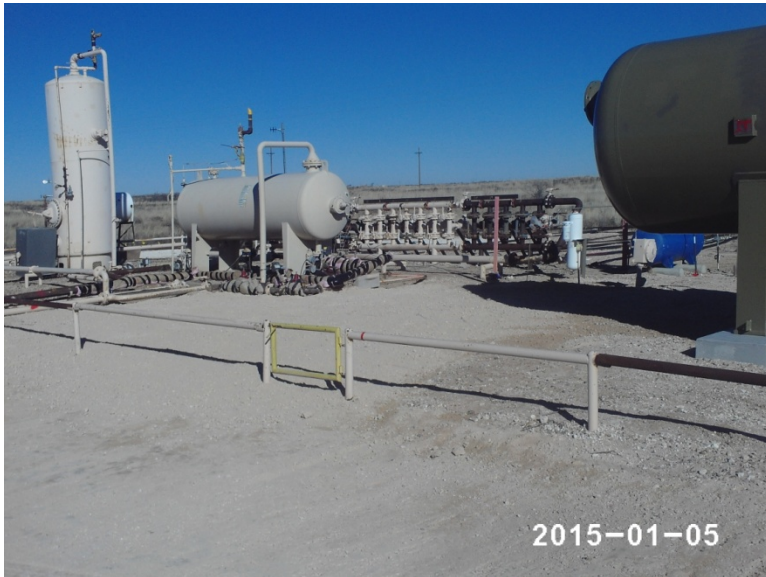
Site completed, facing northeast 1/5/15

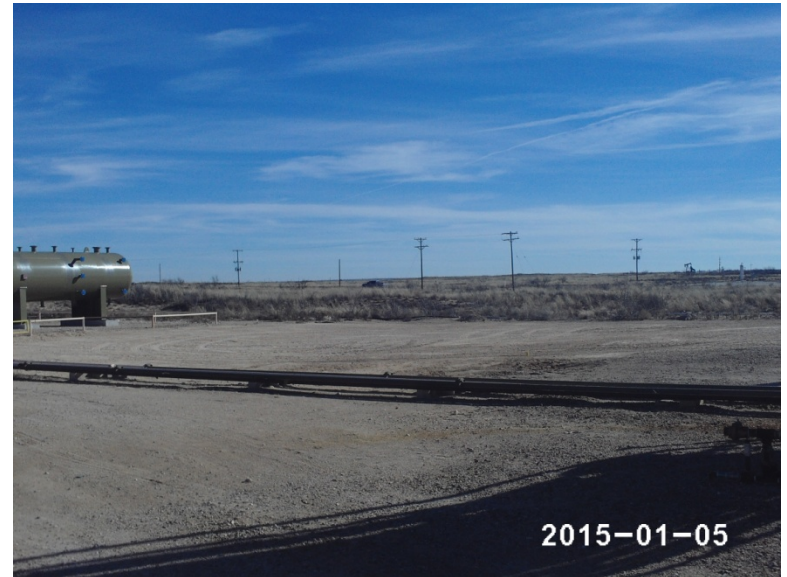
Site completed, facing southeast 1/5/15
