MCA Transfer Line

(1RP-3373)

Termination Request

> RE: Termination Request ConocoPhillips MCA Transfer Line (1RP-3373) UL/C sec. 28 T17S R32E

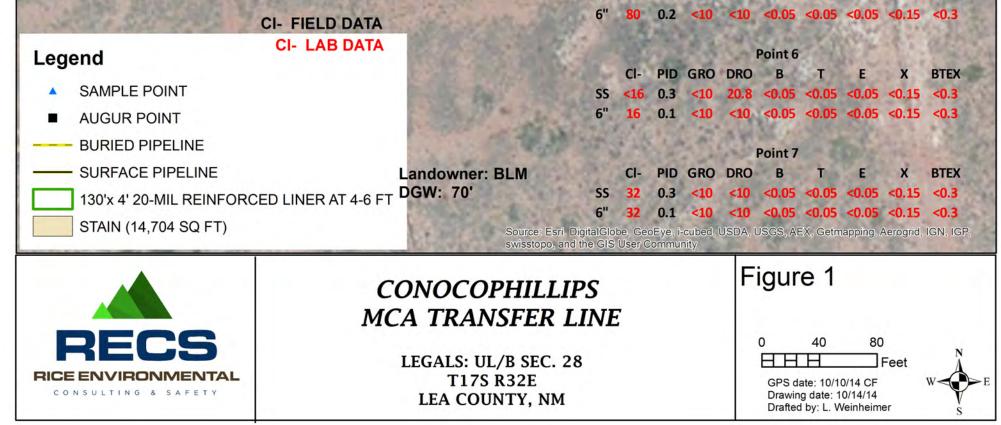
Initial Sampling Data

RECS personnel were on site to visually assess the release on December 20th, 2013. The release was mapped and photographed. Based on the visual assessment, a hydro-vac was used to remove the wet material from the trench. Once all the wet material was removed, samples were taken from the north wall of the trench, and two auger points were installed in the base of the trench. As the auger points were advanced, samples were taken at varying depths and field tested for chlorides and organic vapors. Representative samples from both the auger points and all three wall samples were taken to a commercial laboratory for analysis (Appendix B). Laboratory results from the wall samples confirmed chloride, Gasoline Range Organics (GRO), Diesel Range Organics (DRO) and BTEX readings at or near non-detectable levels. Laboratory sampling from both auger points revealed elevated chloride readings with depth. GRO, DRO and BTEX readings

in Auger Point 1 returned values at or near non-detectable levels at all depths. In Auger Point 2, GRO, DRO and BTEX readings were elevated at 3 ft bgs. However, the readings declined to non-detectable levels at 12 ft bgs, except for the DRO reading, which returned a result of 17.7 mg/kg. Given the elevated chloride readings with depth in both auger points, RECS installed a 20-mil reinforced poly liner measuring 130 ft x 4 ft throughout the base of the trench (Figure 1). NMOCD verbally approved the liner installation on January 8th, 2014.

On October 10th, 2014, seven points within the remainder of the release area were sampled at the surface and with depth. The soil samples were field tested for chlorides and organic vapors, and the samples were then taken to a commercial laboratory for analysis. Points 1 and 2 and Points 4 through 7 returned laboratory chloride readings below regulatory standards with depth. Point 3 returned laboratory chloride values of 7,330 mg/kg at the surface and 80 mg/kg at 2 ft bgs. GRO, DRO and BTEX readings returned values of non-detect at all points at all depths, except at the surface of Point 6, where the DRO reading was 20.8 mg/kg.

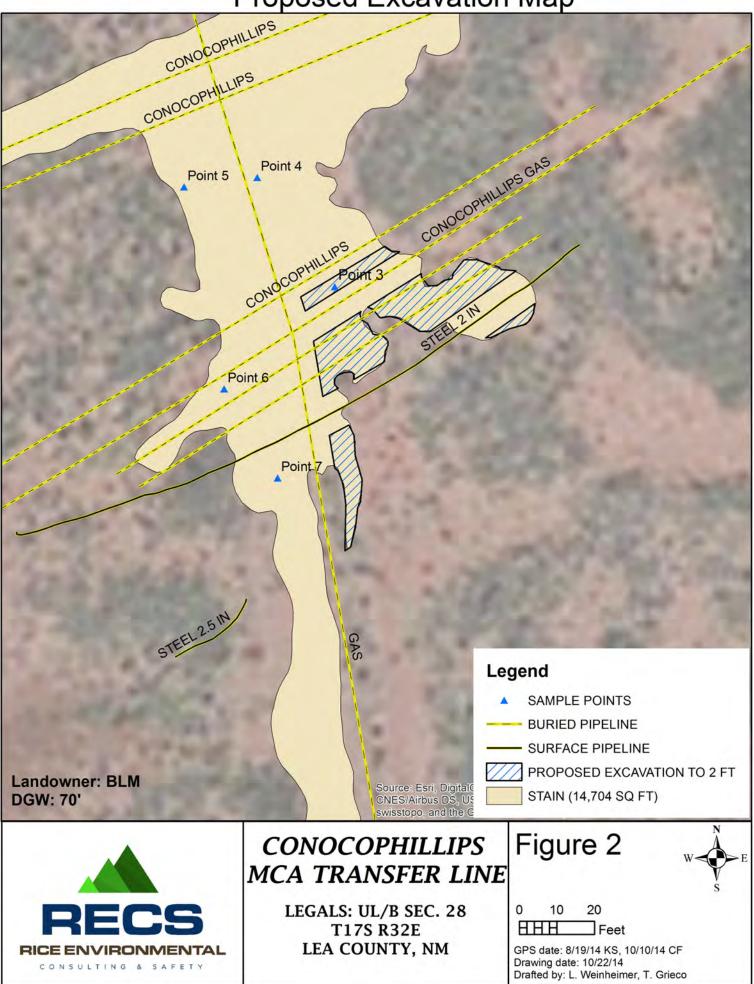
Proposed Excavation Map

Based on the laboratory analysis of the release, a Corrective Action Plan (CAP) was submitted to NMOCD and BLM on October 30^{th} , 2014. BLM approved the CAP on October 30^{th} , 2014, and NMOCD approved the CAP on October 31^{st} , 2014. The CAP stated that the area around Point 3 would be excavated to a depth of 2 ft bgs (Figure 2). To provide for the safety of equipment and personnel, the excavation would remain 3 - 5 ft from the active pipelines. Once the excavation was completed, a bottom composite would be taken and field tested for chlorides. If the field data indicated that the composite would not achieve a chloride reading below regulatory standards, the scrape would be deepened until field testing indicated that the chloride reading from the bottom composite would be below regulatory standards. The bottom composite would then be taken to a commercial laboratory to confirm that the chloride reading is below regulatory standards.

All excavated soil would be taken to a NMOCD approved facility for disposal. Clean top soil would be imported to the site to serve as backfill. A sample of the imported soil would be taken to a commercial laboratory to confirm that the chloride reading was below regulatory standards. The scrape would be backfilled with the imported soil and contoured to the surrounding location. All disturbed areas in the pasture would be seeded with a blend of native vegetation.

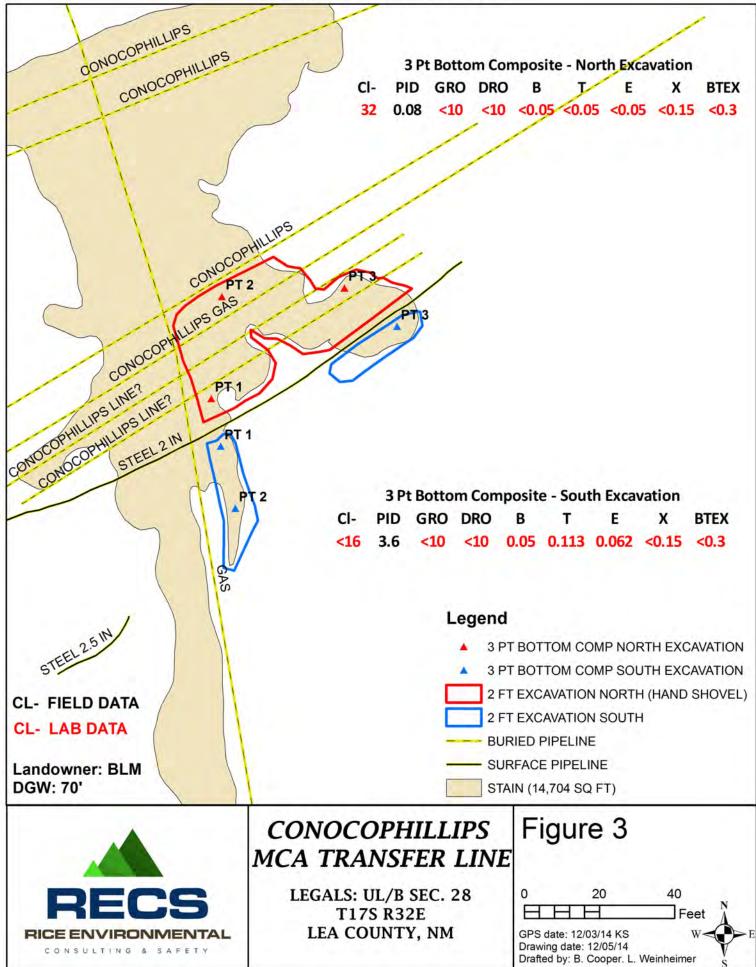
Excavation Data

Corrective actions began at the site on November 25th, 2014. The release area, as stated in the CAP, was scraped down 2 ft (Figure 3). A 3 point bottom composite was taken from both the northern and southern scrape. The composites were field tested for chlorides and organic vapors and then taken to a commercial laboratory for analyses (Appendix C). The northern composite returned a laboratory chloride reading of 32 mg/kg, and the southern composite returned a laboratory chloride reading of non-detect. GRO, DRO and BTEX readings for both composites returned readings of non-detect, except for the benzene, toluene and ethyl-benzene in the southern composite. In the southern composite, the benzene reading returned a value of 0.05 mg/kg, the toluene reading returned a value of 0.113 mg/kg and the ethyl-benzene reading returned a value of 0.062 mg/kg.

On December 5th, 2014, a request to backfill the site was sent to NMOCD and BLM. BLM approved the site to be backfilled on December 8th, 2014, and NMOCD approved the site to be backfilled on December 9th, 2014. All excavated soil, for a total of 105 cubic yards, was taken to NMOCD approved facilities for disposal. A total of 135 cubic yards of top soil was imported to the site to serve as backfill. A 5 point composite of the imported soil was taken to a commercial laboratory for analysis and returned a chloride value of non-detect. The site was backfilled with the imported top soil and contoured to the surrounding location. On December 10th, 2014, the disturbed area was seeded with a 50/50 mix of BLM #2 and BLM #3.

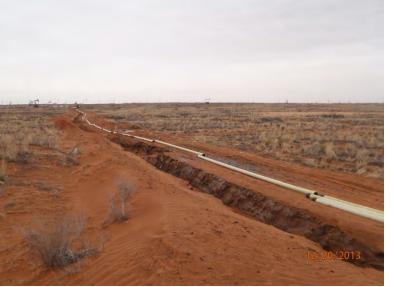
12/20/13

Initial release area, facing south

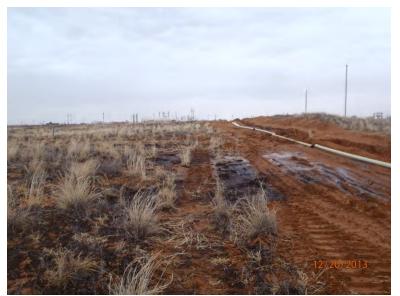
12/20/13

Initial release area, facing northwest

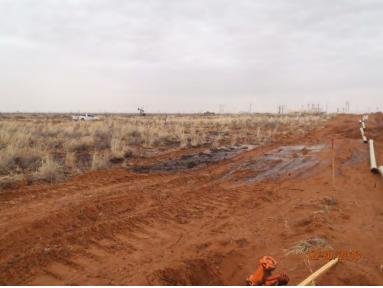
12/20/13

Initial release area, facing west

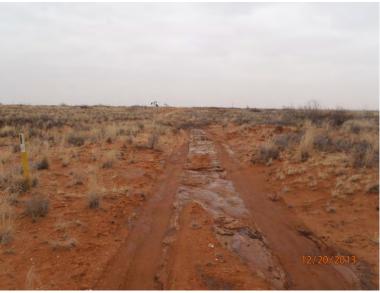
12/20/13

Initial release area, facing southwest

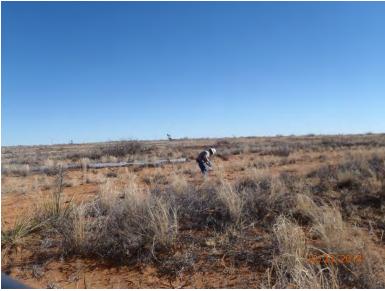
12/23/13

Sampling release, facing south

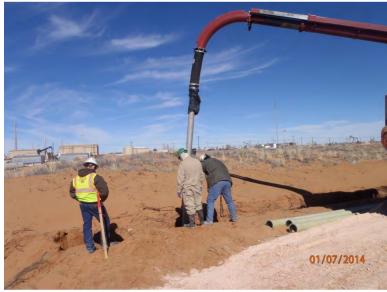
1/7/14

Hydro excavation, facing northeast

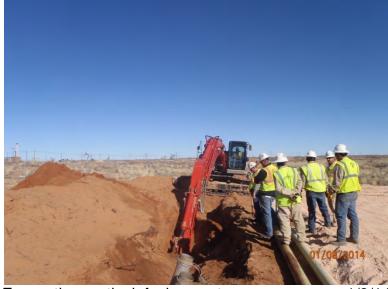
1/8/14

Excavating vertical, facing east

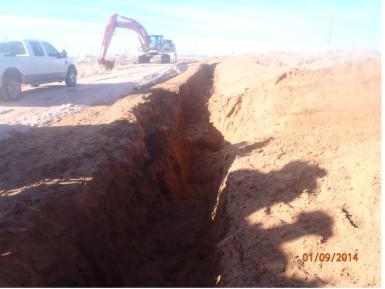
Excavation ready for liner, facing southwest 1/9/14

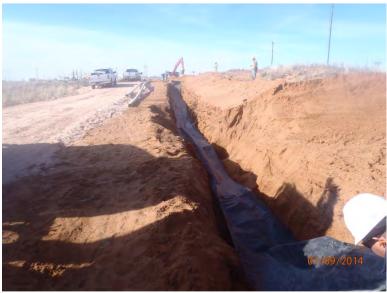
1/9/14

Installing liner in excavation, facing west

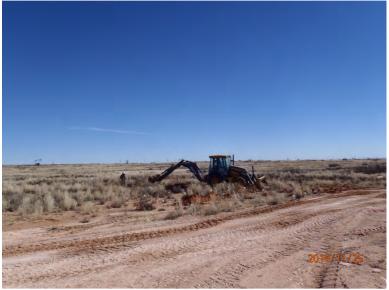
Beginning the south 2 ft excavation, facing southeast 11/25/14

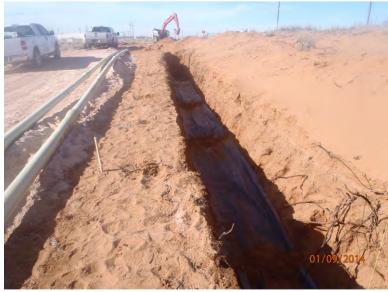
1/9/14

Liner installation completed, facing west

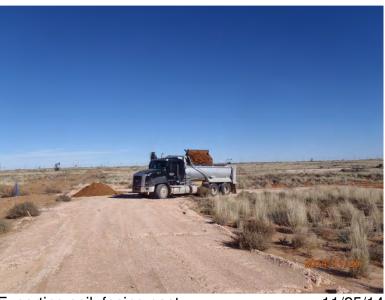
11/25/14

Exporting soil, facing east

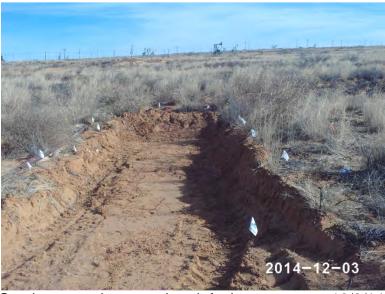
South excavation completed, facing east 12/3/14

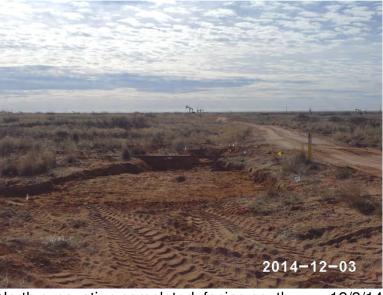
North excavation completed, facing south 12/3/14

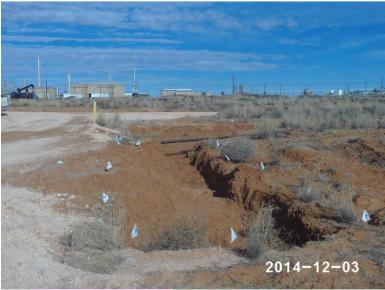
South excavation completed, facing north 12/3/14

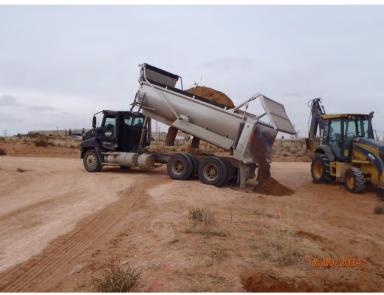
12/9/14

Importing top soil, facing north

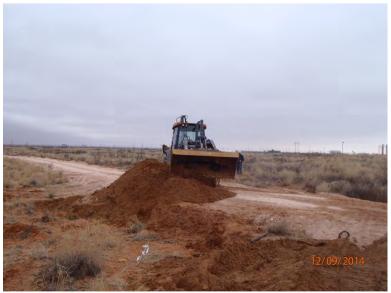
12/9/14

Backfilling site, facing southwest

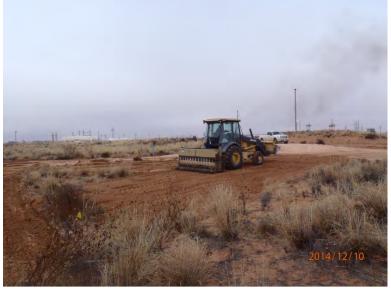
12/10/14

Seeding site, facing northwest

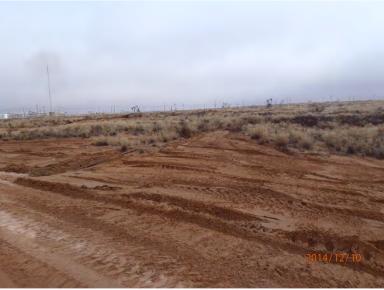
Backfilling completed, facing northeast

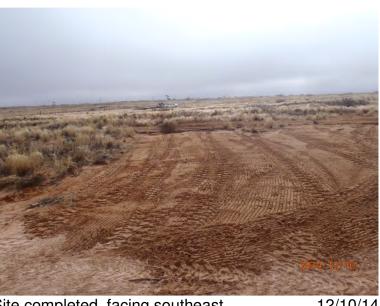
12/10/14

Site completed, facing southeast

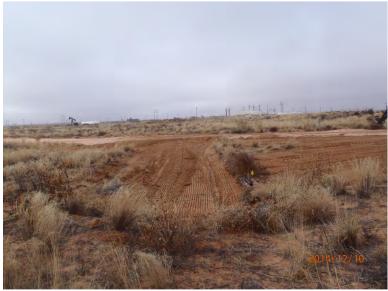
12/10/14

Site completed, facing west

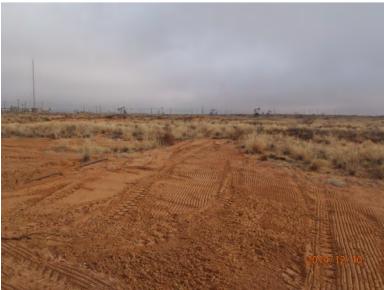
12/10/14

Site completed, facing northeast
