**Investigation Work  
Plan OW-29 & OW-  
30 and N. Drainage  
Ditch Areas**

**RE: APPROVAL WITH MODIFICATIONS  
INVESTIGATION WORK PLAN  
OW-29 & OW-30 AND NORTH DRAINAGE DITCH AREAS  
WESTERN REFINING SOUTHWEST INC., GALLUP REFINERY  
EPA ID # NMD000333211  
HWB-WRG-15-003**

RE: INVESTIGATION WORK PLAN  
OW SERIES WELLS AND CONTAMINANT PLUME MIGRATION  
HYDROCARBON DISCOVERY NORTH DRAINAGE DITCH  
WESTERN REFINING SOUTHWEST, INC., GALLUP REFINERY  
EPA ID # NMD000333211  
HWB-WRG-MISC

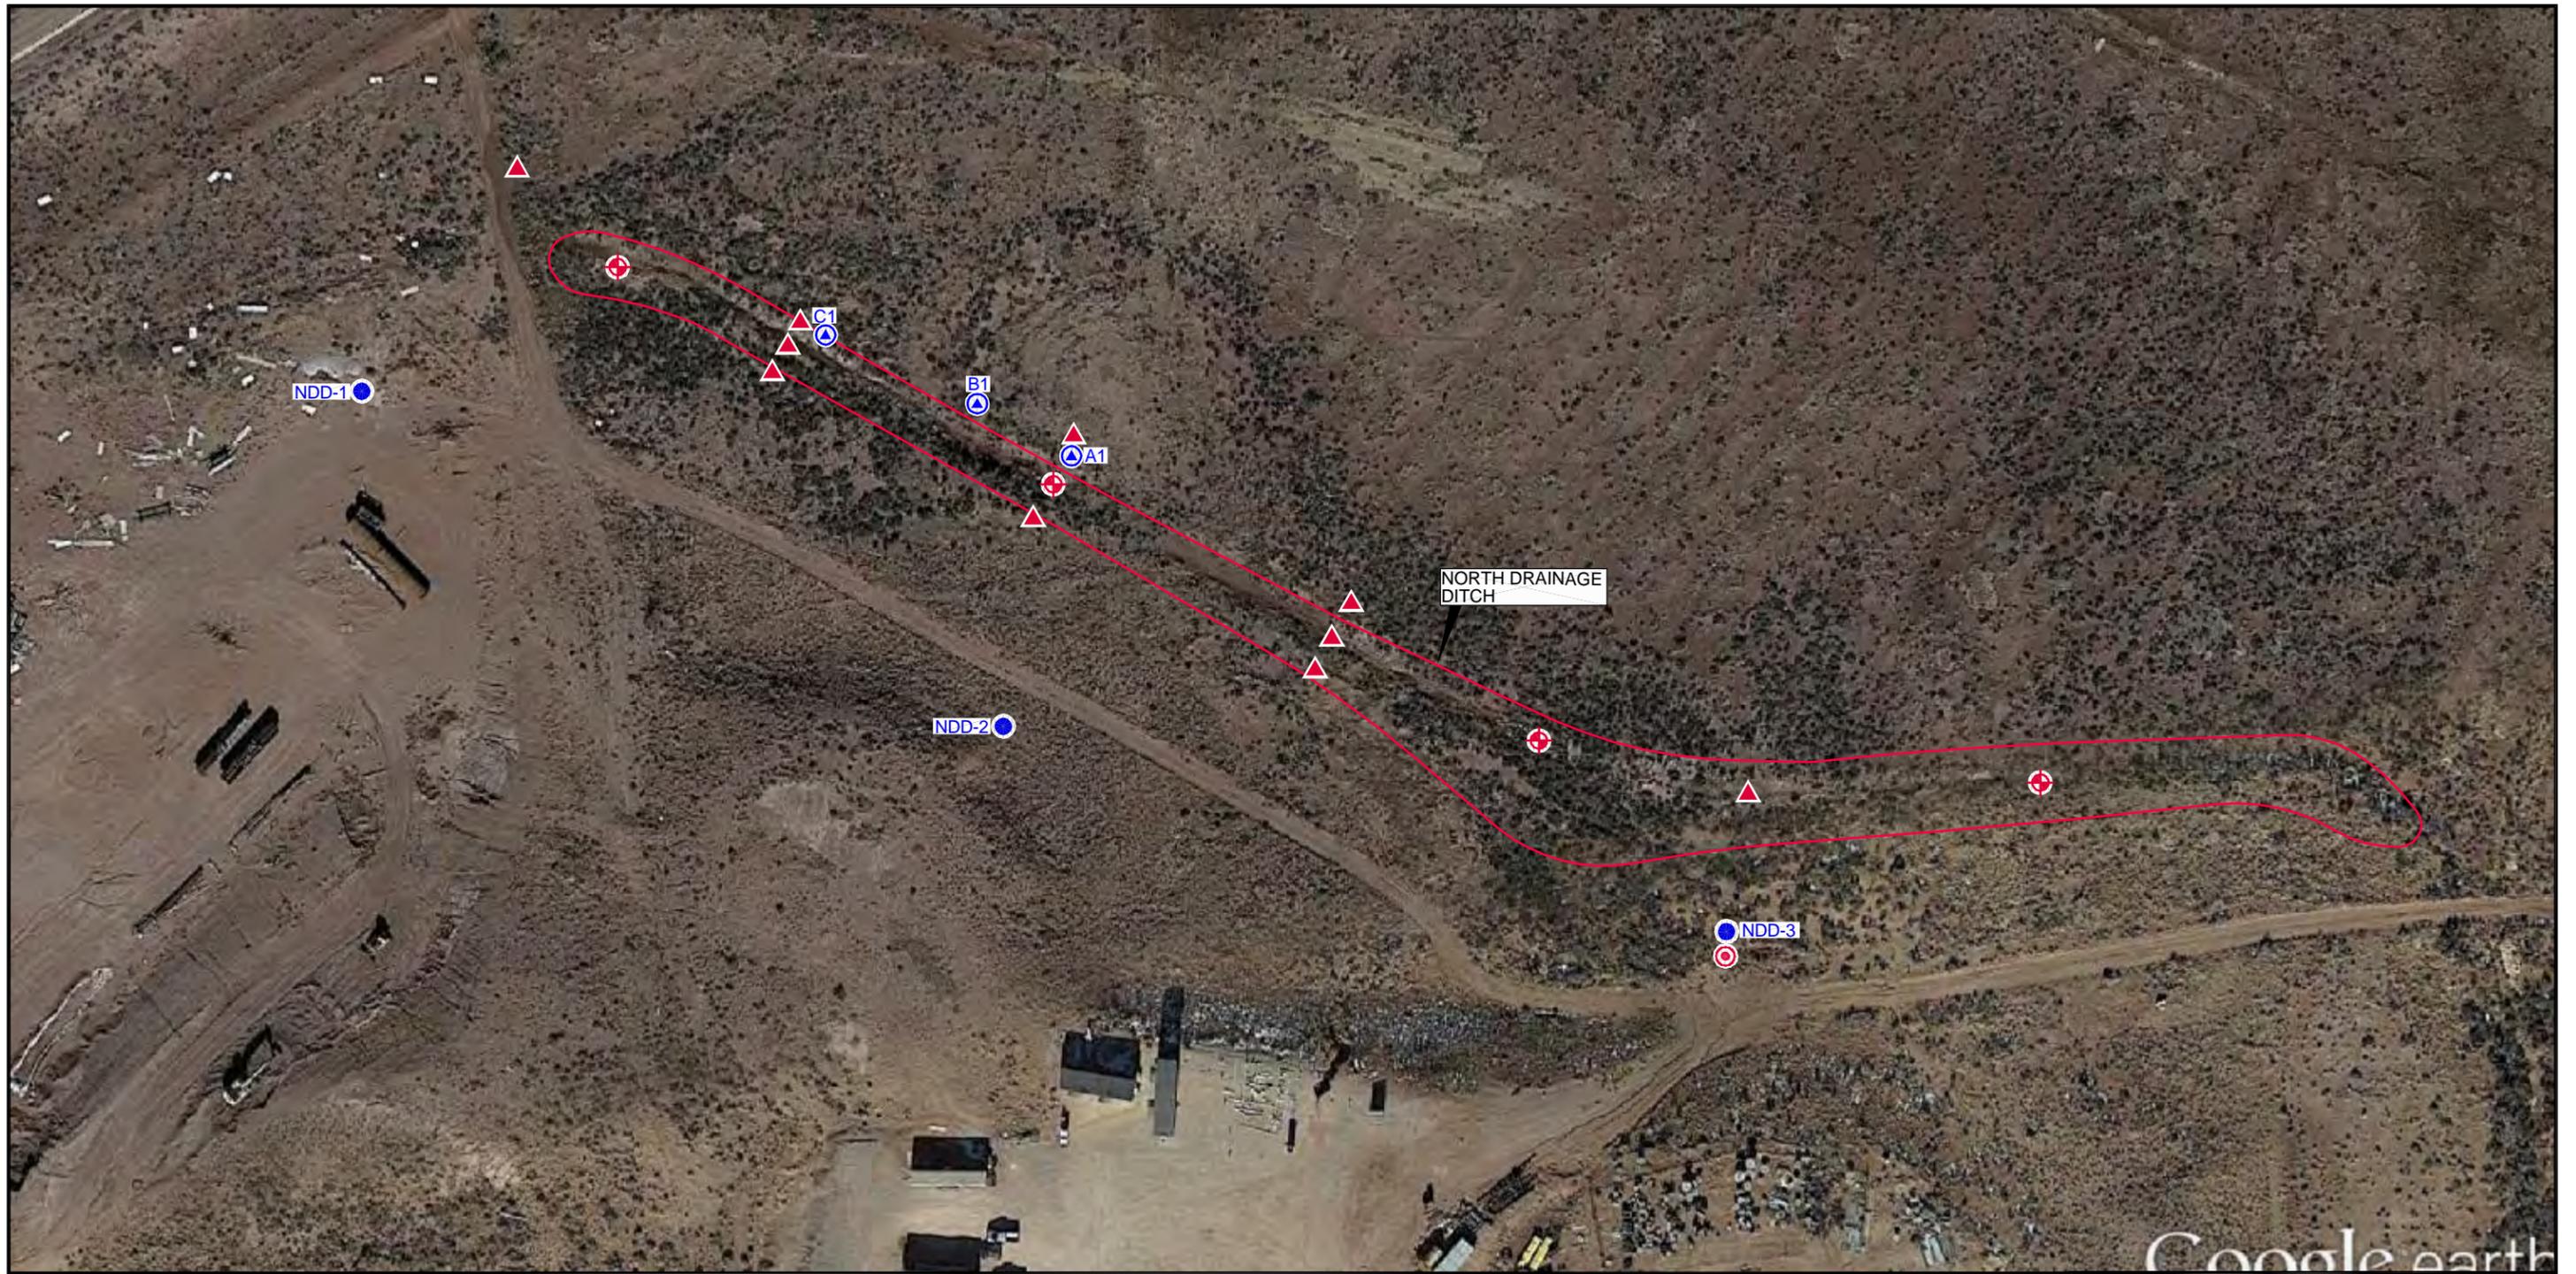
**FIGURE 2**  
INVESTIGATION AREA

This investigation work plan addresses the area to the north and northwest of the refinery tank farm. Wells OW-29 and OW-30 are located due north of the eastern portion of the refinery tank farm and the railroad loading rack. The area identified herein as the North Drainage Ditch is located to the northwest of the tank farm (Figure 2).

The area designated as the North Drainage Ditch is actually part of a larger drainage feature that begins on the north side of the tank farm, extends north along the western boundary of Solid Waste Management Unit (SWMU) 9 – Drainage Ditch and Inactive Landfarm, and passes beneath a dirt road, where it bifurcates (Figure 2). One lesser segment extends to the northeast and the other turns to the west, where it extends westward for approximately 400 feet and then turns northwest through the area that is the focus of the investigation. There is an area along the ditch that is lower in elevation than the sections to the east or west and has the potential for standing water to be present as least during a portion of the year. At the western end of the North Drainage Ditch, as shown on Figure 2, the ditch basically ends and there is no clearly defined channel beyond this point. It appears any flow of surface water beyond this point would move to the north along the east side of a dirt road. There is no record of waste or other contaminants being handled in the proposed area of investigation, nor is there a record of site operations in this area.
