### **Remediation Plan**

Re: Hawk B-1 Battery  
API# 30-025-35799  
Case # 1RP-5252

## Hawk B-1 Battery

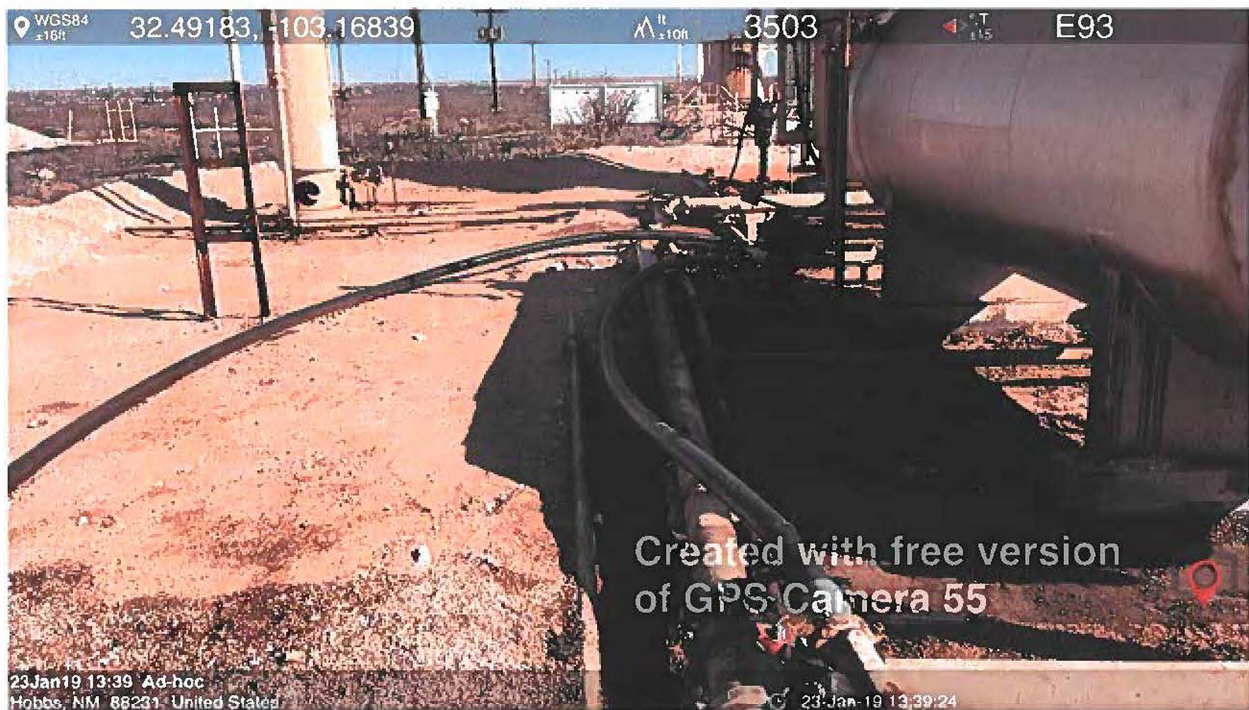
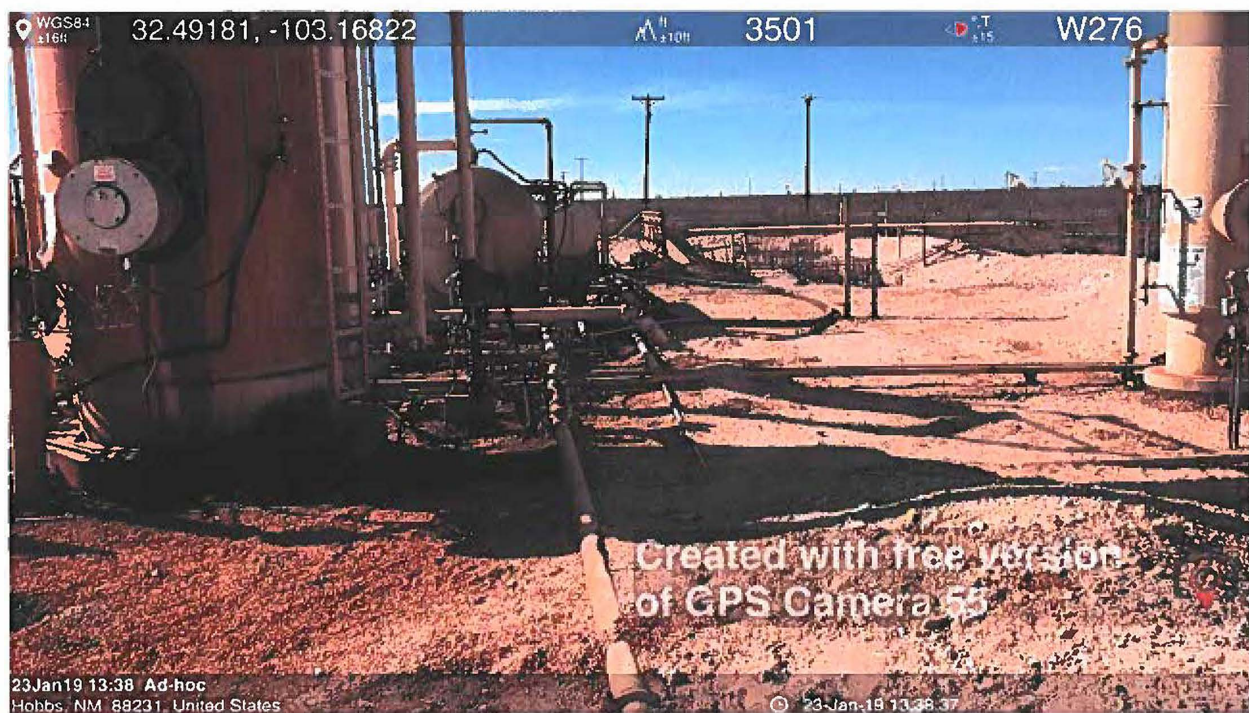
## Hawk B-1 Battery Photos

On 10/23/2018 a release was discovered due to gasket on the water leg of the fresh water knockout failed. An initial C-141 was submitted and approved by NMOCD on 11/5/2018. The Hawk B-1 Battery (GPS Coordinates 32.49164 -103.16801) is located north of Eunice New Mexico in unit letter K section 9 township 21S range 37E. A 2000 meter radius groundwater survey was conducted utilizing the NMOSE web page and USGS web page. There are four USGS wells located in section 9 with an average depth of groundwater at 63 feet below ground surface.

To date the release area has been excavated to a depth of 6 inches and all excavated material (12 yards) has been exported to a NMOCD approved facility. After the excavation was complete composite samples were collected in a 200 square foot radius and field tested for chlorides and representative samples were submitted to a commercial laboratory for analysis for chlorides, TPH, and BTEX. Due to the discolored soil still remaining at composite point 6 the middle sample was advanced to a depth of 1 foot utilizing a hand shovel (the only method available due to the presence of the fresh water knockout) in the area and submitted to a commercial laboratory for analysis of TPH and BTEX. The 1 foot sample had visual hydrocarbons but deeper delineation was not possible due to the hardness of the soil. The field and laboratory results yielded chloride values below table 1 standards (10,000 mg/kg) for releases 50 to 100 feet to groundwater. Hydrocarbons exceeded the table 1 standards at composite point 5 and the 1 foot sample at composite point 6.

Apache Corporation proposes that the area inside the battery at composite point 5 and 6 be excavated to a depth of 1 foot. After excavation is complete in those areas final 5 point bottom composites and side wall samples will be collected not to exceed 200 square feet for the entire release area and submitted to a laboratory for analysis of chlorides, TPH, and BTEX. All excavated material approximately 50 yards will be hauled to an NMOCD approved facility. Apache will notify NMOCD 48 hours prior to collect final samples. Remediation will be completed within 90 days of NMOCD approval of the plan.
