Central Vacuum Unit Header 3 Trunkline New Mexico Oil Conservation Division (NMOCD) District RP #1RP-5706

# Initial Site Assessment/Characterization Report

Central Vacuum Unit Header 3 Trunkline Produced Water Spill Site Lea County, New Mexico NMOCD RP #1RP-5706

November 2019 AECOM Project No. 60615071

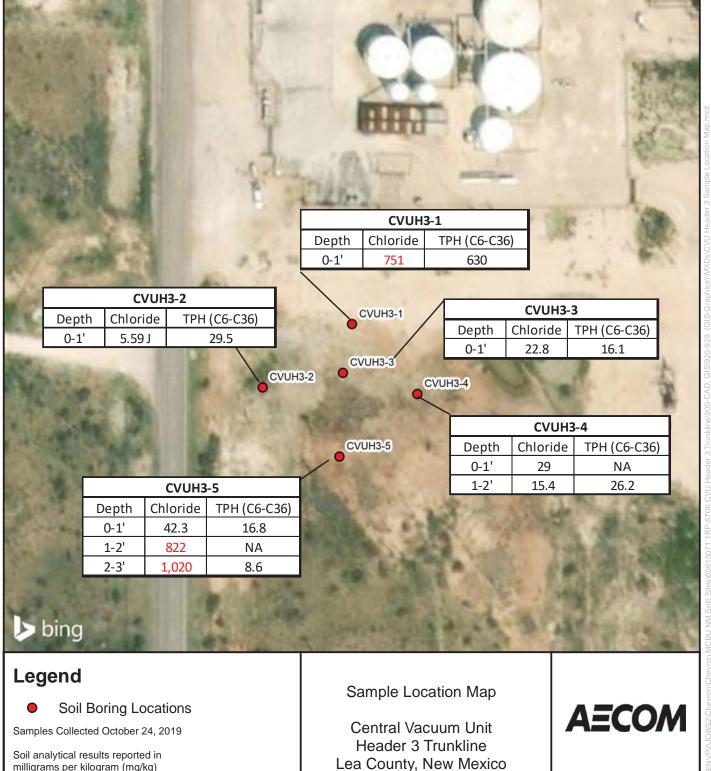
Figure 2

On October 24, 2019, initial soil assessment activities were conducted at the Site, which included collection of soil samples from five hand auger boring locations (CVUH3-1 through CVUH3-5) as shown on **Figure 2**. Hand auger boring CVUH3-3 was drilled in a topographically low area in the immediate spill location, just outside of an area where standing water was observed at the time of sampling. The remaining borings were drilled at locations outside the release area for horizontal delineation purposes. Site photographs are provided **in Appendix C**.

The soil analytical results for the Site were also compared to the chloride regulatory limit of 600 milligrams per kilogram (mg/kg) specified for the upper four feet of soil under 19.15.29.13.D.(1) NMAC for *RESTORATION*, *RECLAMATION AND RE-VEGETATION*. A chloride concentration of 751 milligrams per kilogram (mg/kg) was reported for boring CVUH3-1 (0-1 ft bgs). Chloride concentrations reported for boring CVUH3-5 were 822 mg/kg and 1,020 mg/kg at 1-2 ft bgs and 2-3 ft bgs, respectively.

The laboratory analytical results for the initial soil assessment samples are summarized in **Table 1** and on **Figure 2**. The laboratory analytical report is provided in **Appendix F**.

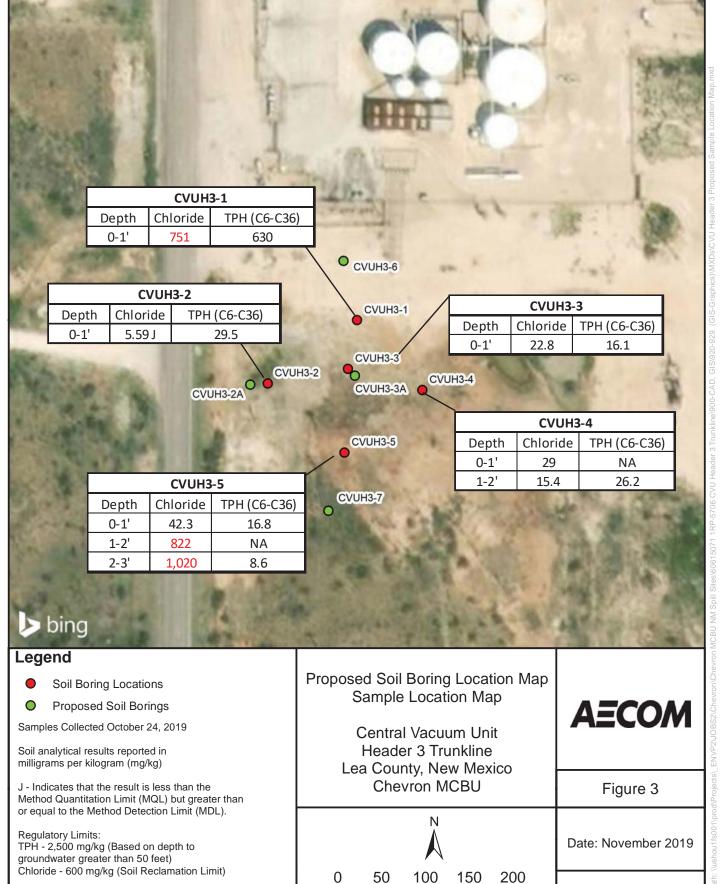
Proposed additional soil assessment activities include drilling and sampling of four additional borings as shown on **Figure 3** and further described below. Borings CVUH3-2 and CVUH3-3 will be re-drilled since those borings could only be drilled to one ft bgs. Horizontal delineation borings will be drilled north of CVUH3-1 and south of CVUH3-5. The borings will be drilled to a total depth of five ft bgs using a

combination of hand auger and air rotary drilling methods as appropriate for sample collection and Chevron safety requirements. Soil samples will be collected at one ft depth intervals to a total depth of five ft bgs in each of the proposed borings. Each depth interval sample will be field-screened for elevated petroleum hydrocarbon concentrations using a PID to measure organic vapor concentrations and for elevated chloride concentrations using an electrical conductivity (EC) meter.

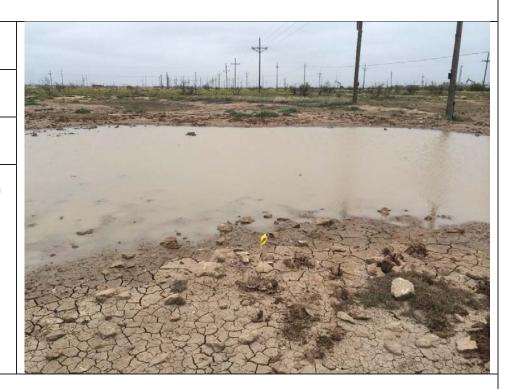
Looking south from the location of boring CVUH3-3.

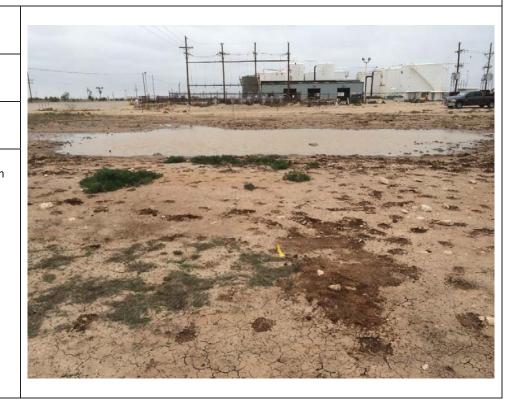
Looking north from the location of boring CVUH3-5. Note the CVU Battery site immediately adjacent to the north.
