RIVER BANK INVESTIGATION

GIANT REFINING COMPANY

BLOOMFIELD REFINERY

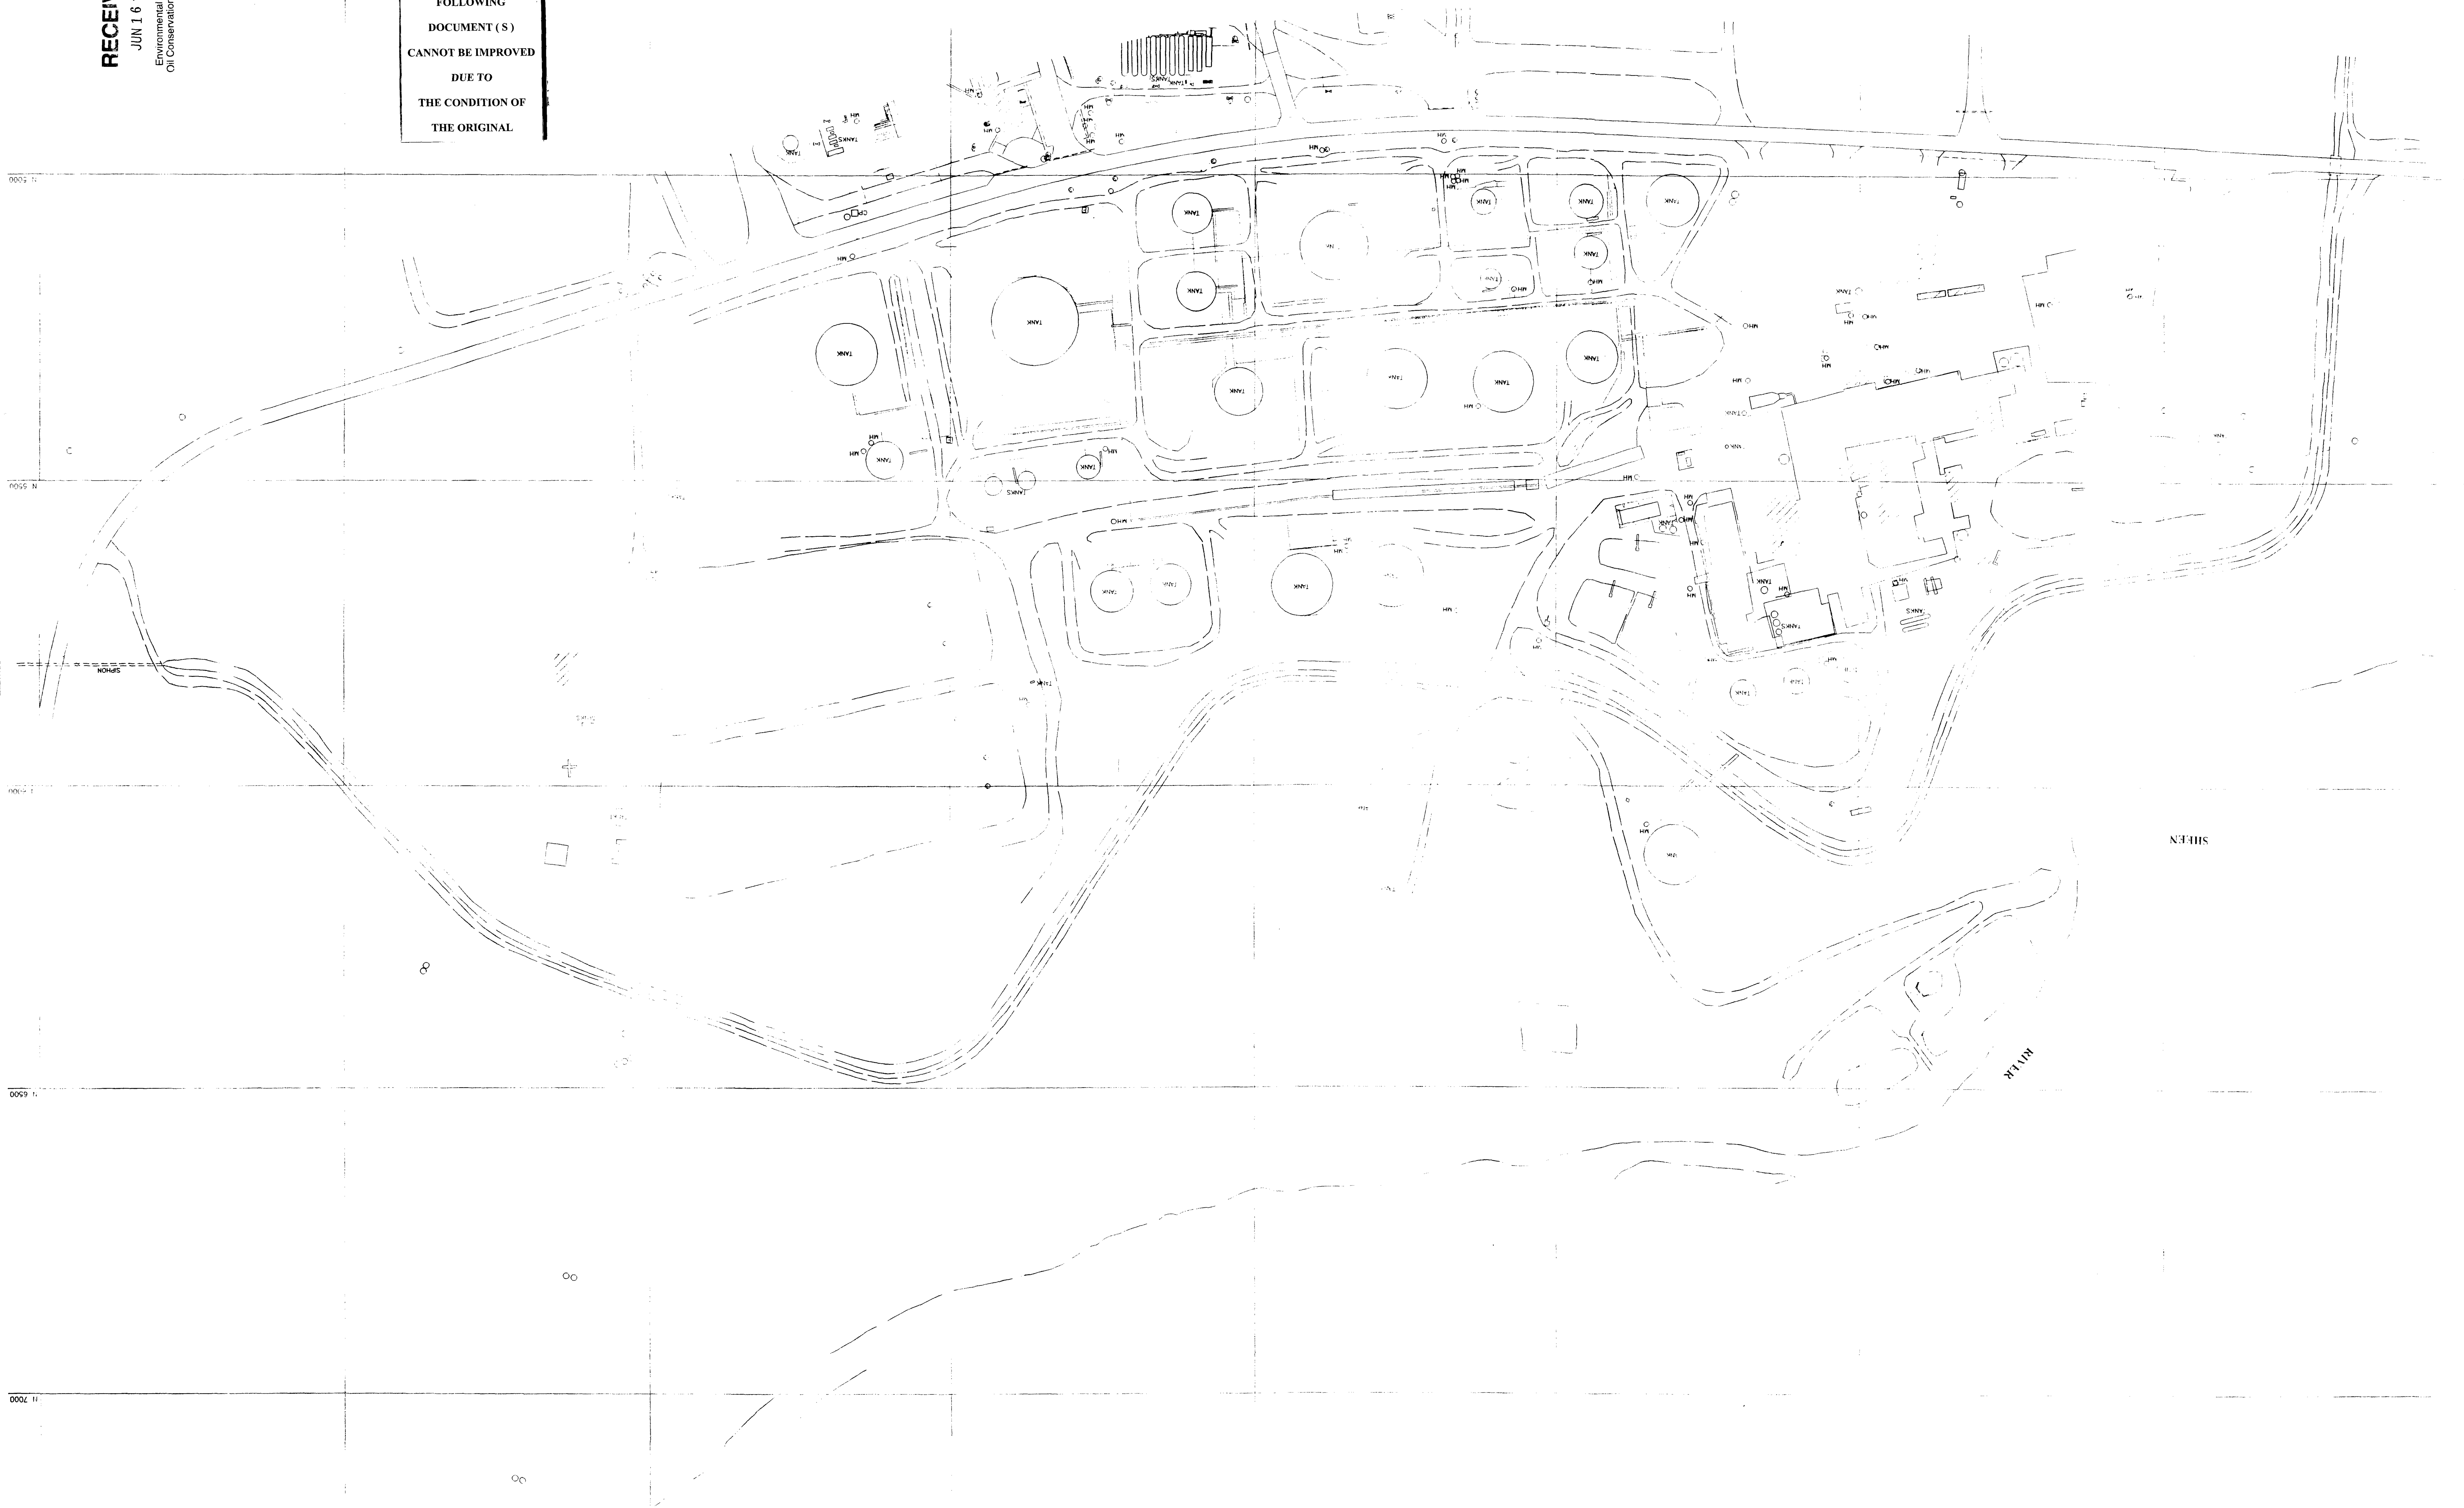
View Looking SW

Nacimient Formation in the river bank area (Figures 2 - 4) the surface of the Nacimient, from the precipice to the river area, shows several depressions and some river channel scarring. In the area of the most prominent Jackson Lake Terrace seep, which is located north of the flare along the interface of the Jackson Lake Terrace cobble bed and the Nacimient formation, there appears to be an erosional feature in the vertical face of the precipice that tends to channel groundwater seepage down to the river bank and then westward, within the bank, into a depression on the Nacimient Formation. The western most, as well as northern most, boundary of the contamination that has flowed into this depression is the San Juan River, which acts as a hydraulic barrier during times of normal flow (500 + cfs).

Horizontal extent of the contamination was found to be from north of the primary seep out to the south edge of the water intake lagoon, then westerly to the west edge of the water intake lagoon and then northerly to the river bank, around the bank south southwest to the outcrop of the Nacimient Formation along the precipice then easterly along the plane of the Nacimient Formation beneath the talus slope back to the area of the seep. A line marking the extent of the contamination is included in Figures 2-4.
