***Re: Information Provided in Follow-up to
Discharge Plan GW-028 Inspection
Navajo's Artesia, NM Refinery***

Navajo-Artesia Refinery GW-020 Discharge Plan Inspection
October 16, 2001 OCD Inspectors: W Price, M Stubblefield, E Martin: Page 1

Navajo-Artesia Refinery GW-028 Discharge Plan Inspection

Navajo Refining Company
Reconnaissance Inspection, July 25, 1995
Photographs by Rich Powell, NMED

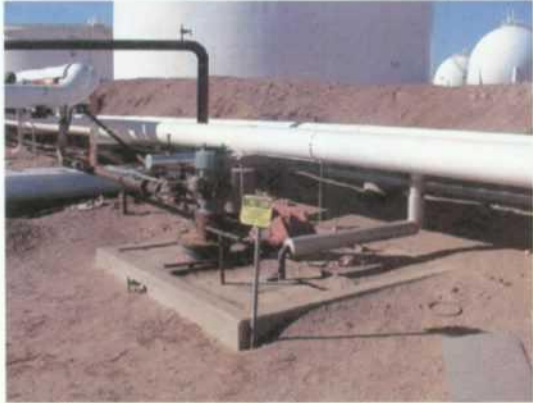
Pic #1- Main blender tank farm sump-single wall.

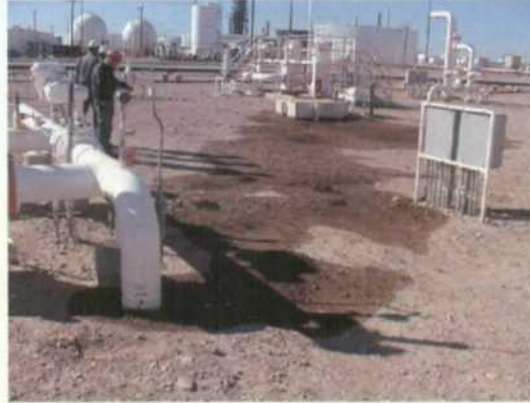
Pic #4- Crude oil pipeline pump area spill. Sump overflowed oil.- Requires action.

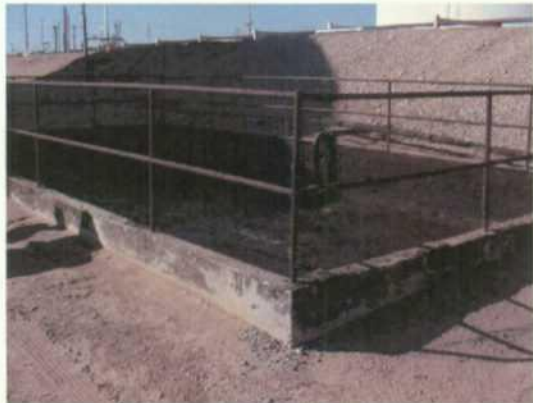
Pic #2- Tank 437 water draw sump. Out of service. Requires closure.

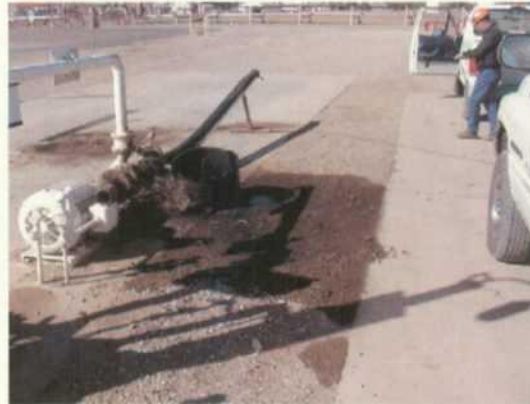
Pic #5- Crude oil Lact unloading area needs containment.

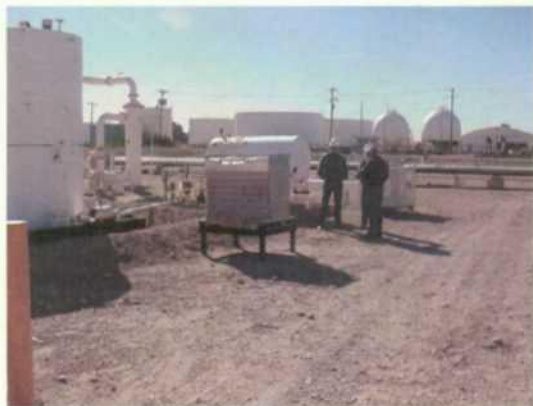
Pic #3 - Pipeline pump area. Chemical tote tanks need containment.

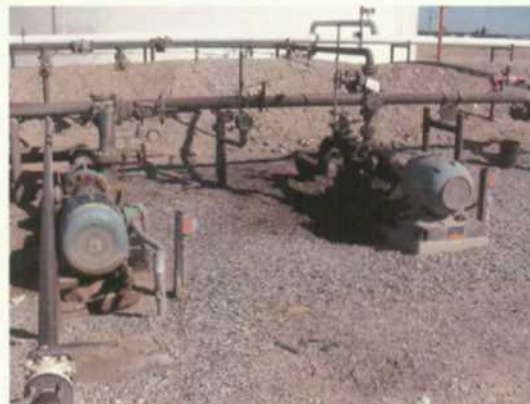
Pic #6- 437 Crude oil tank transfer pumps. Needs containment.

- **Pumps Adjacent to Tank T-437**
You observed that a tramp pump in temporary service (inter-tank transfer between crude tanks T-437 and T-439) did not have spill containment. Navajo will obtain and install spill containment for this pump until a permanent pump equipped with spill containment is installed.

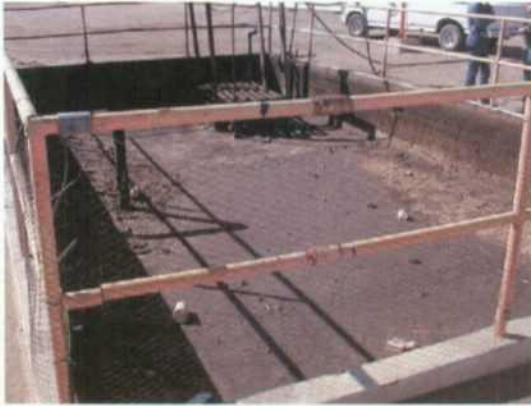
Pic #7- 439 water draw sump. Out of service. Requires closures.

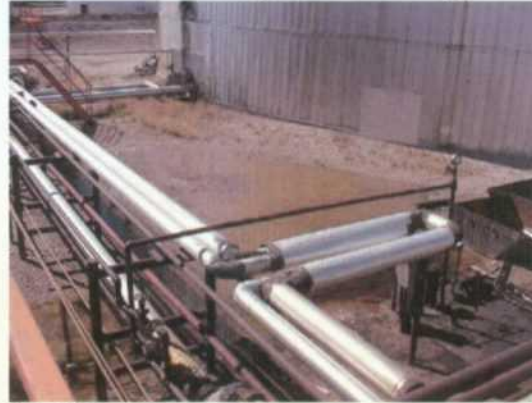
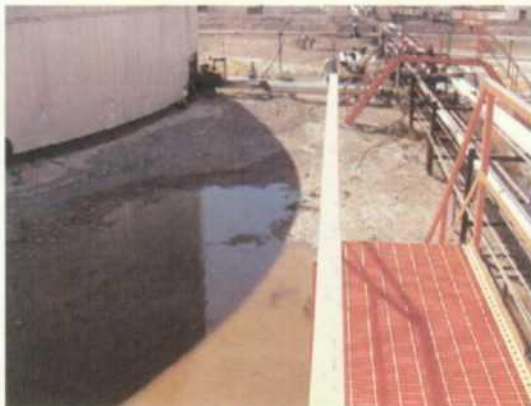
Pic #9a- Same as 9.

Pic #9- Water discharged from steam condensate around asphalt tanks.

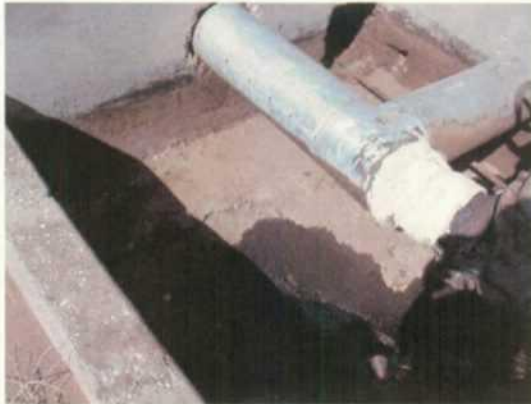
Pic #8- Gas-Oil transfer pumps sump. Bottom of sump has lost integrity.

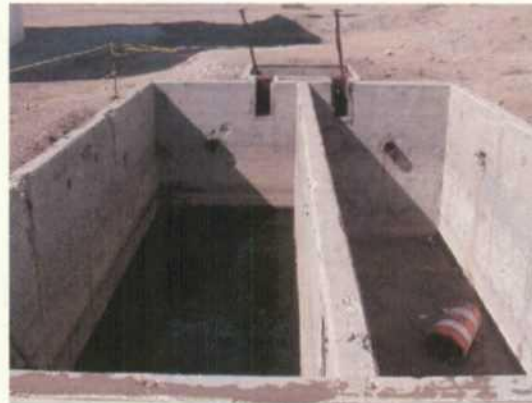
Pic #10- Old API separator located near the south side asphalt tank farm. Requires closure. Standing fluids.

- **API Removal and Closure**
Navajo's May 31, 2002 response addressing items 8 and 12 referenced forthcoming submittals related to the removal and/or closure of various APIs. Navajo has worked closely with NMED on these items as part of Navajo's closure-post closure care permit. Relevant correspondence with NMED is enclosed comprised of two letters from Navajo to NMED and one letter from NMED to Navajo.

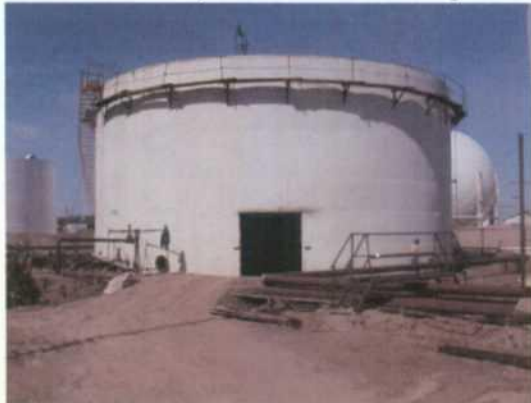
Pic #11- South Plant Tank Farm. Tanks 417, 418, and 419. Area. 418 & 419 Tanks are being repaired. Tank above is receiving new floor and top. One tank 419 (Diesel) in this area was recently repaired and noted to have been leaking. This area requires an investigation to determine contamination extent.

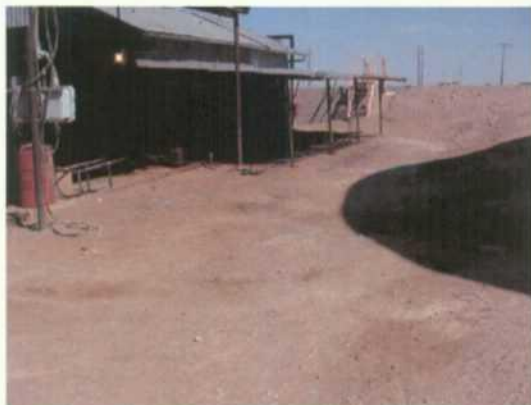
Pic #12- Slurry oil treatment area. Oil is reaching ground surface. Area needs containment. Slurry pits schedule for inspection early December 2001.

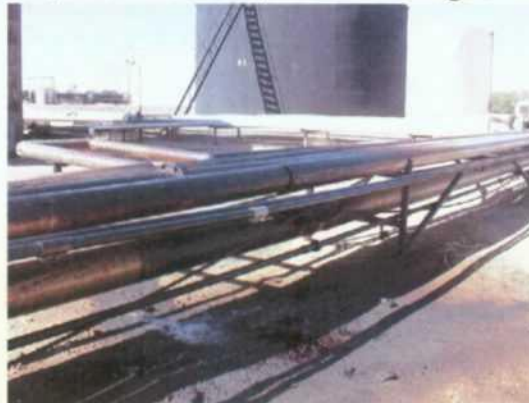
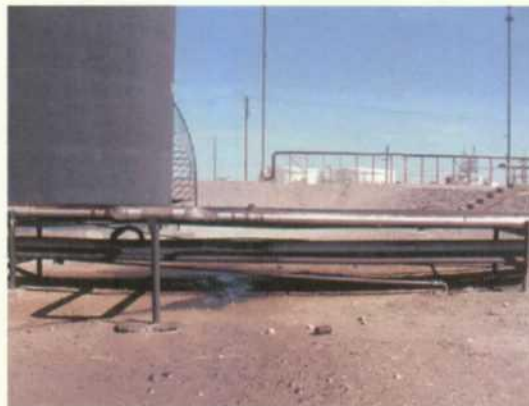
Pic # 13- Active leak in CBO line North Plant N Tank Farm. Near LCO and CBO Tanks. Requires action.

Pic #14- Same as Above.

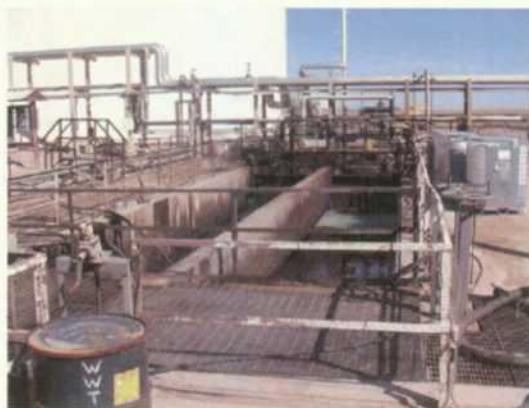
Pic #15- North Plant API Separator. ABT tanks shown in background. This separator is single wall and will be scheduled for inspected.

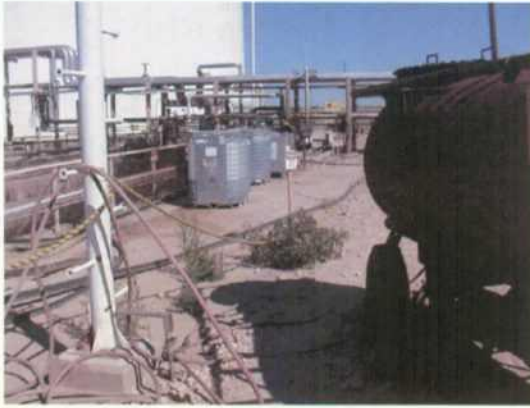
Pic # 16- AST's chemical tote tanks located next to Main API Separator needs containment.

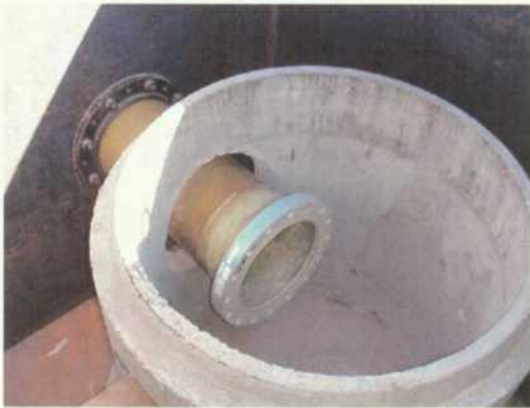
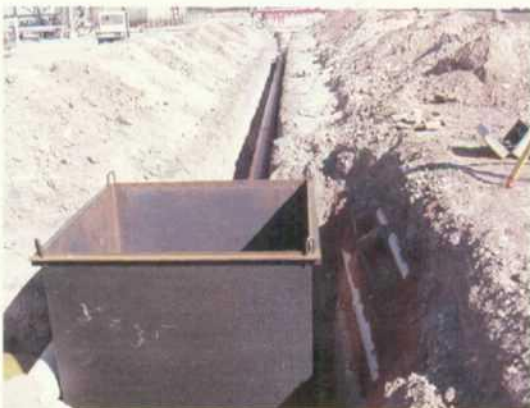
Pic #17- New wastewater system for new north side Gas-Oil Hydro-treater.

Pic #18- Same as above. Navajo needs to submit design information for OCD approval and include in Discharge Plan.

- **Gas Oil Hydro-Treater (GOHT) Wastewater Lines**
Navajo's May 31, 2002 response addressing item 14 indicated that the plans and drawings for the new GOHT were yet to be prepared. These drawings are now complete and are included in the enclosure.
- **SPCC and Stormwater Control**
Navajo's May 31, 2002 response addressing item 19 indicated that the SPCC plan was being updated to reflect stormwater changes. A copy of the current SPCC plan drawing is enclosed along with Navajo's notice of termination (NOT) submitted to (and approved by) EPA. The NOT voided Navajo's NPDES permit for stormwater runoff based upon the successful implementation of stormwater retention measures that eliminated outfalls. These actions negated the need for a stormwater plan (i.e., all stormwater is contained on Navajo's property).

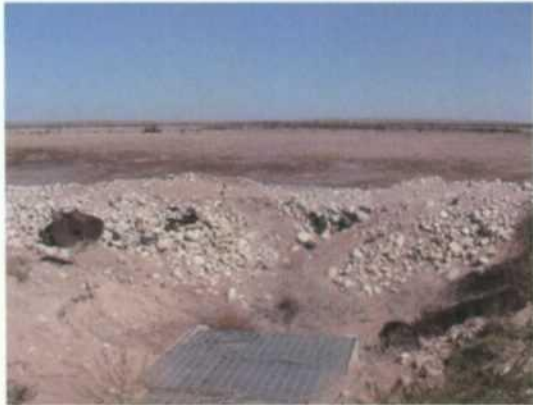
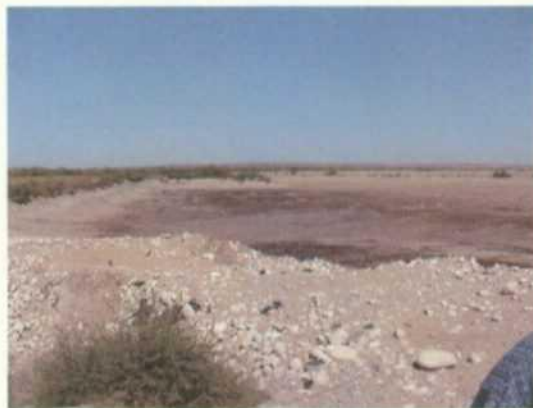
Pic #1- Old wastewater pond area located 3 miles east of refinery. The picture shows the last outfall area. Picture looking east shows pond 2 & 3.

Pic #2- Same as Above. This is the last outfall area located between ponds #1 and ponds 2 and 3.

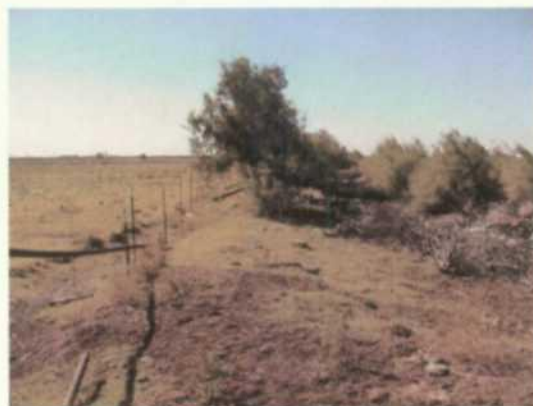
Pic #3- Area NW of wastewater ponds. Per Darrell Moore the 3 mile ditch was located on the left of the berm. The irrigation/drainage ditch on the right has

not been identified but is connected to farm property to the west for drainage.

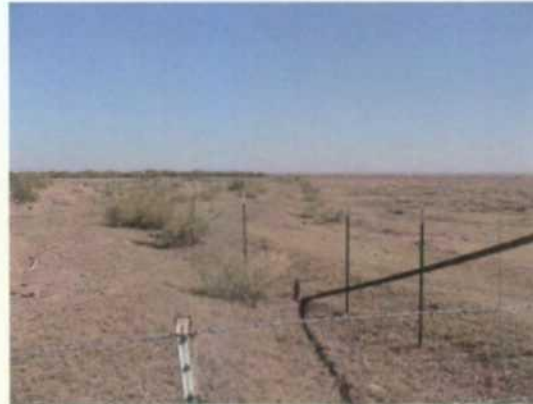
Pic#4- Picture looking SE. Shows old 3 mile refinery wastewater ditch and possible pipeline.

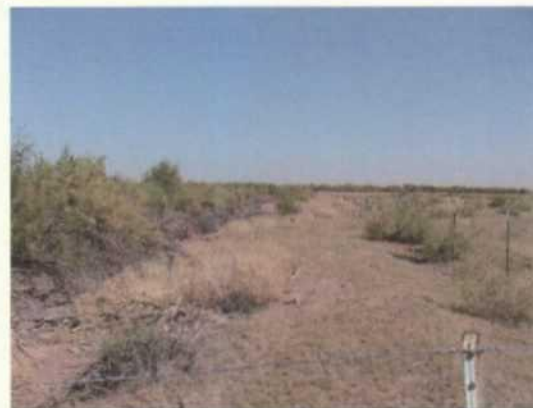
Pic #5- This picture shows the unidentified irrigation drainage ditch transgressing to the Pecos river.

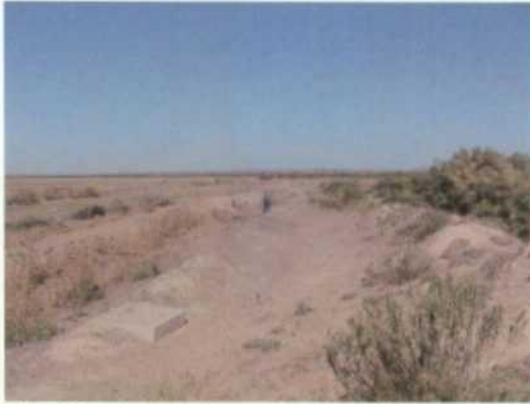
Pic #6- Area where 3 mile ditch starts to parallel Eagle Draw. Picture looking NE. The 3 mile wastewater ditch is now on the north side of the Irrigation/drainage ditch.

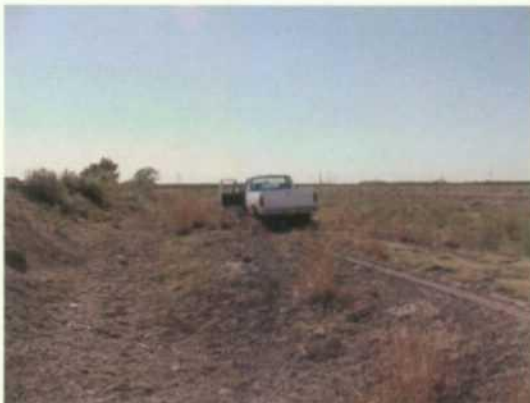
Pic #7- Wastewater ditch. Eagle Draw is located to the right. Berm on left is divider between refinery (OLD) wastewater ditch and farm irrigation/drainage ditch. This is same irrigation/drainage ditch that is unidentified in previous pictures. Picture looking west.

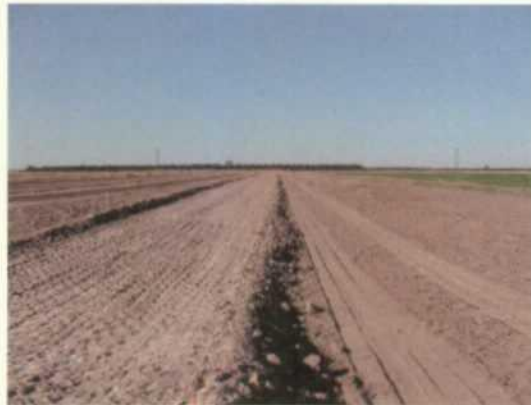
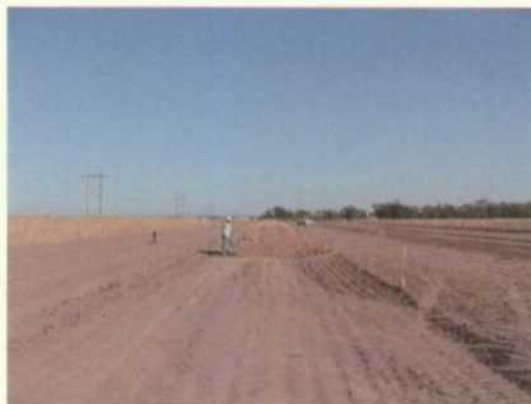
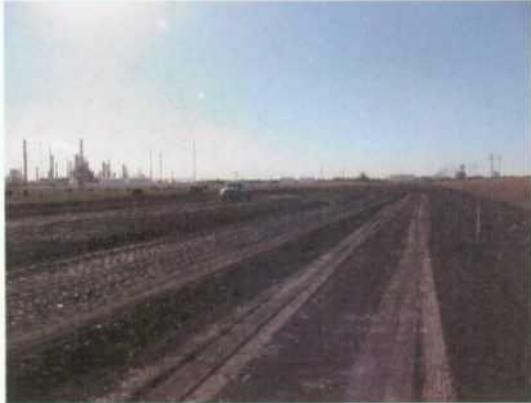
Pic #9- SE corner of south plant farm area. Picture looking north. Area being prepared for new stormwater berm.

Pic # 10- North side of south plant farm area. Picture looking east at new stormwater berm being built.

Pic # 11- Same area as above looking west.

- **GW-028 Condition 15 (Stormwater Plan)**
Navajo has no plans to line the stormwater retention basins. The water received by these basins is fresh water. As operated, the regulations do not require these basins to be lined. If oily runoff somehow enters these basins, the water will be removed to prevent possible soil contamination.
