EME C-2 boat

**RICE OPERATING COMPANY  
JUNCTION BOX CLOSURE REPORT**

## EME C-2 Boot

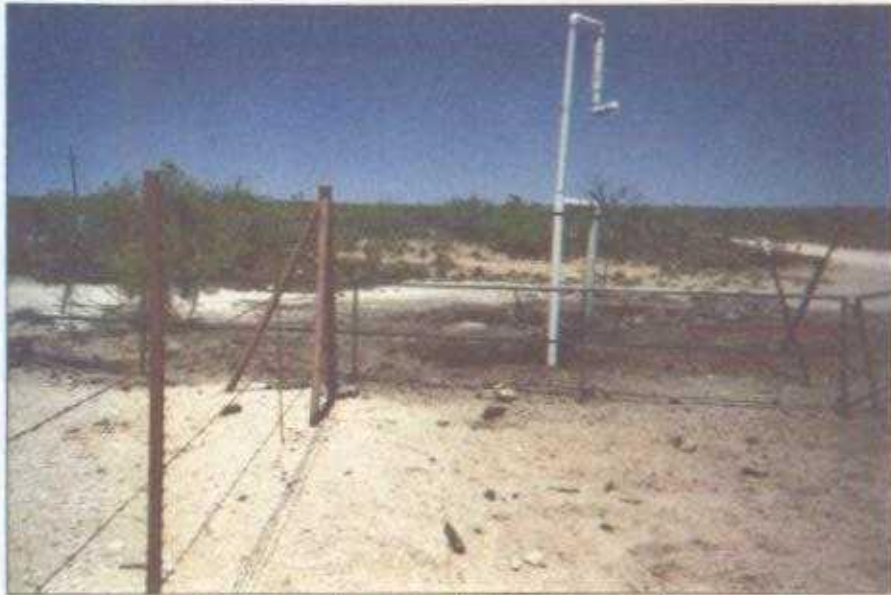
C-2 Boot Location Before Excavation

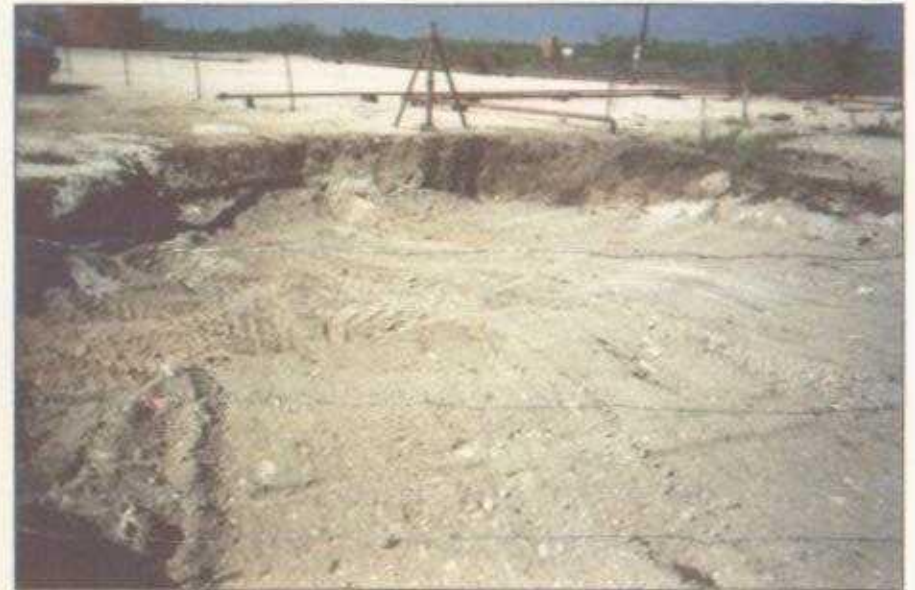
Excavation—June 2003

**General Description of Remedial Action:** This was the site of a junction box with a boot. Chloride concentrations exhibited a decline with depth that illustrates the presence of non-saturated conditions in the vadose zone. A 20 x 25 ft area was excavated to varying depth of 8-16 ft bgs (see diagram). The excavated soil was landfamed and backfilled into the hole up to 4 ft below surface. At 4 ft, a 1 ft clay barrier was installed and was compacted as standard operating practice. The remaining soil was blended with imported clean soil and then backfilled on top of the clay up to the surface (labeled "remediated" for lab purposes). The remaining TPH under the clay will naturally attenuate. The site has been re-seeded with native vegetation and is expected to return to productive capacity at a normal rate.

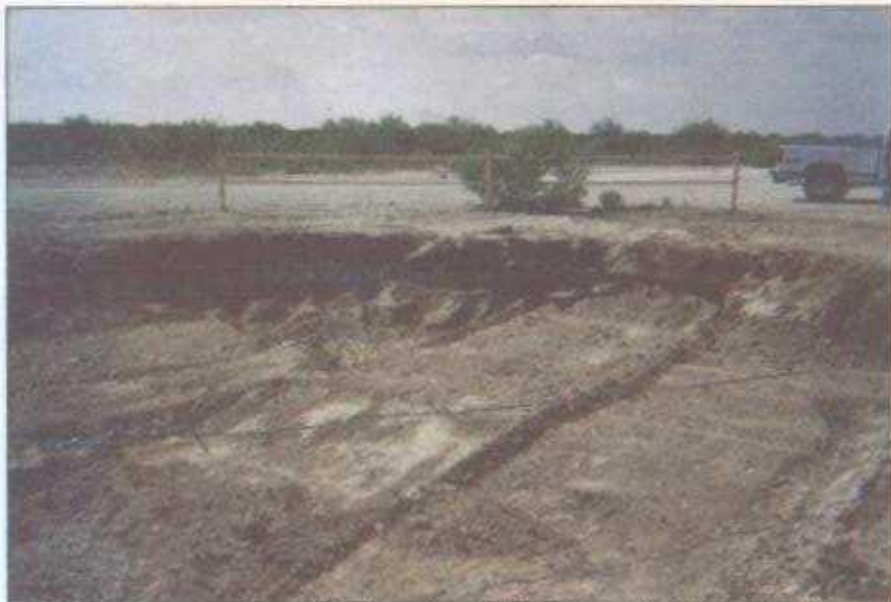
Excavation Backfilled to 4 ft With Remediated Backfill

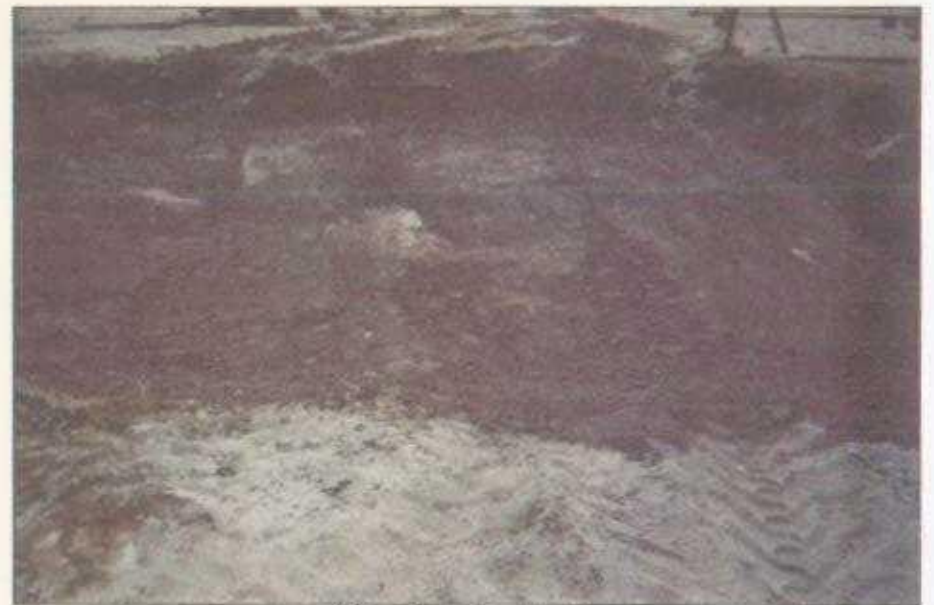
Clay Barrier At 4 ft

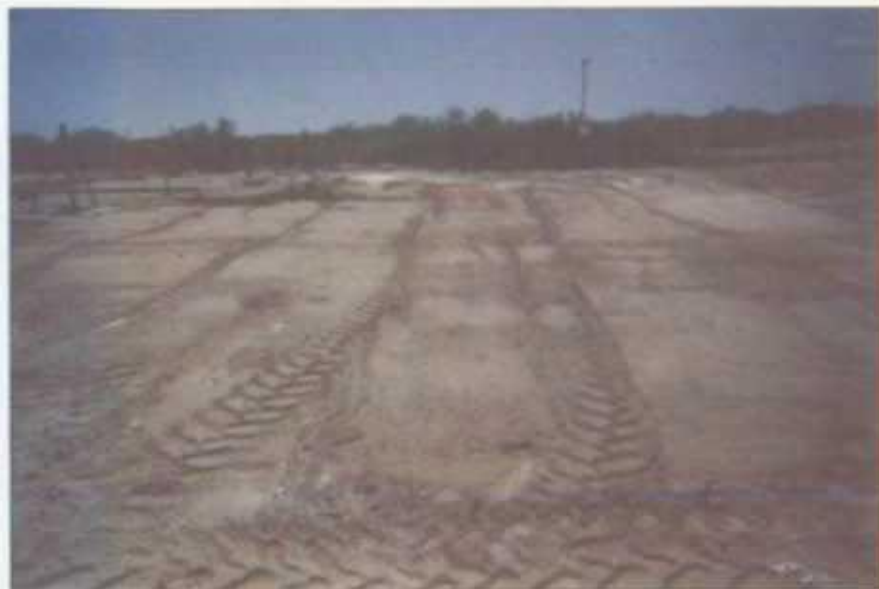
Backfilled—6/24/2003

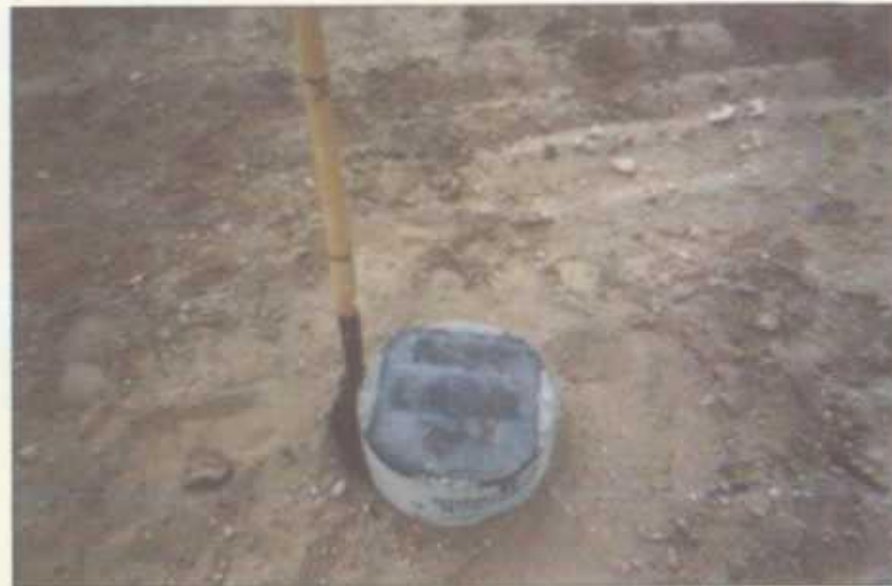
ID Plate Marking Clay Liner At Backfilled Site

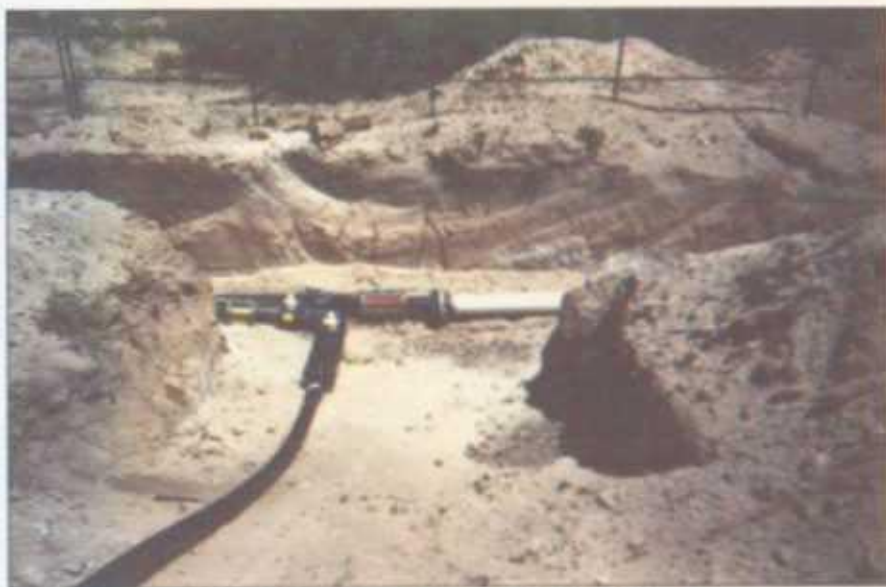
New Plumbing At New Jct. 90 ft West

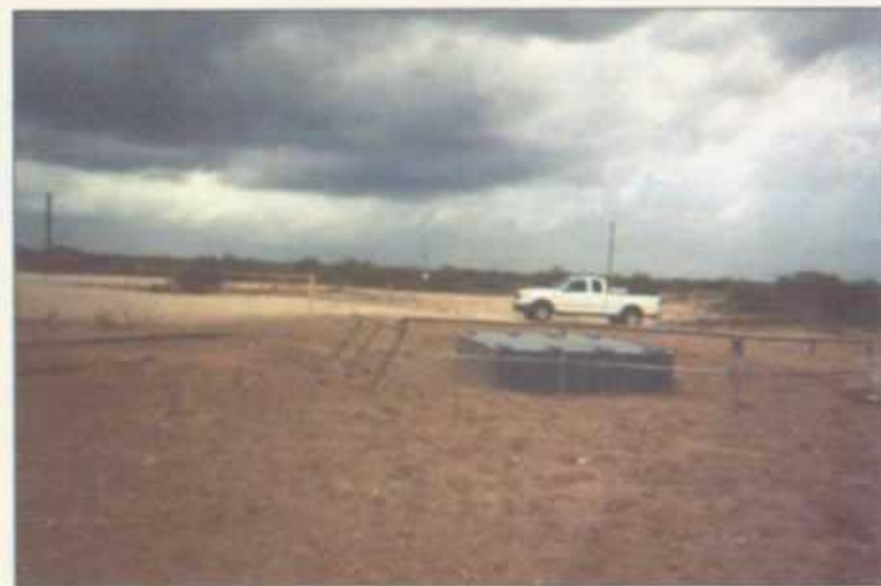
Looking East From New Box (backfilled site in background)
