JAN 3, 2006

Final Report

**RICE OPERATING COMPANY
JUNCTION BOX FINAL REPORT**

Vacuum jct. A-31-1

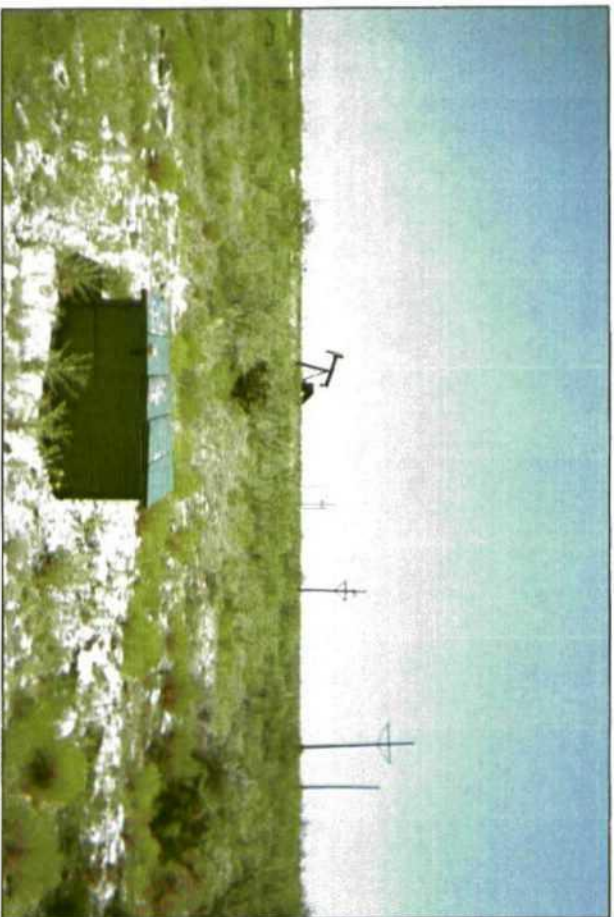
6/27/2005

undisturbed junction box

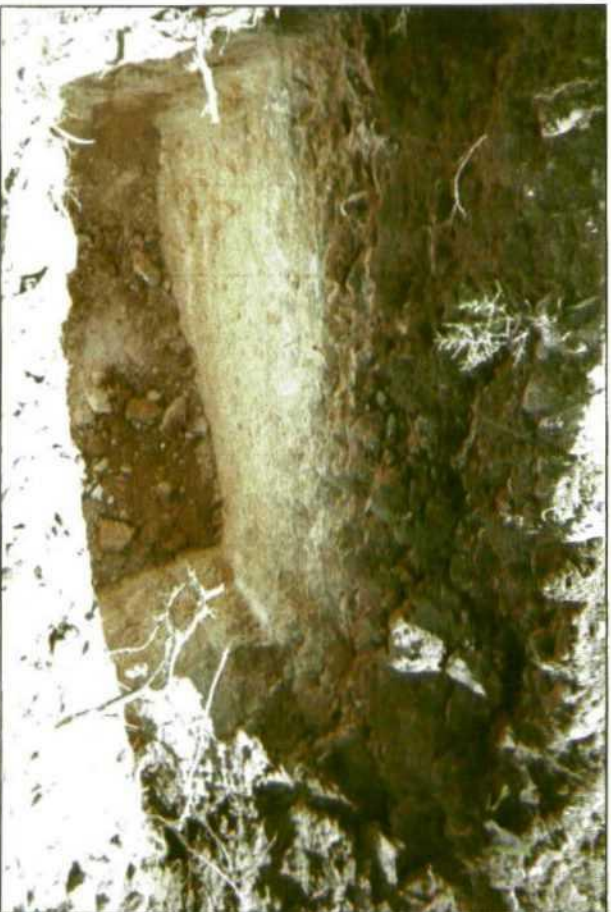
8/30/2005

delineation trench at former box site

part of the Vacuum SWD System Abandonment. After the box materials were removed, a delineation trench was made using a backhoe while soil samples were collected every ft of depth at 4-9 ft BGS. Chloride field tests were performed on these samples and yielded very low concentrations. PID screenings were also performed on the samples and these concentrations were also very low. The soil samples did not exhibit any physical indications of impact from the junction box operations. A grab sample at 9 ft BGS was analyzed at a laboratory for confirmation of the field tests. TPH was not present within the lab's detection limits (<10.0 ppm), meeting NMOCD guidelines. The excavated soil was blended on site and then backfilled into the trench. The disturbed surface was seeded with a blend of native vegetation and is expected to return to productive capacity at a normal rate.

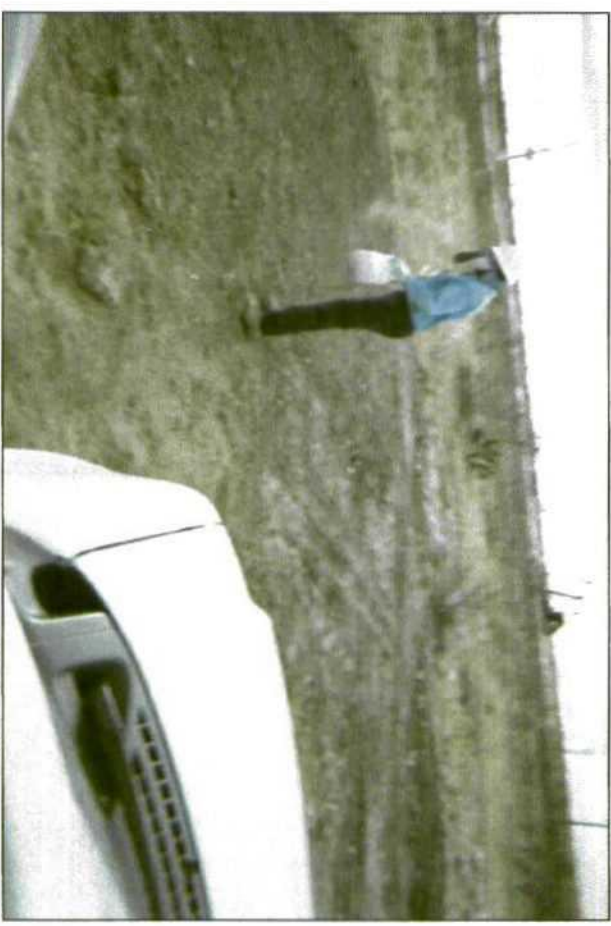
12/23/2005

seeding backfilled site
