**RICE OPERATING COMPANY
JUNCTION BOX DISCLOSURE REPORT**

SWD SYSTEM	JUNCTION	UNIT	SECTION	TOWNSHIP	RANGE	COUNTY	BOX DIMENSIONS - FEET		
EME	O-24	O	24	20 S	36 E	Lea	Length	Width	Depth
							No Box

EME jct. O-24

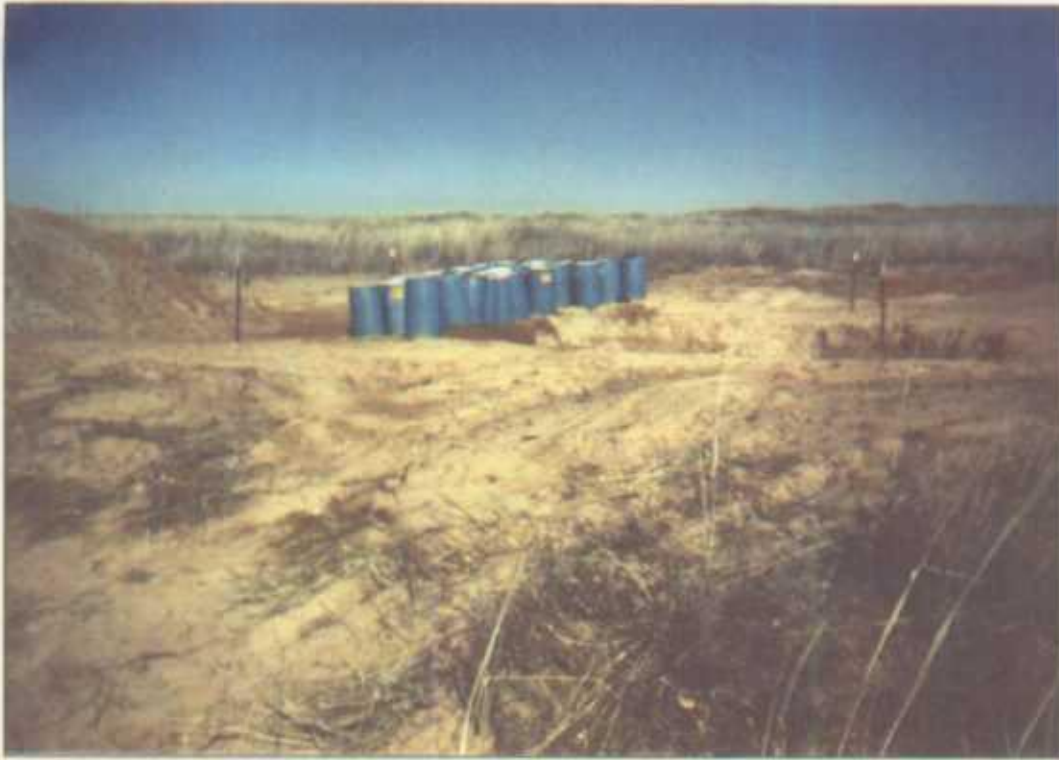
General Description of Remedial Action: This junction box location was visibly impacted with TPH prior to excavating. Vertically, the visual TPH ceased at 11' bgs.

NORM Excavation

The walls were then extended until visual TPH virtually diminished, creating a 35'x 35' x 12' excavation. The excavated soil was landfarmed on-site and then backfilled into the excavation. The backfill was contoured to mimic the surrounding landscape and the surface is expected to experience a re-growth a vegetation. The bottom and wall composite samples were tested for chlorides at two different labs. Cardinal Laboratory's results have been significantly inconsistent with field tests, as was the case when these results were received. The samples were then sent to Environmental Lab of Texas whose results were congruent with field tests and those results are reported above.

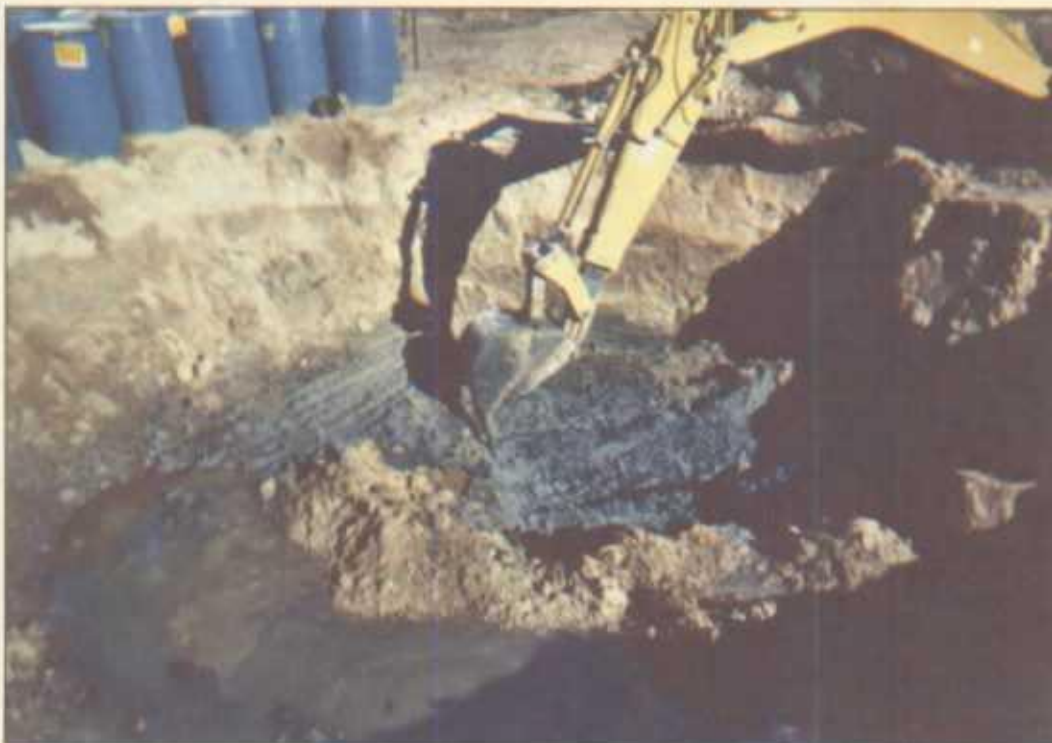
Beginning Excavation

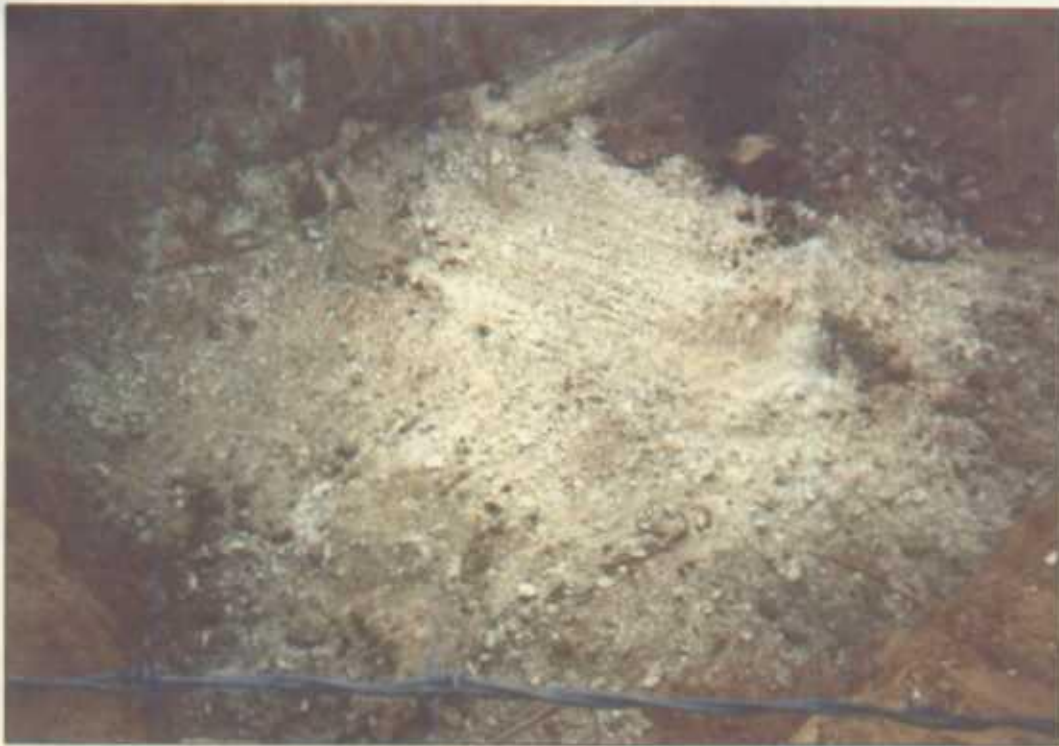
EME jct. O-24

Bottom of Excavation

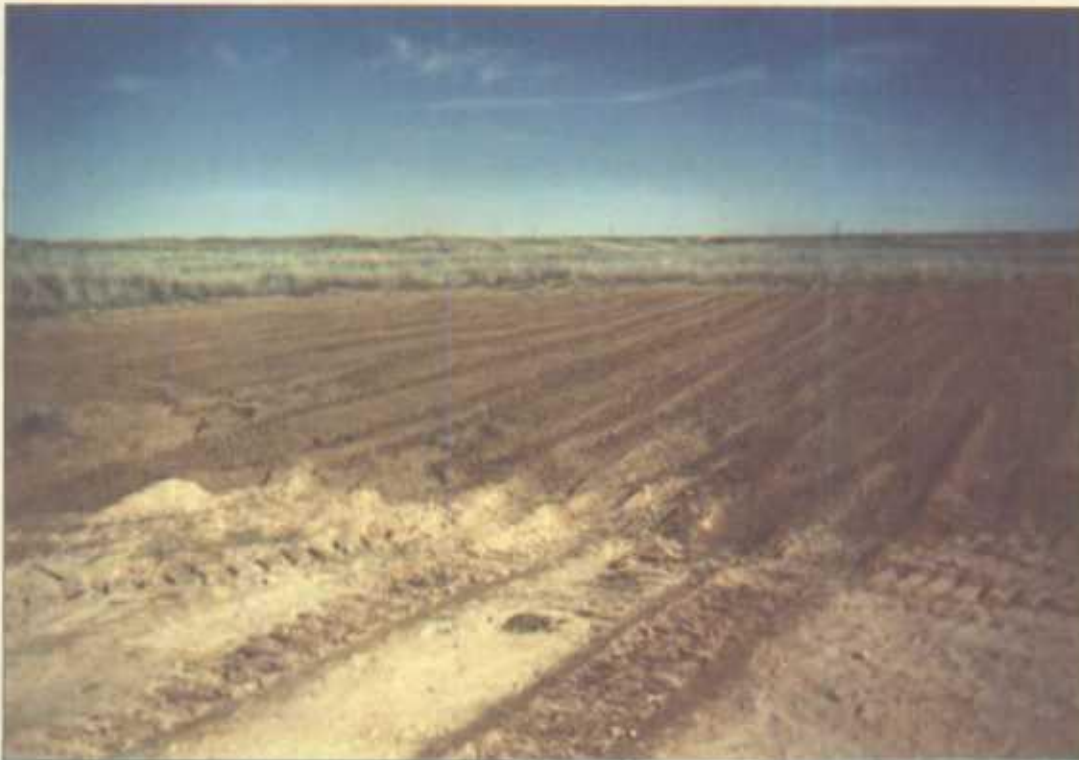
Backfilled

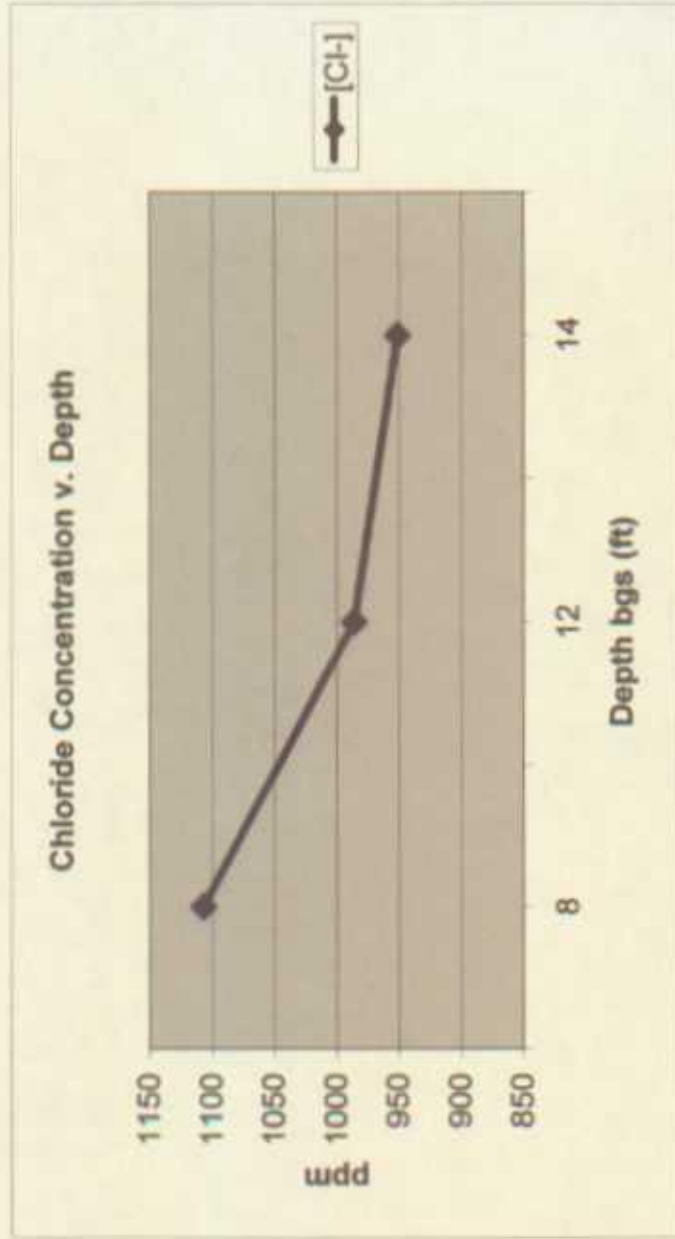
CHLORIDE CONCENTRATION CURVE

LOCATION	DEPTH	ppm
Vertical	8'	1107
	12'	986
	14'	951
17' E	6'	489
17'W	8'	1102
	12'	507
17'N	12'	1073
17'S	8'	476
	12'	910

Depth bgs (ft)	[Cl ⁻] ppm
8	1107
12	986
14	951

Groundwater = 36-117 ft???
