EME Amerada WE 'F' ECL

FINAL REPORT

**RICE OPERATING COMPANY
JUNCTION BOX FINAL REPORT**

EME WE 'F' EOL

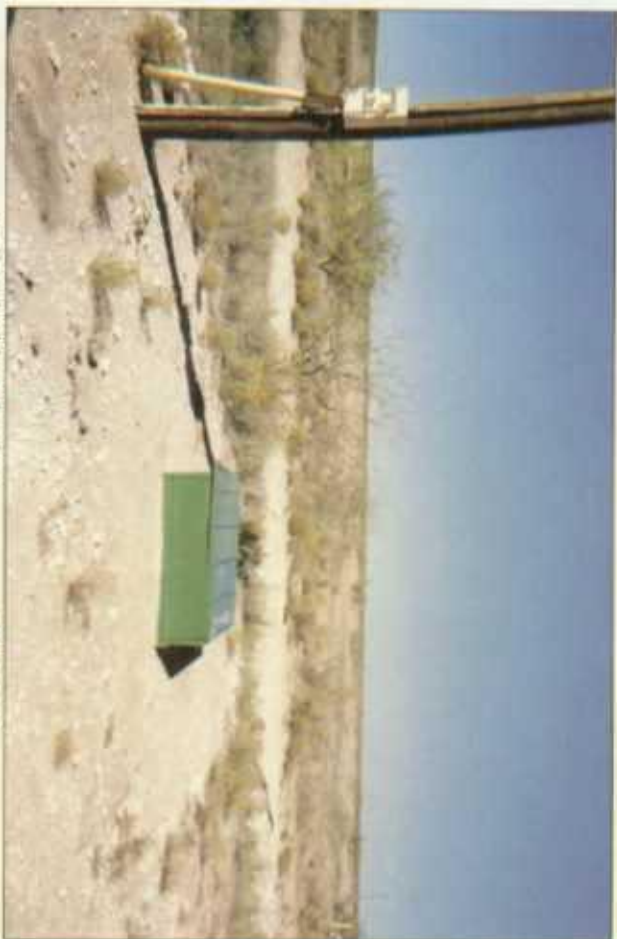
11/19/2003

undisturbed junction box

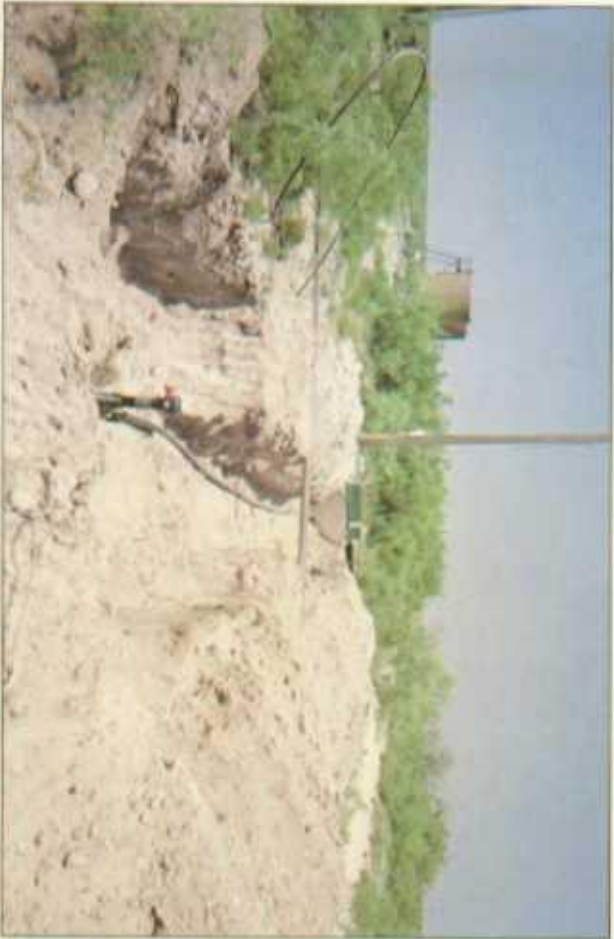
5/21/2004

New plumbing with pig launcher in foreground, old box in background

were well below NMOCD guidelines. The box lumber was removed and the hole backfilled.

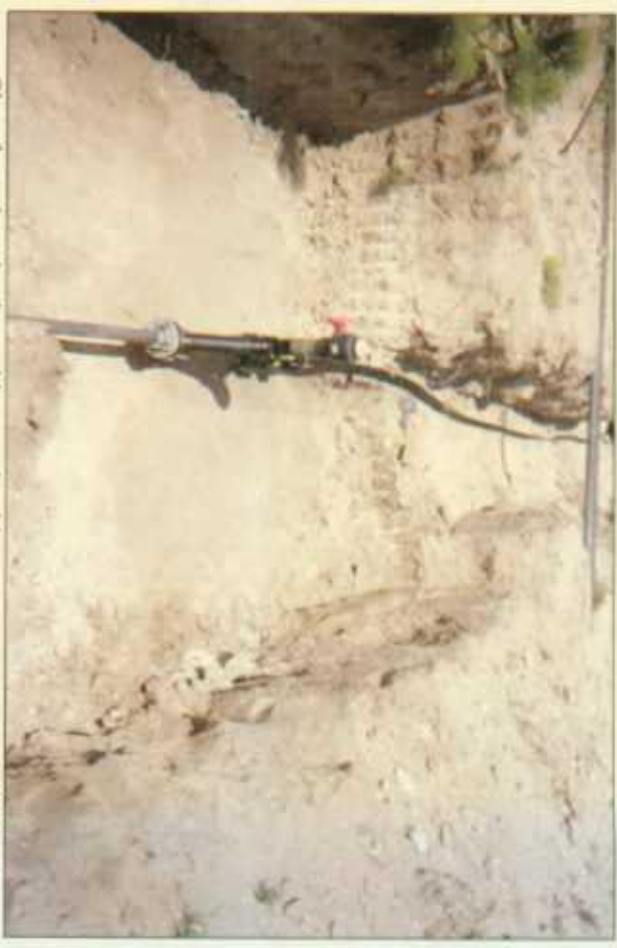
7/23/2004

Site of new junction box with new plumbing

This box was replaced with a new watertight junction box 40 ft East of this site during the

pipeline replacement.

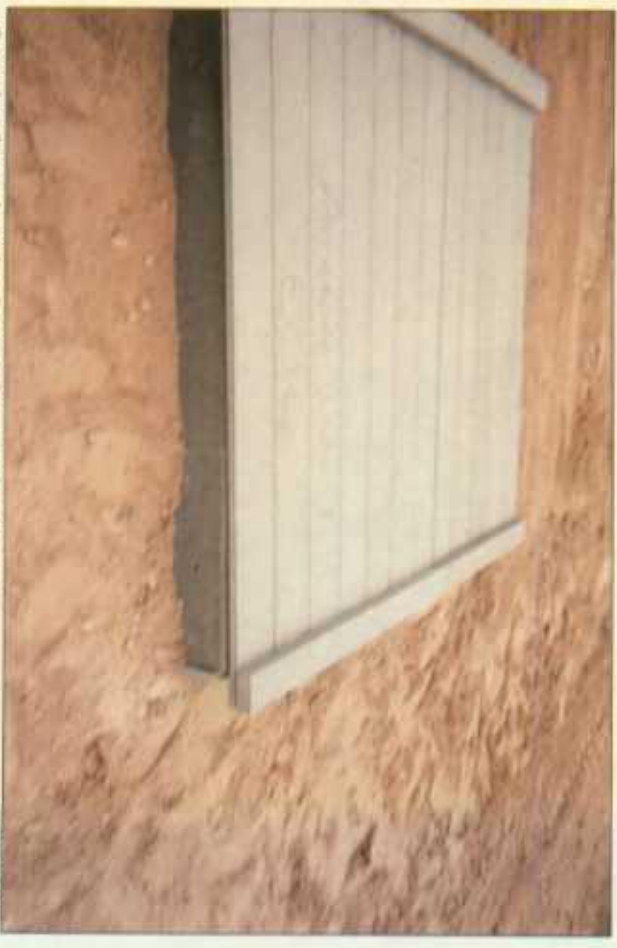
7/26/2004

Completed new junction box 40 ft west of old box site
