EME Jct J-18

RICE OPERATING COMPANY JUNCTION BOX FINAL REPORT

EME jct. J-18

unit 'J', sec. 18, T19S, R37E

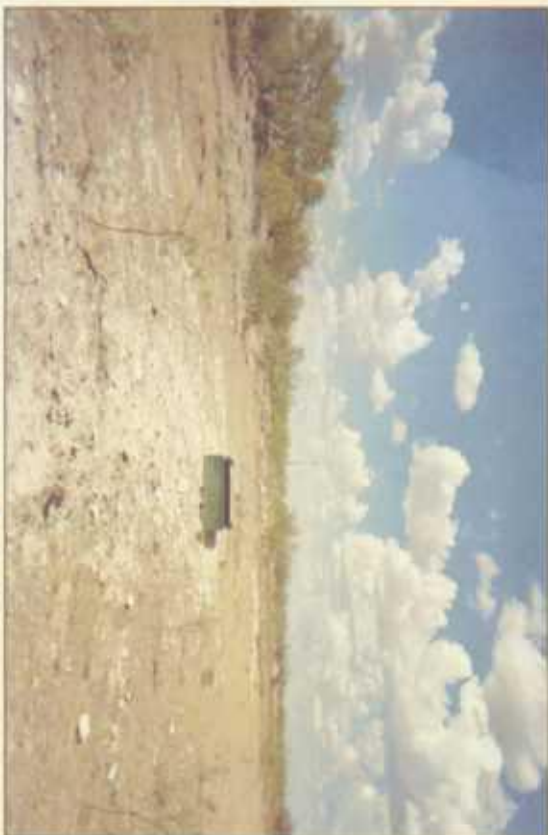
undisturbed box 8/28/2003

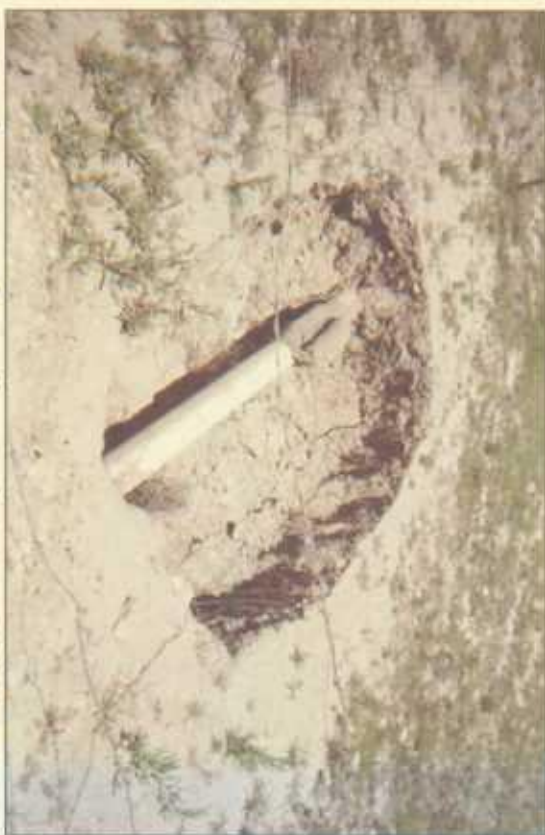
box removed; coupling anode 5/5/2004

General Description of Remedial Action: This junction was eliminated as the pipeline was re-plumbed straight-through. The junction box site did not exhibit any physical signs of hydrocarbon or chloride impact. Samples were collected at the site using a hand auger and were field-tested for chloride and screened with a PID. Field chloride tests yielded concentrations similar to background levels and laboratory tests confirmed TPH concentrations in non-detect levels, meeting NMOCD guidelines. The hole left by the box was backfilled using clean, imported soils. The graded surface was seeded with a blend of native vegetation and is expected to return to productive capacity at a normal rate.

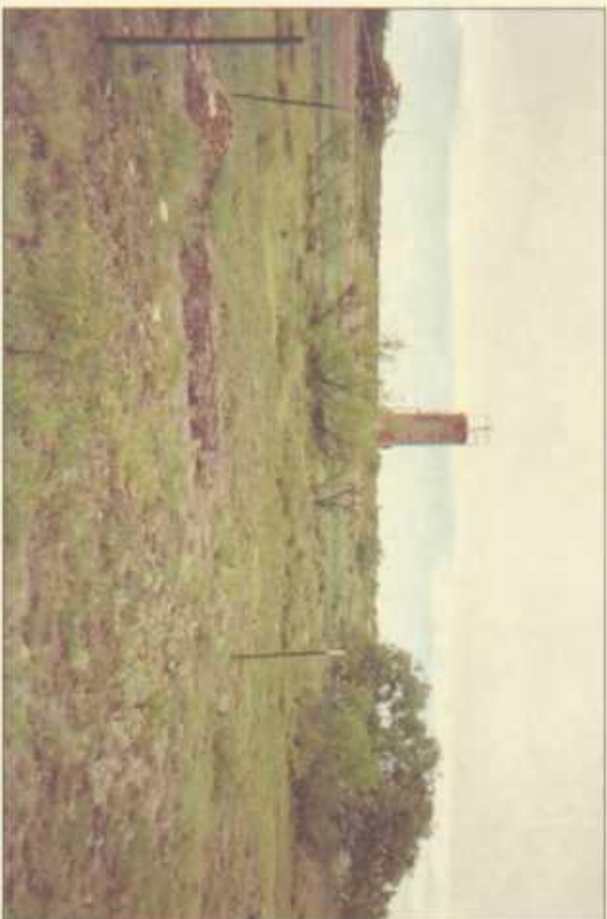
open hole; lumber removed 5/27/2004

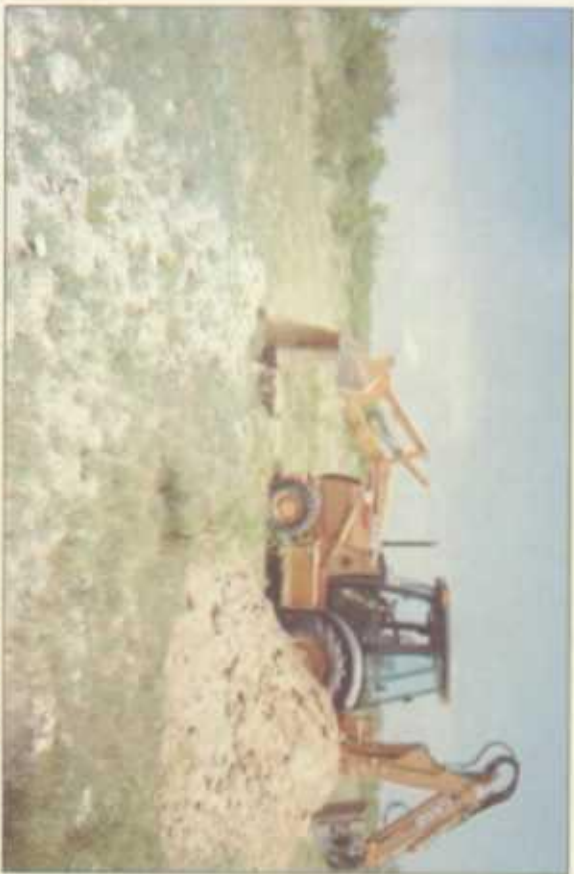
8/11/2004

backfilling with clean

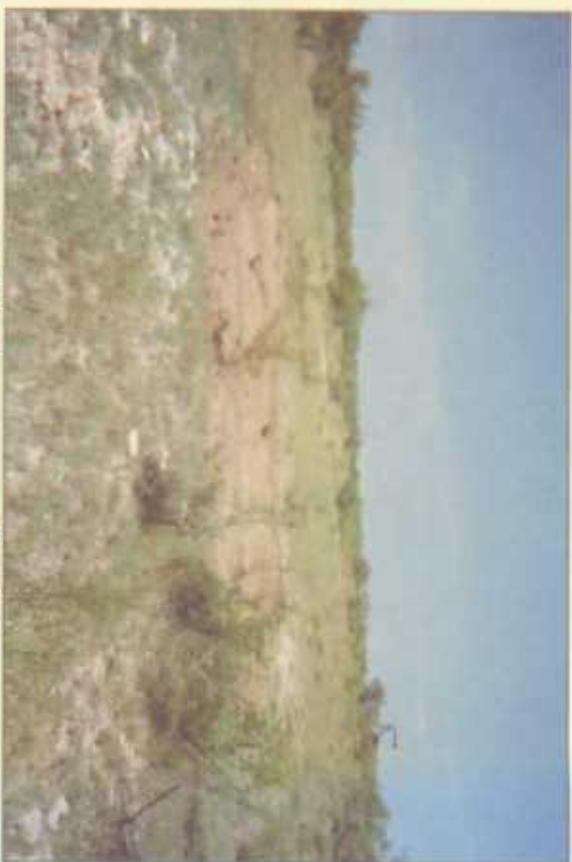
8/11/2004

backfilled

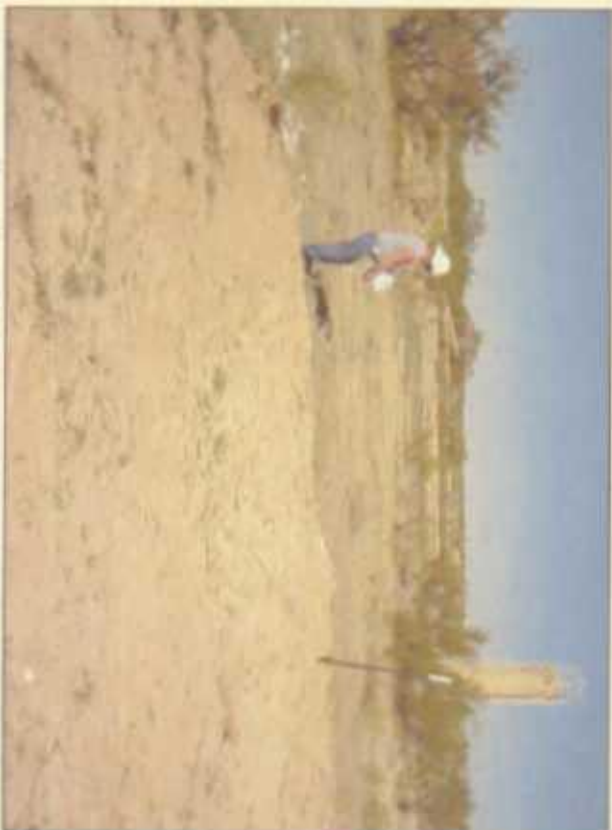
9/17/2004

seedling disturbed area
