IME Jct B-1-2

**RICE OPERATING COMPANY
JUNCTION BOX DISCLOSURE* REPORT**

EME jct. B-1-2

unit 'B', sec. 1, T20S, R36E

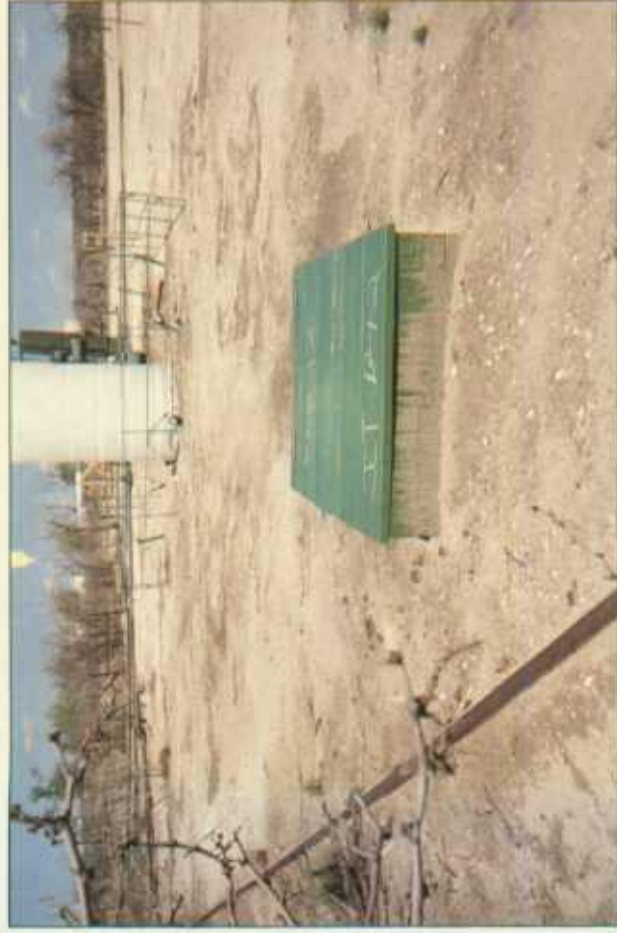
undisturbed junction box

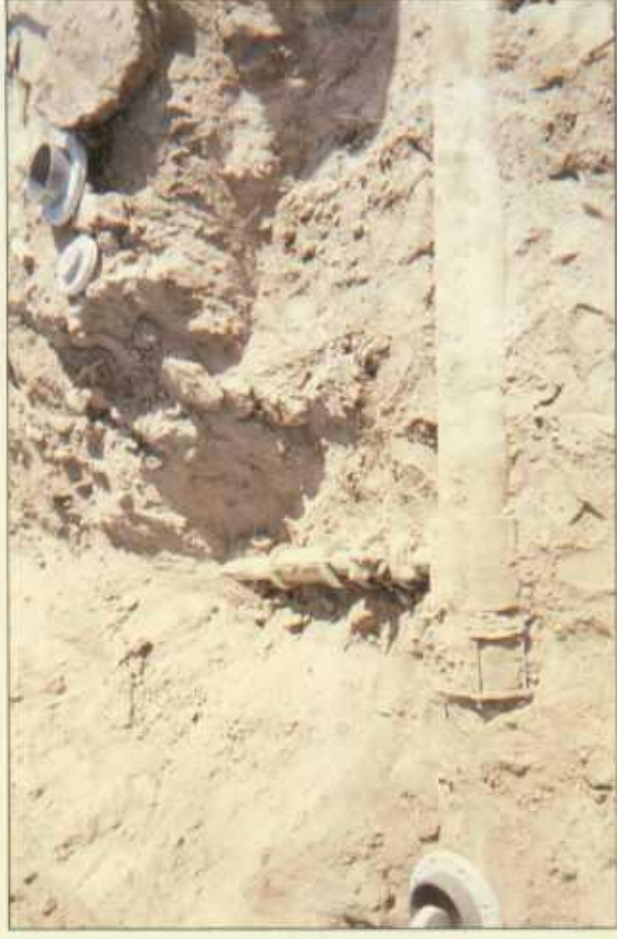
box removed; old plumbing

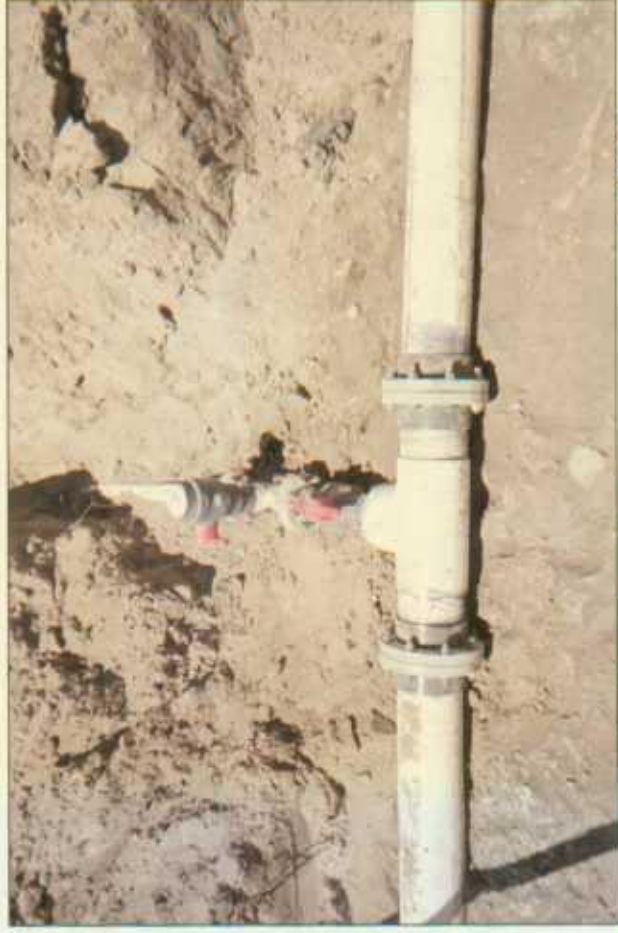
new plumbing at junction

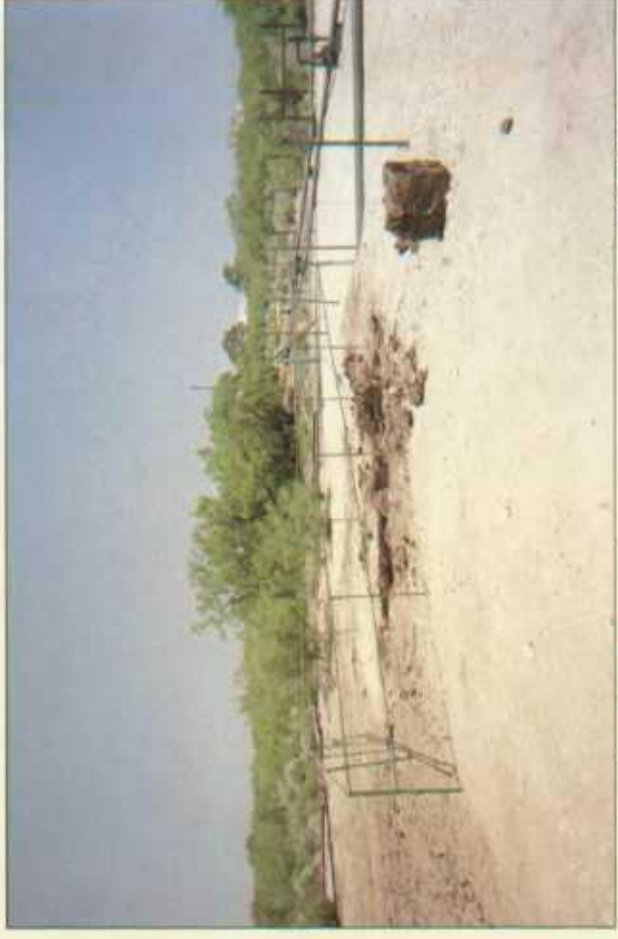
junction box removed

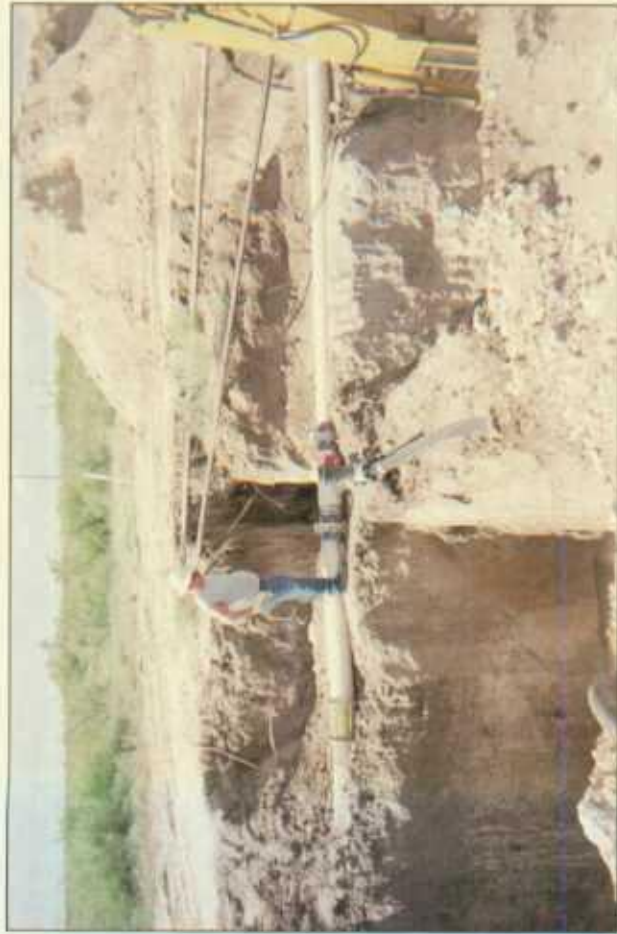
30 x 30 x 12-ft excavation with pipe supports

General Description of Remedial Action: This junction box was located just south of the fence of an active production facility. The pipeline was replaced and the site was delineated using a backhoe while PID screenings and chloride field tests were conducted at regular intervals on grab soil samples. PID readings were low throughout the 30 x 30 x 12 ft deep excavation and composite lab samples confirmed non-detect (<10.0 ppm) TPH concentrations that meet NMOCD guidelines. Chloride concentrations did not exhibit significant declines at this site. The excavated soil was blended on site and then backfilled into the excavation and contoured to the surrounding surface. The disturbed surface was seeded with a blend of native vegetation and is expected to return to productive capacity at a normal rate. A new watertight junction box has been built over this junction. An identification plate has been placed next to the box to identify the junction site for future environmental considerations. NMOCD has been notified of potential groundwater impact at this site.

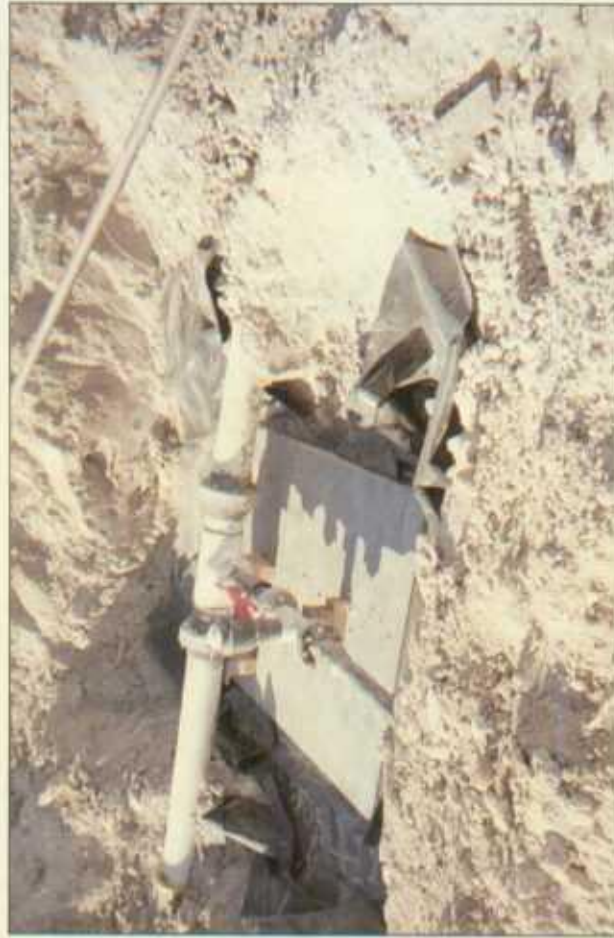
floor of new box at backfilled site

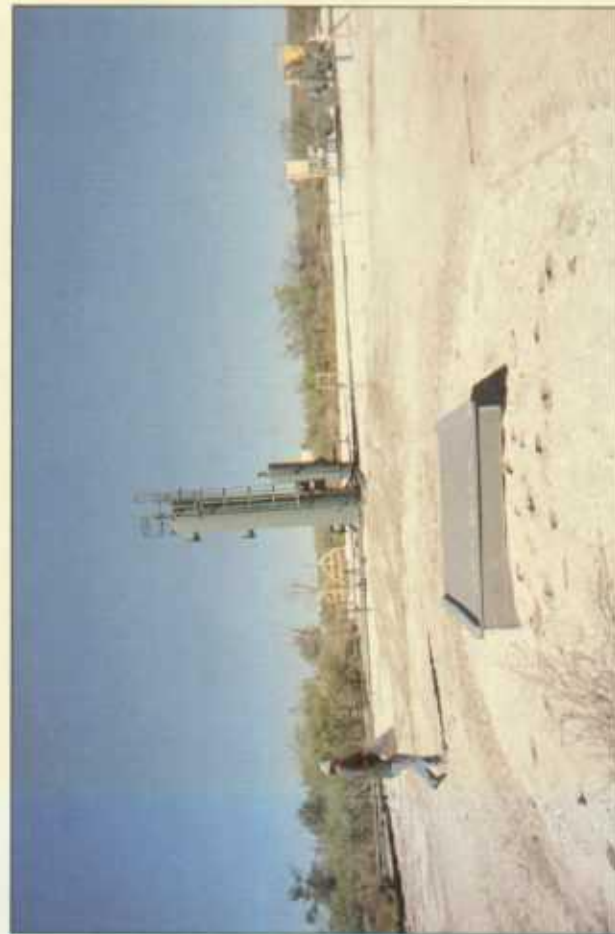
seeding disturbed surface; new junction box in foreground

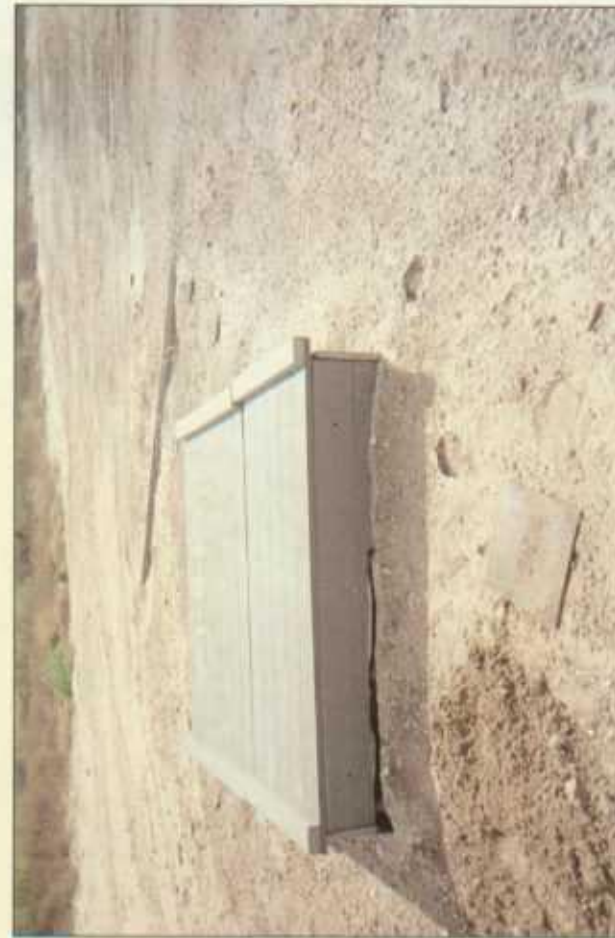
disclosure plate at junction box

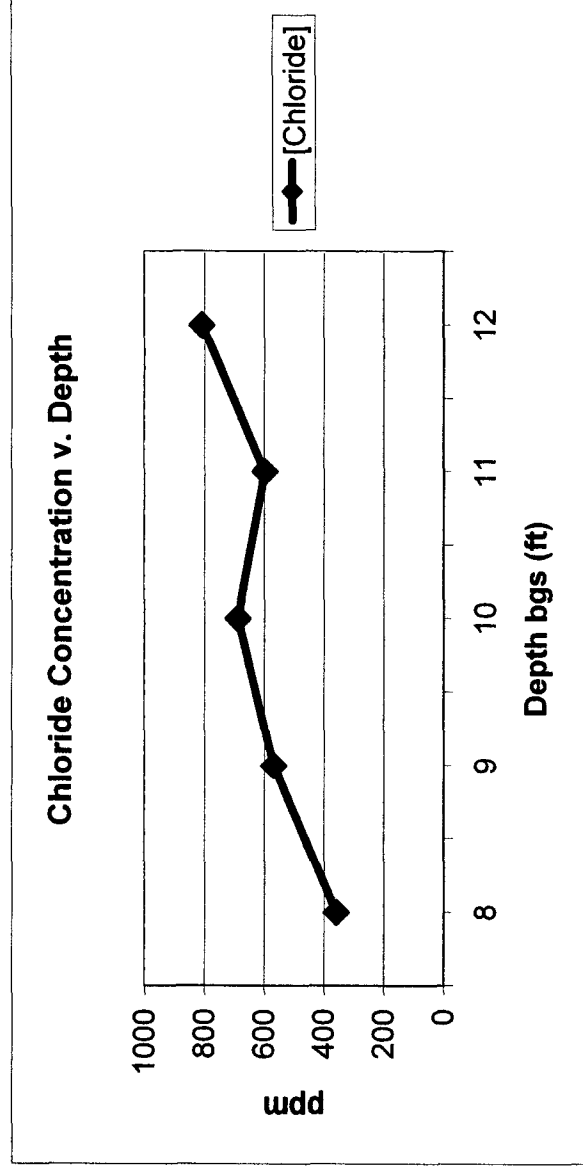
Vertical Delineation at Source

Depth bgs (ft)	[Cl ⁻] ppm
8	359
9	569
10	689
11	599
12	809

Groundwater = 40 ft

LOCATION	DEPTH (ft)	ppm
15 ft NORTH of junction	8	359
	9	569
	10	689
	11	599
	12	809
15 ft SOUTH of junction	8	659
	9	419
	10	659
	11	719
	12	749
4-wall comp.	12	689
bottom comp.	12	209
remed. backfill	n/a	389
