**RICE OPERATING COMPANY  
JUNCTION BOX FINAL REPORT**

## EME jct. P-31

Unit 'P', Section 31, T21S, R36E

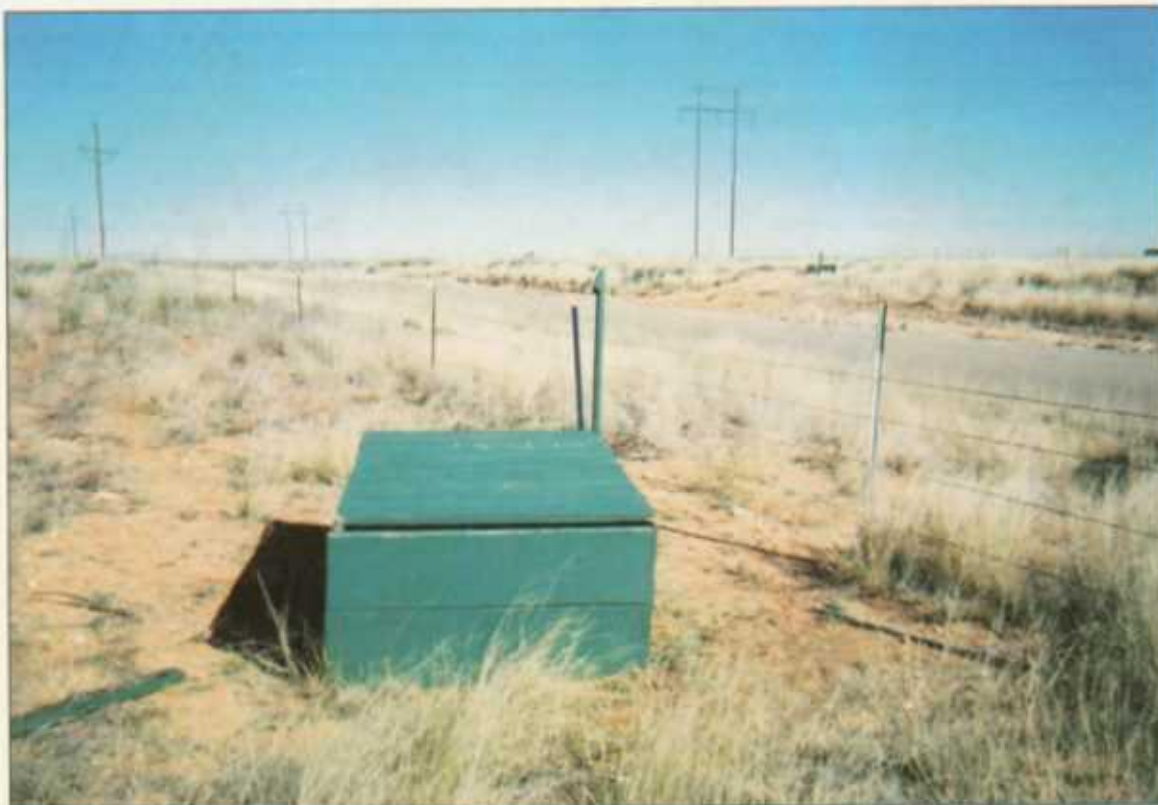
undisturbed junction box

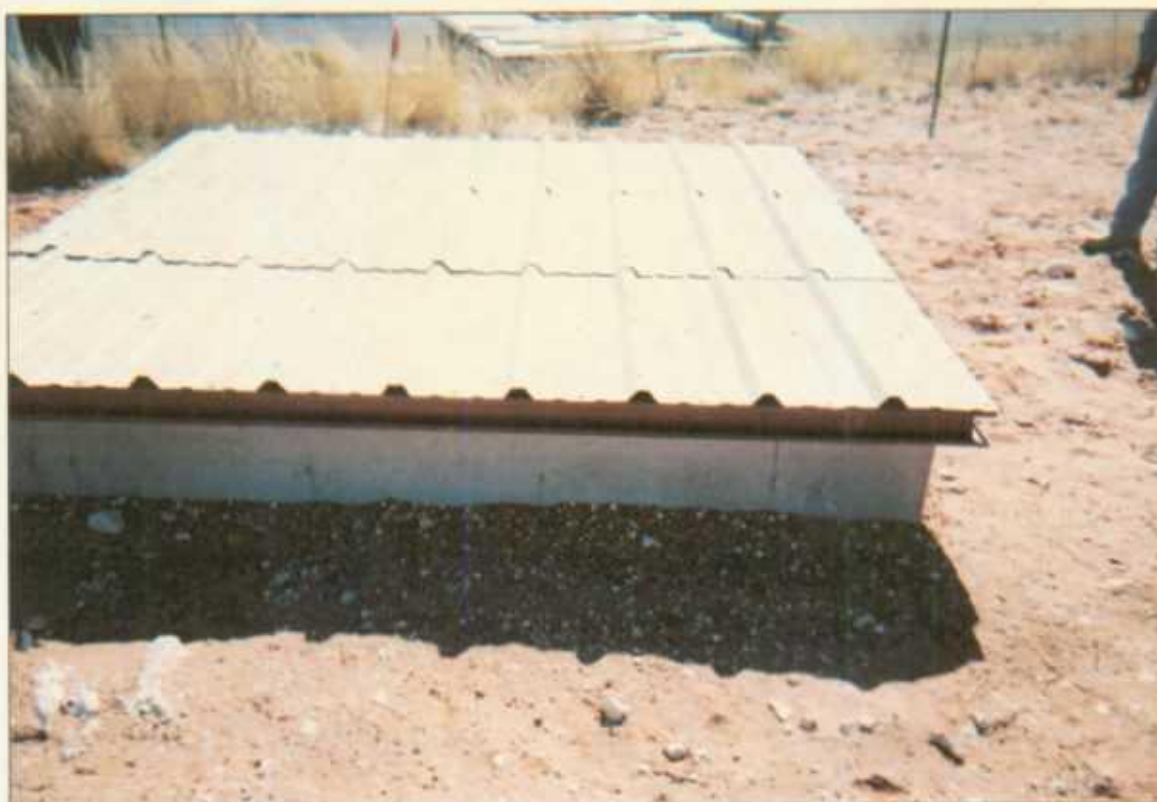
new watertight junction box 5 ft southeast of former box

part of the pipeline replacement program. The junction has been moved 5 ft southeast. A delineation trench was made at the former junction box site and soil samples were collected every foot of depth from 8 ft to 12 ft BGS. Chloride field tests were performed on each sample and yielded very low concentrations. PID screenings were also performed on all the samples and concentrations were also very low. For confirmation, the deepest sample at 12 ft was analyzed at a laboratory and confirmed the low chloride concentrations. TPH was not present within the lab's detection limit (<10.0 ppm), meeting NMOC guidelines. The excavated soil was blended on site and then backfilled into the trench. A new watertight junction box will be built at the new junction 5 ft southeast of this site. The disturbed surface resulting from these activities will be seeded with a blend of native vegetation.
