## **JUNCTION I-9**

### **Stage 2 Abatement Report**

Rice Operating Company  
Hobbs, New Mexico

Prepared by:  
ARCADIS G&M, Inc.  
1004 N. Big Spring Street  
Suite 300  
Midland,  
Texas 79701  
Tel 432.687.5400  
Fax 432.687.5401

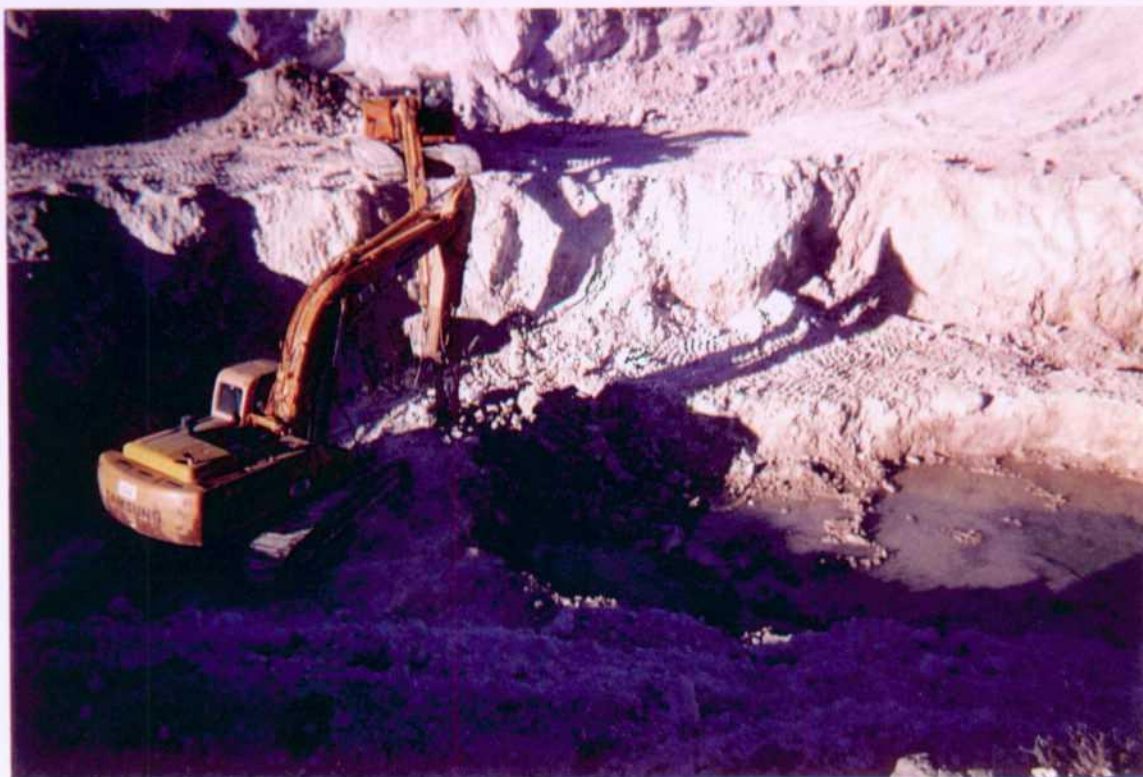
Excavation to groundwater in area where PSH was detected.

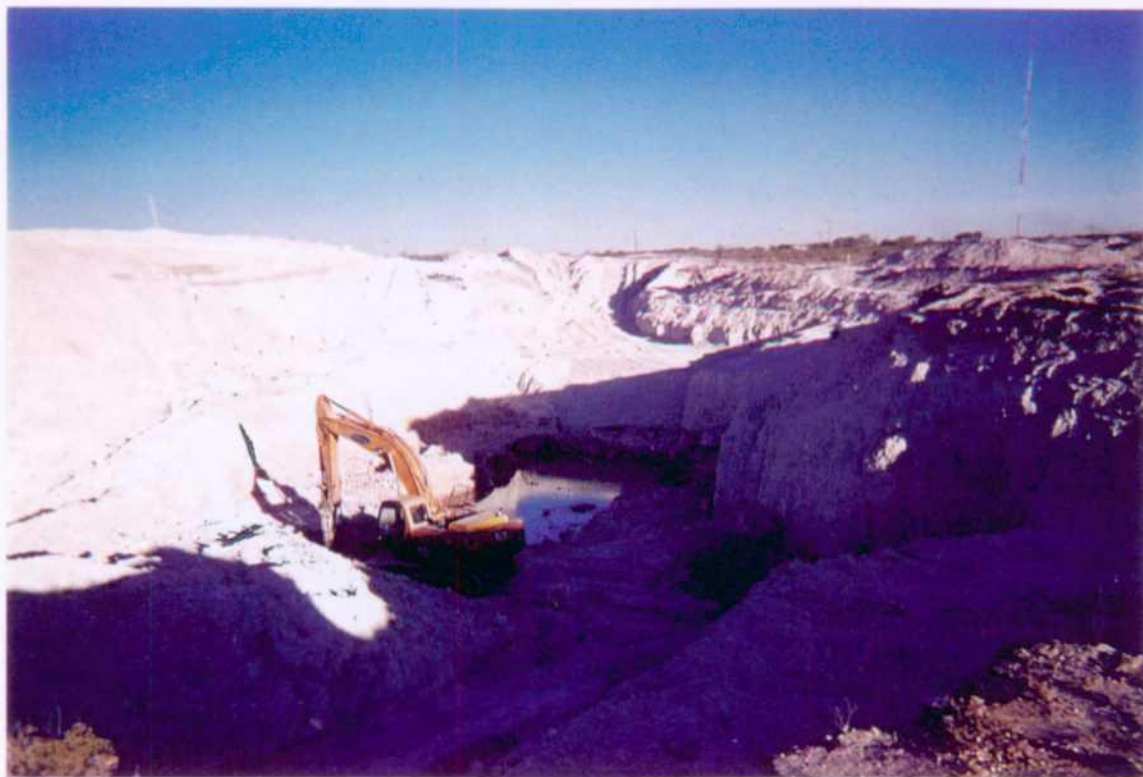
Excavation to groundwater in area where PSH was detected.

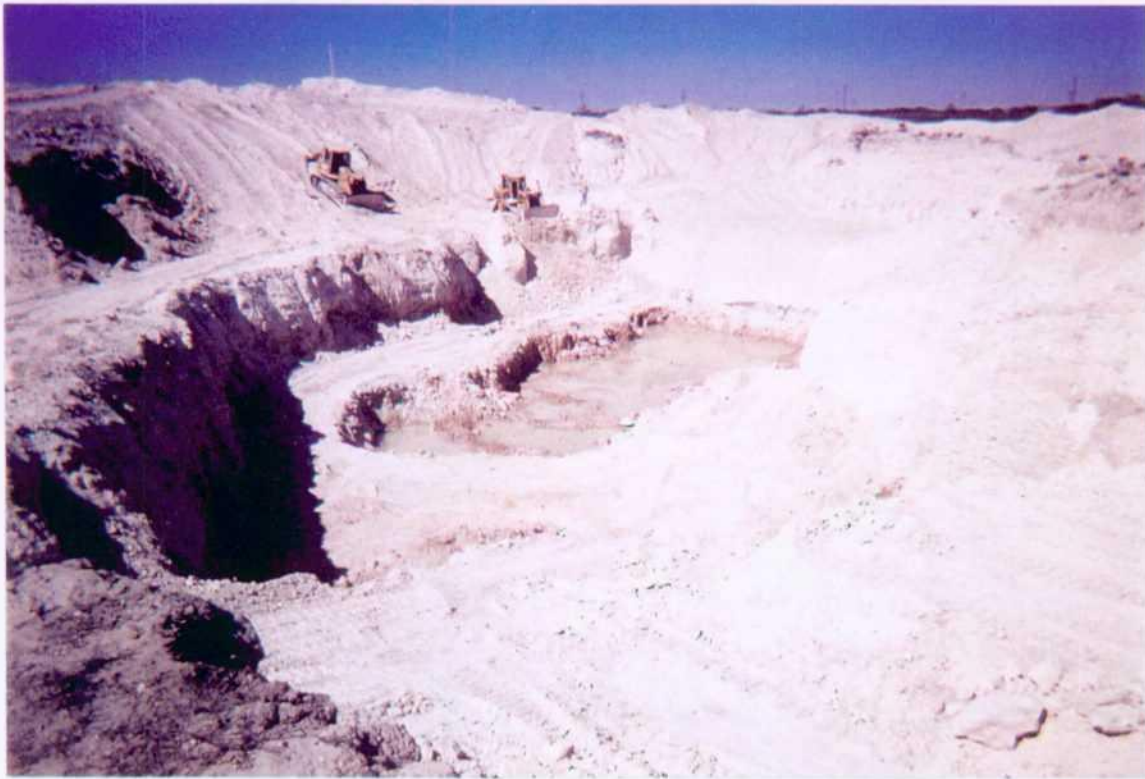
Excavation to groundwater in area where PSH was detected.

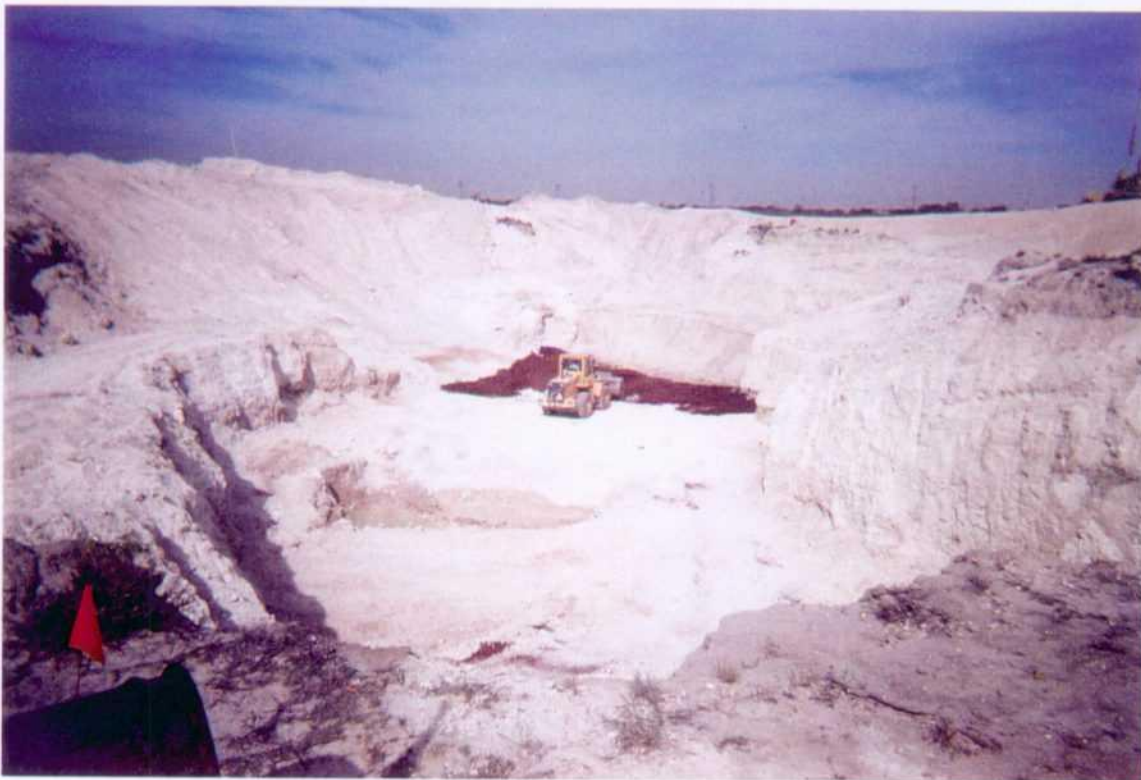
Installation of lower liner.

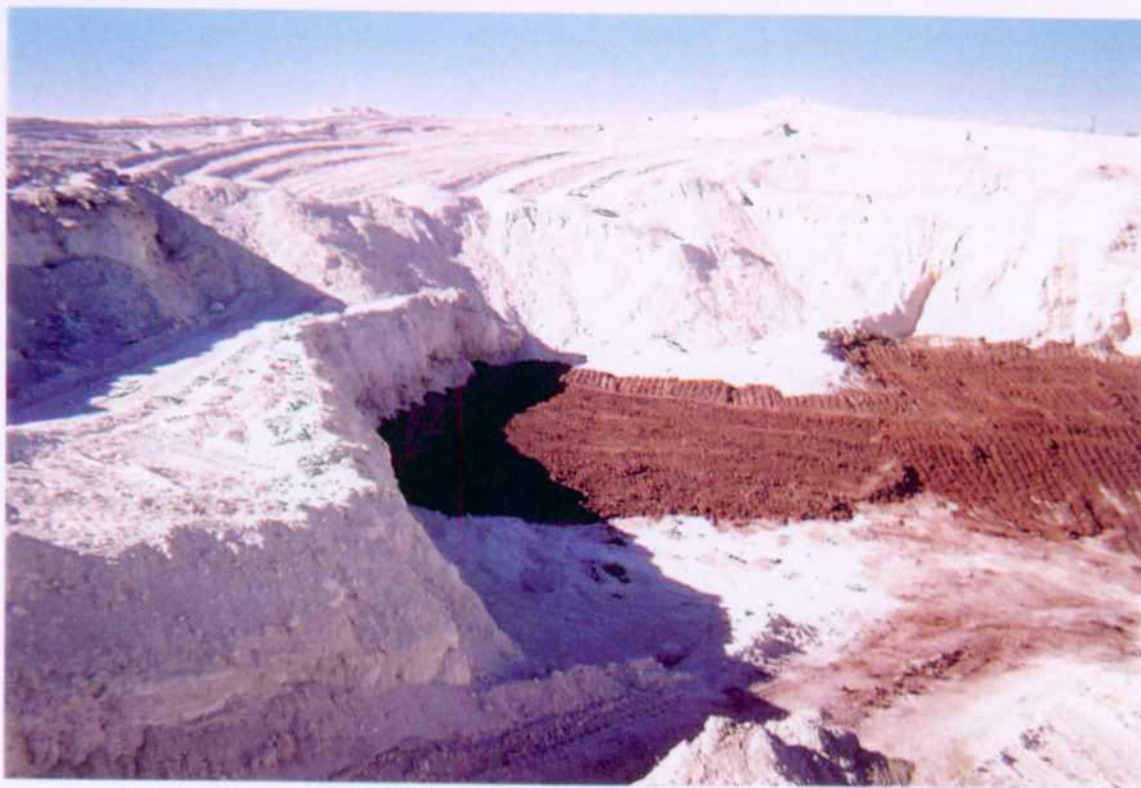
Installation of lower liner.

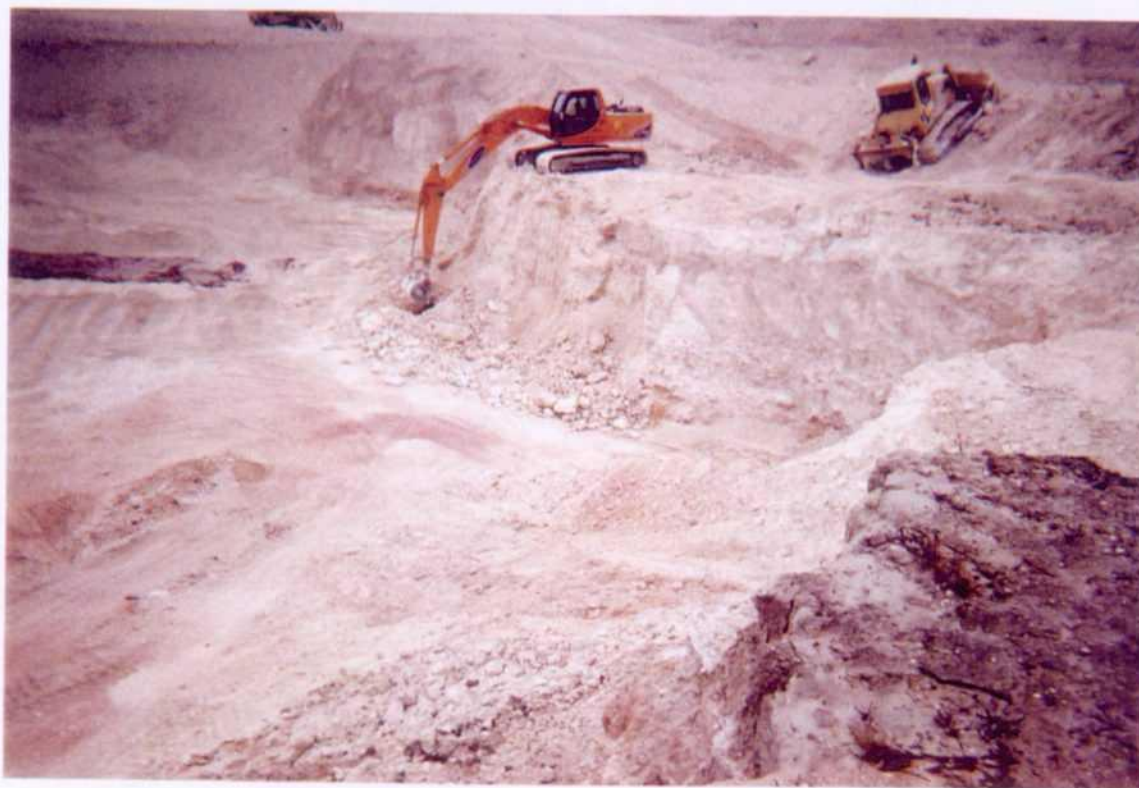
Excavation of sidewalls.

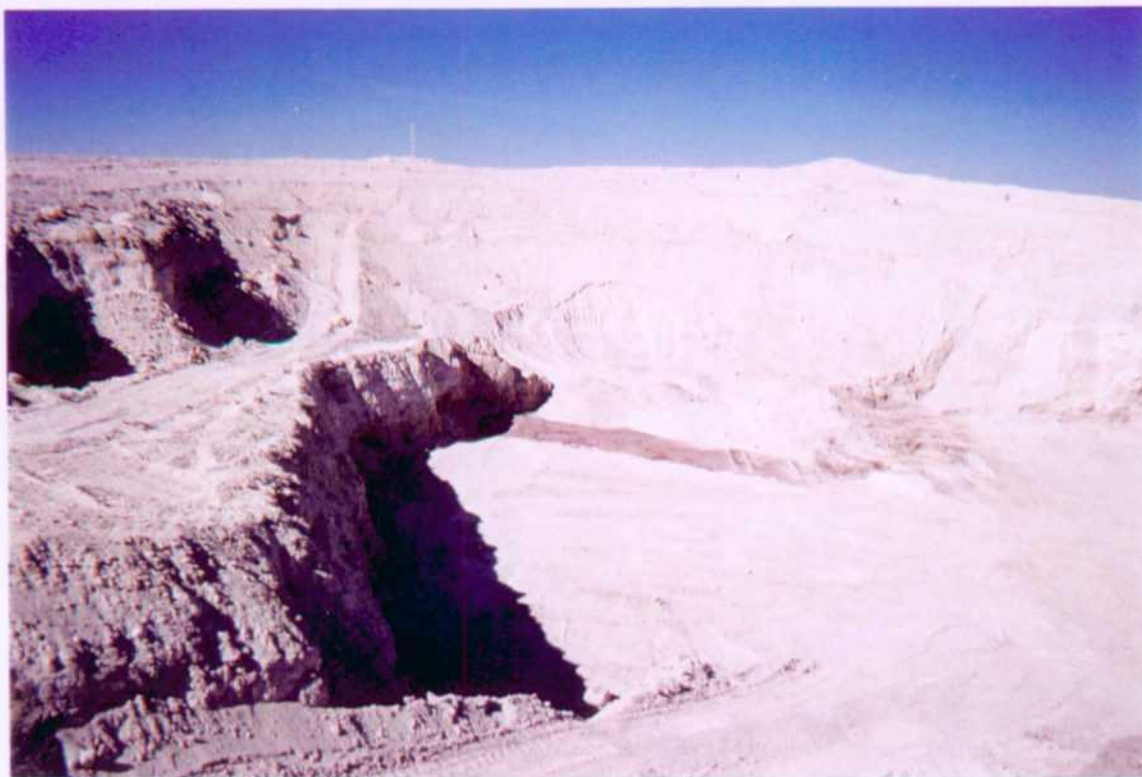
Backfilling over lower liner.

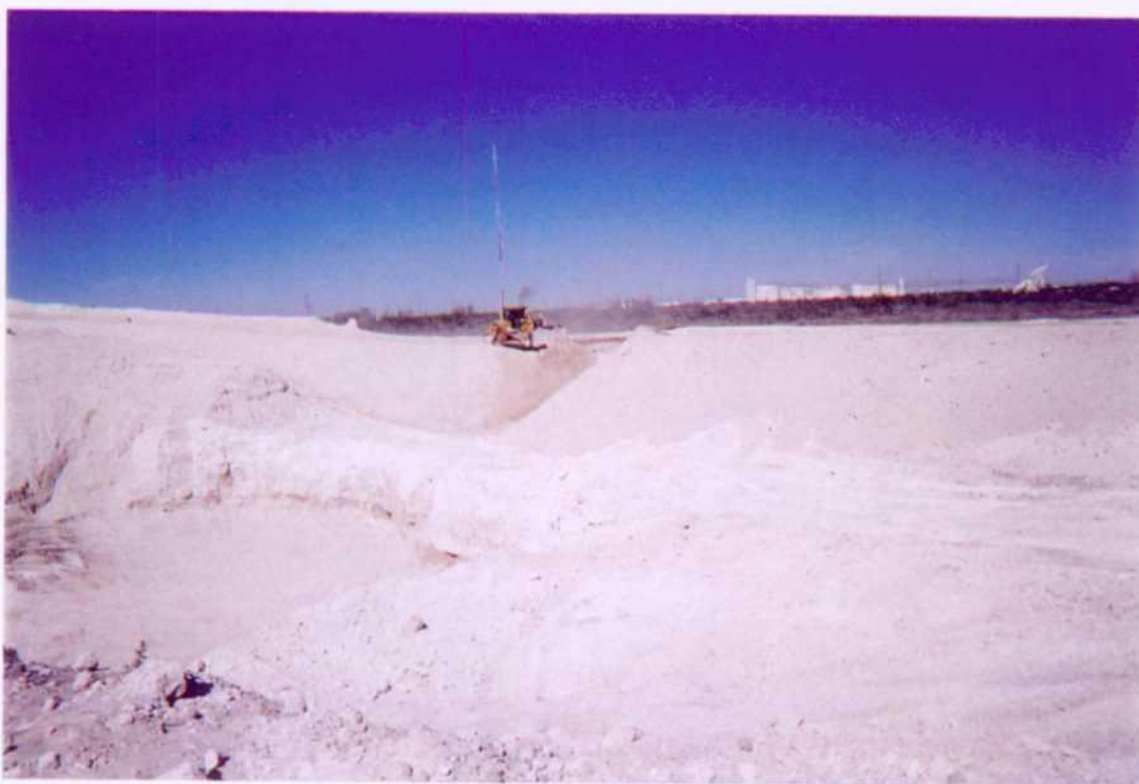
Backfilling over lower liner.

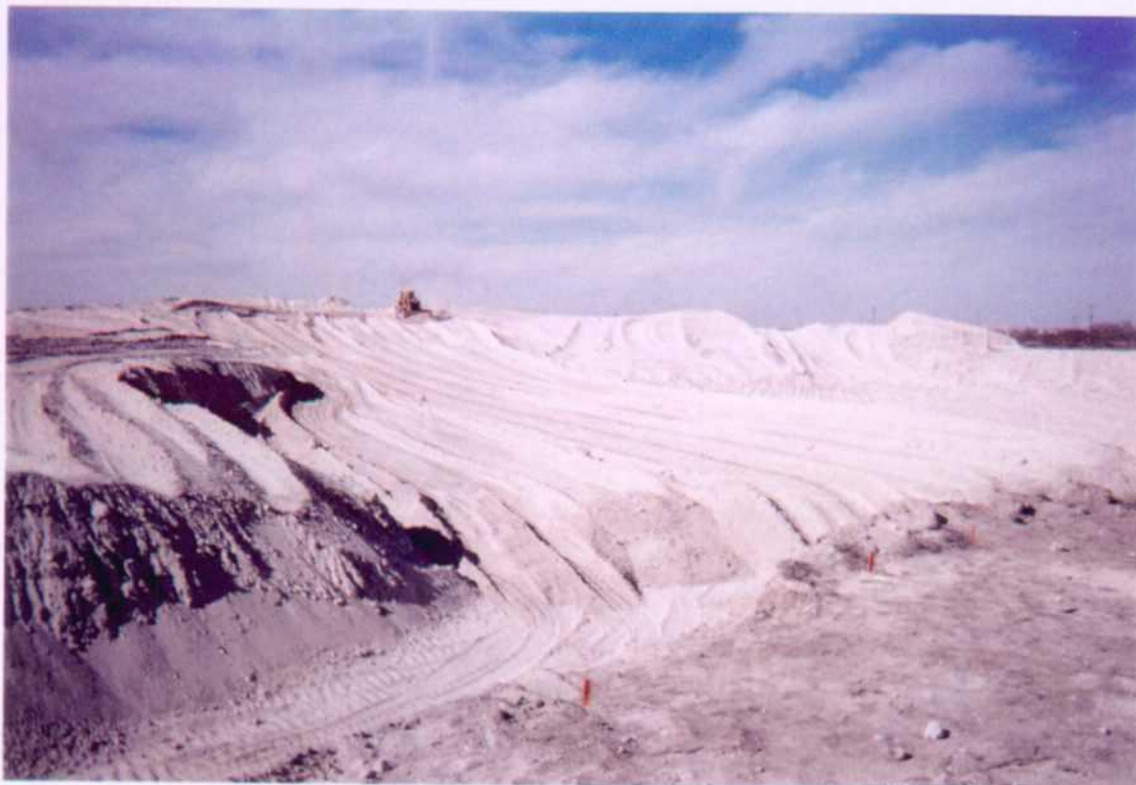
Backfilling.

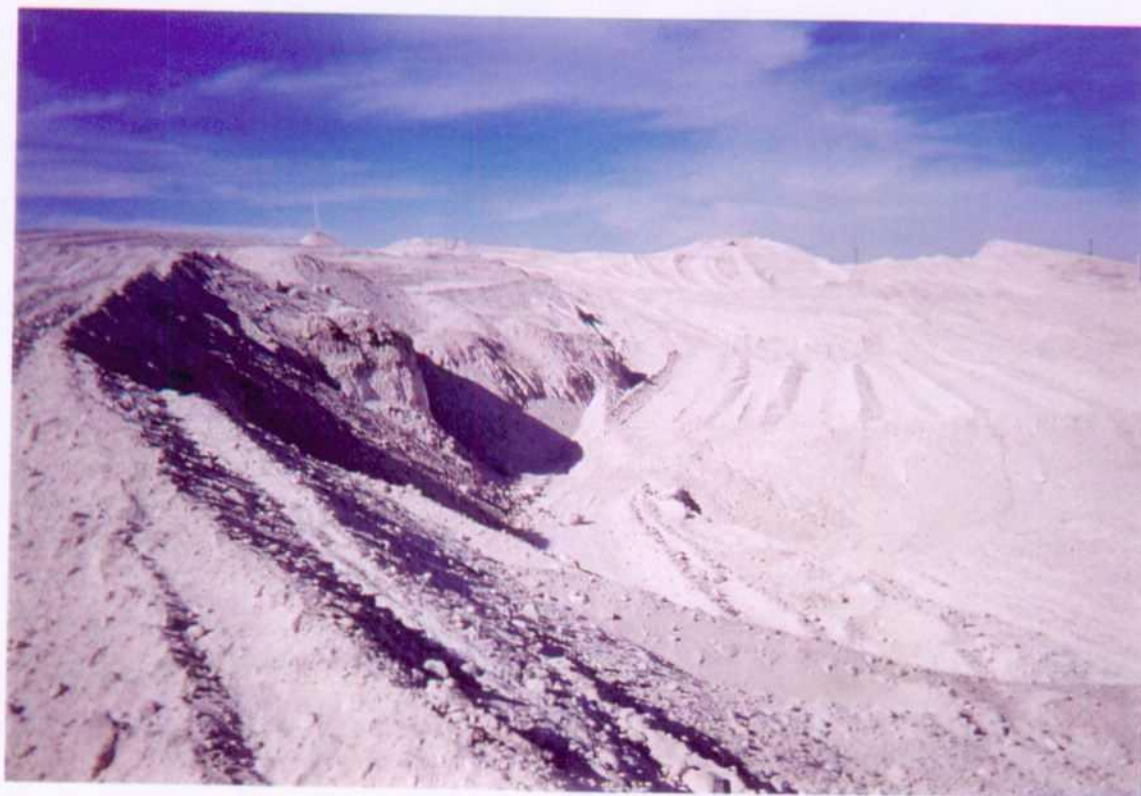
Backfilling.

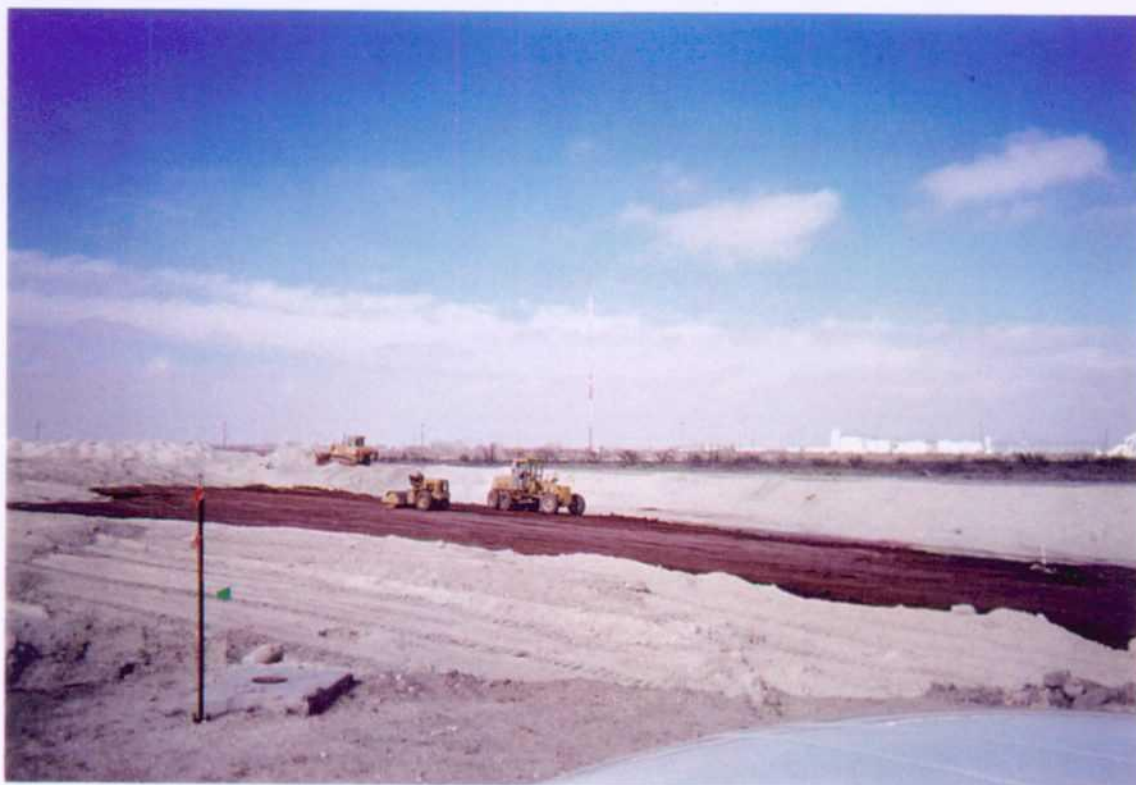
Installation of upper liner.

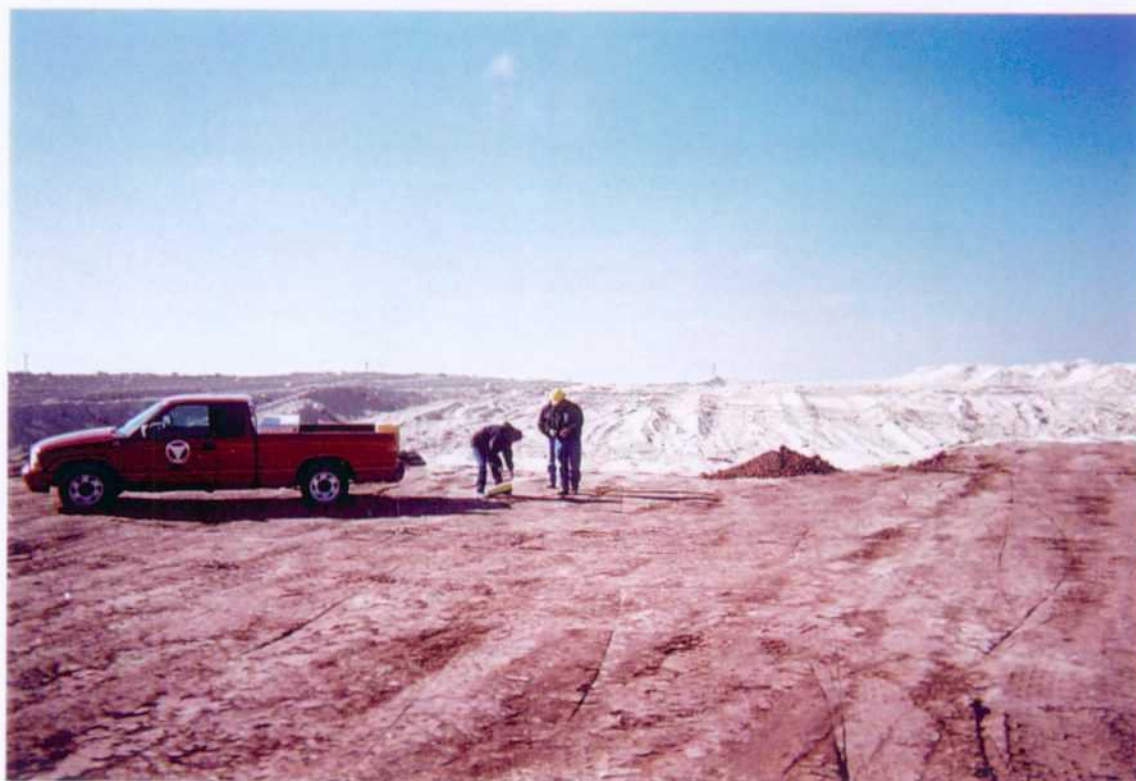
Proctor testing of upper liner.

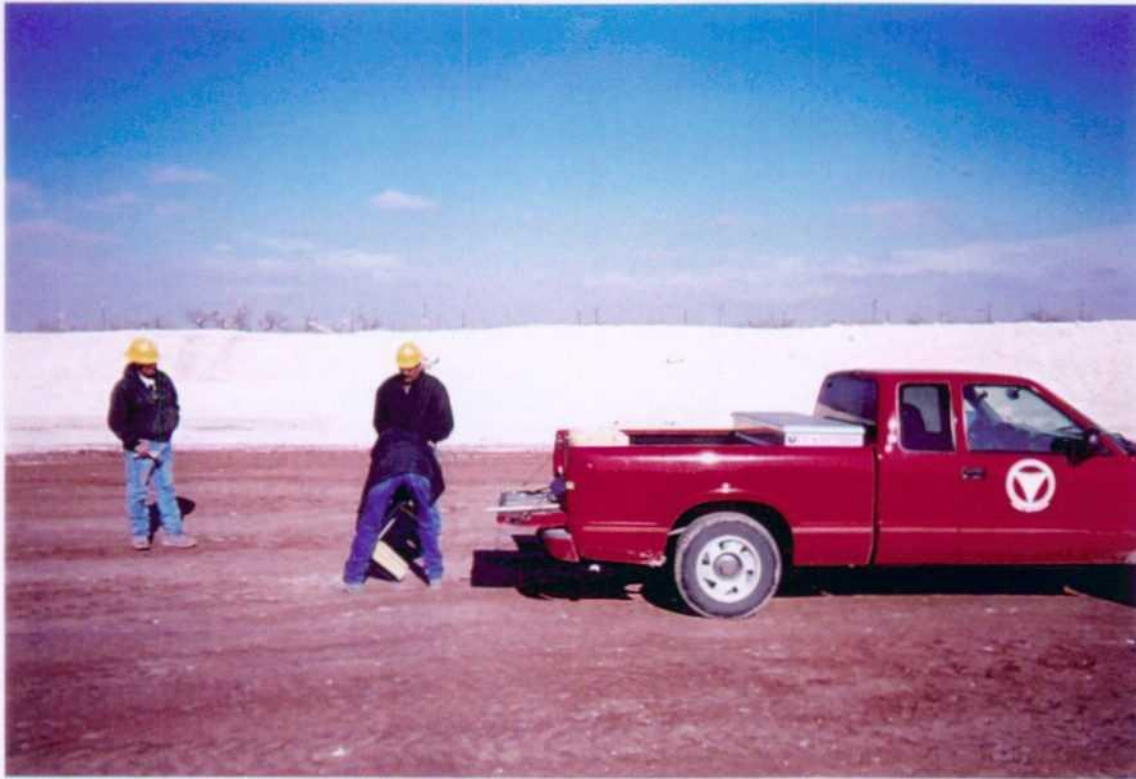
Proctor testing of upper liner.

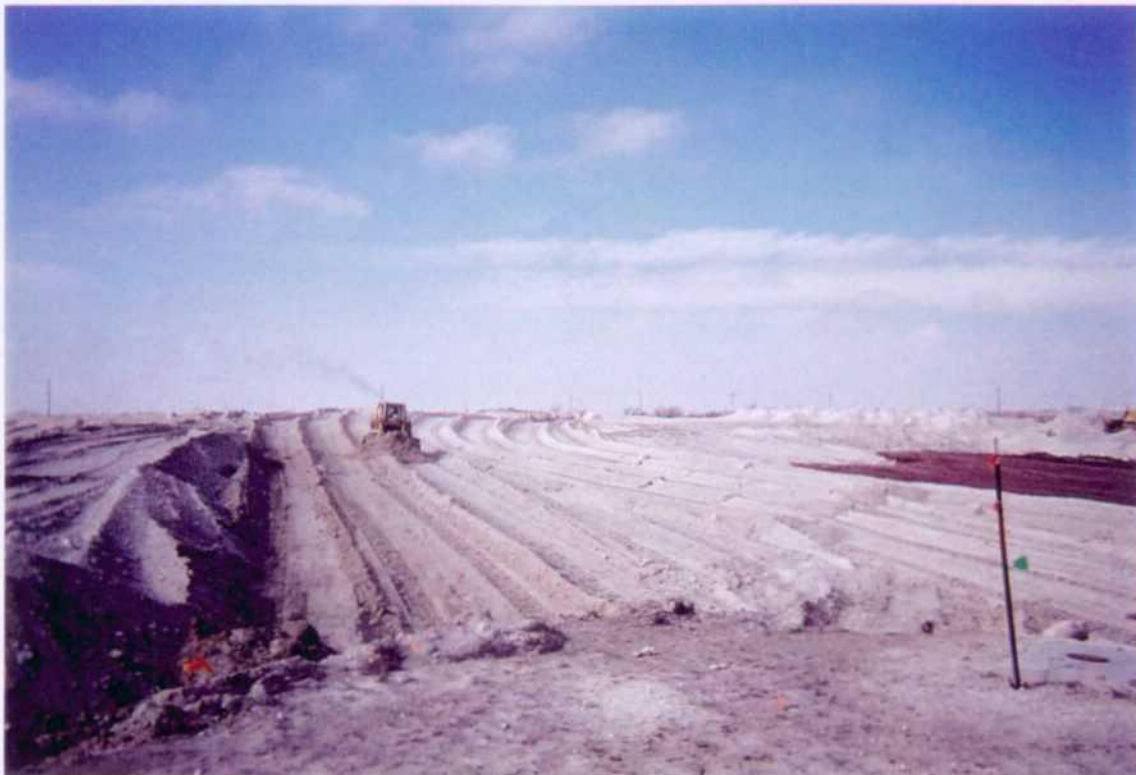
Backfilling over upper liner.

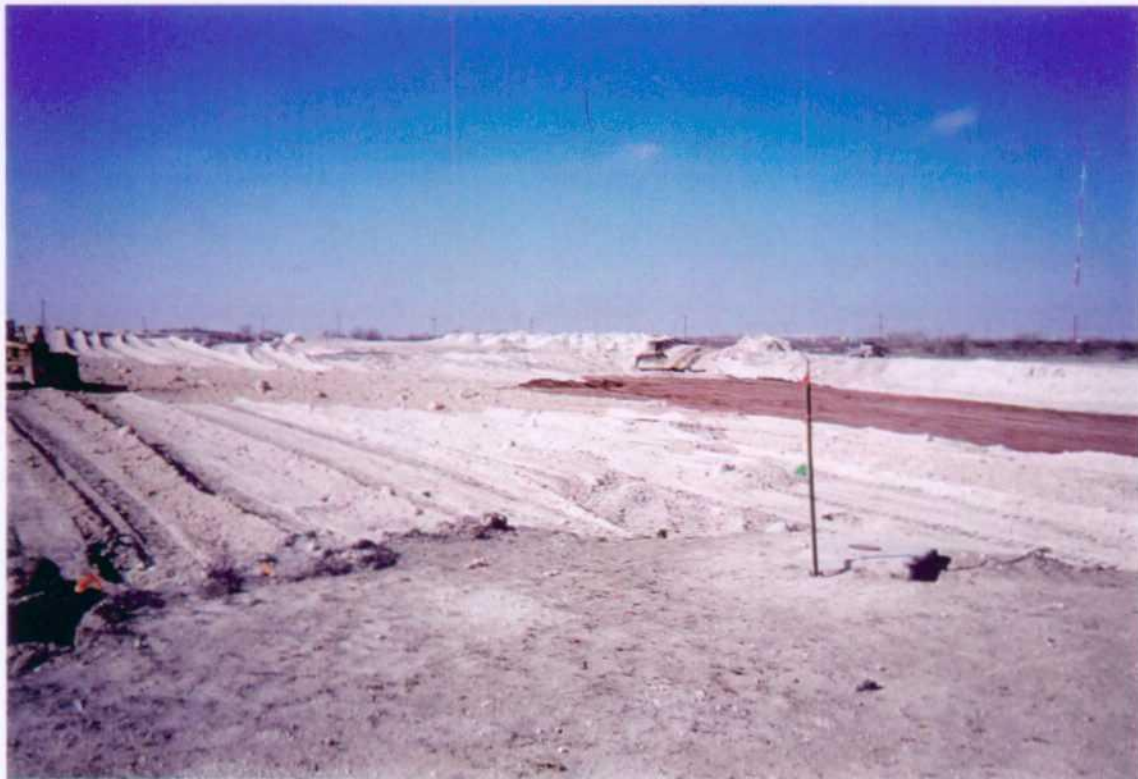
Backfilling over upper liner.

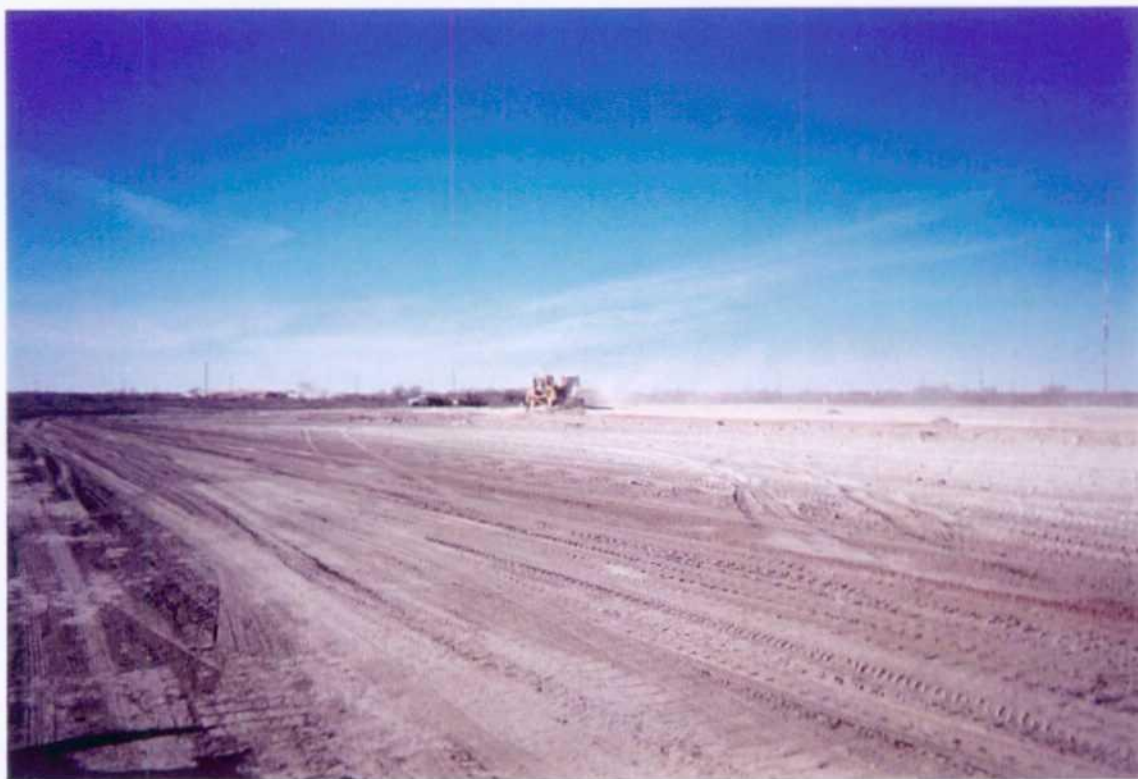
Site grading.

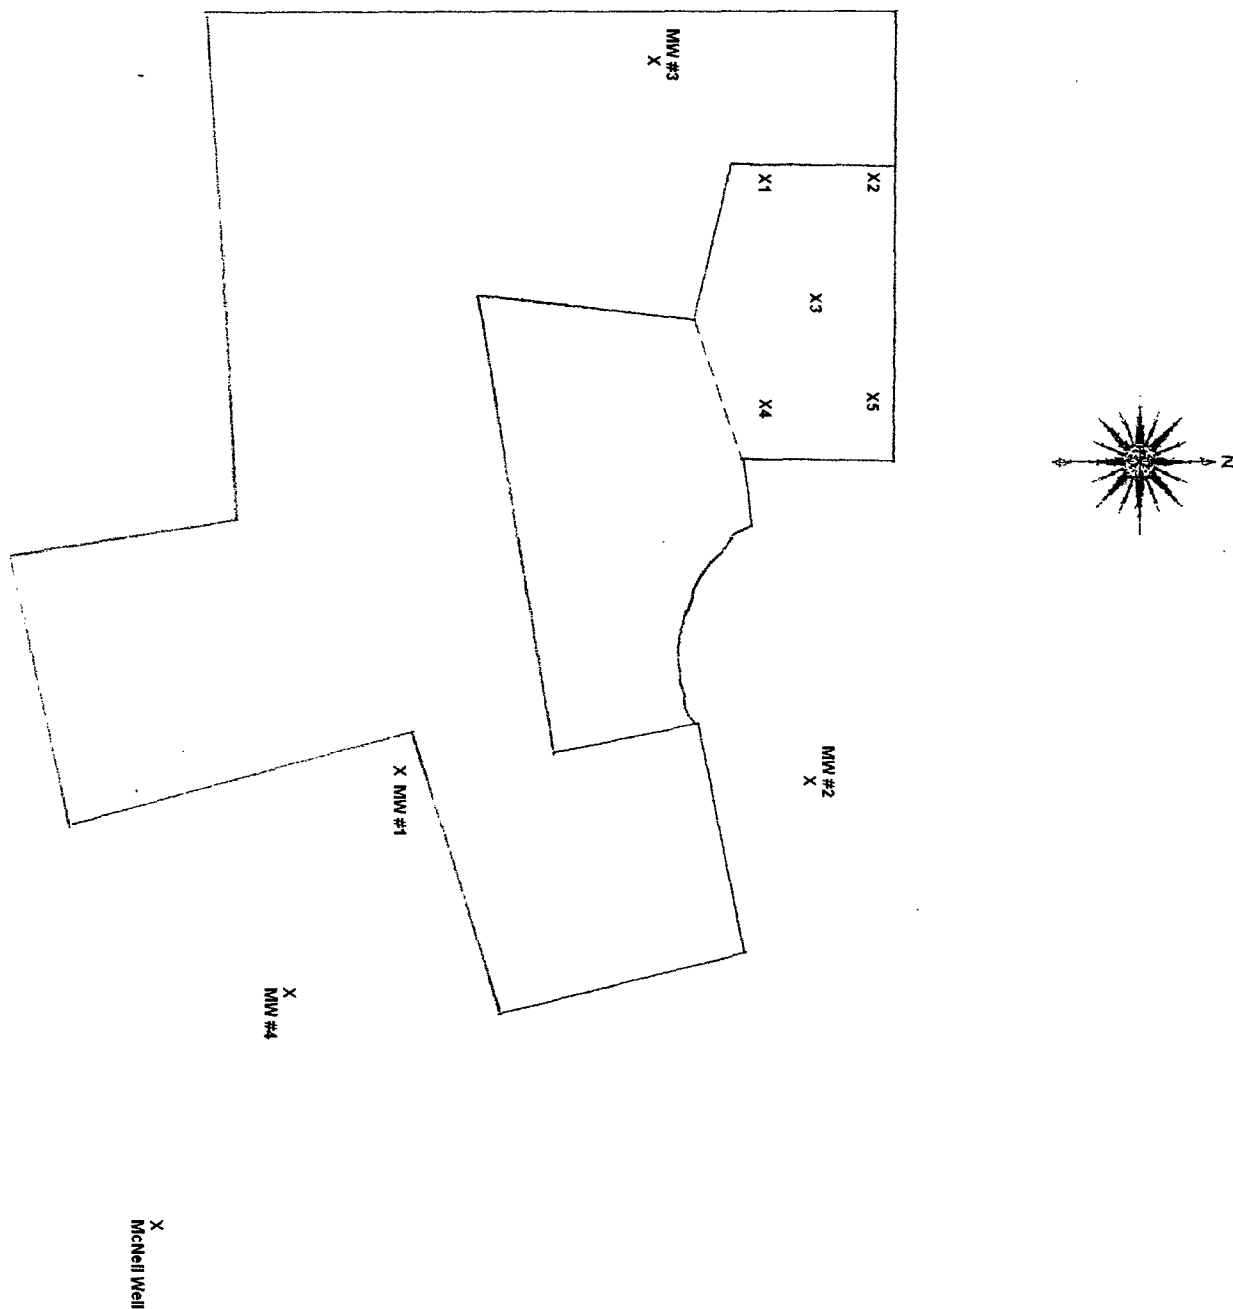
Hobbs I-9 Sample Points Prior to Clay Liner Installation  
Lab #H8053 #1 - #5

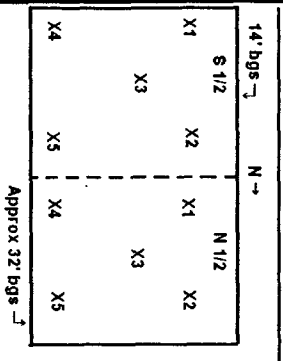
Side View of West Wall N. 1/2 & S. 1/2  
 Sample Points

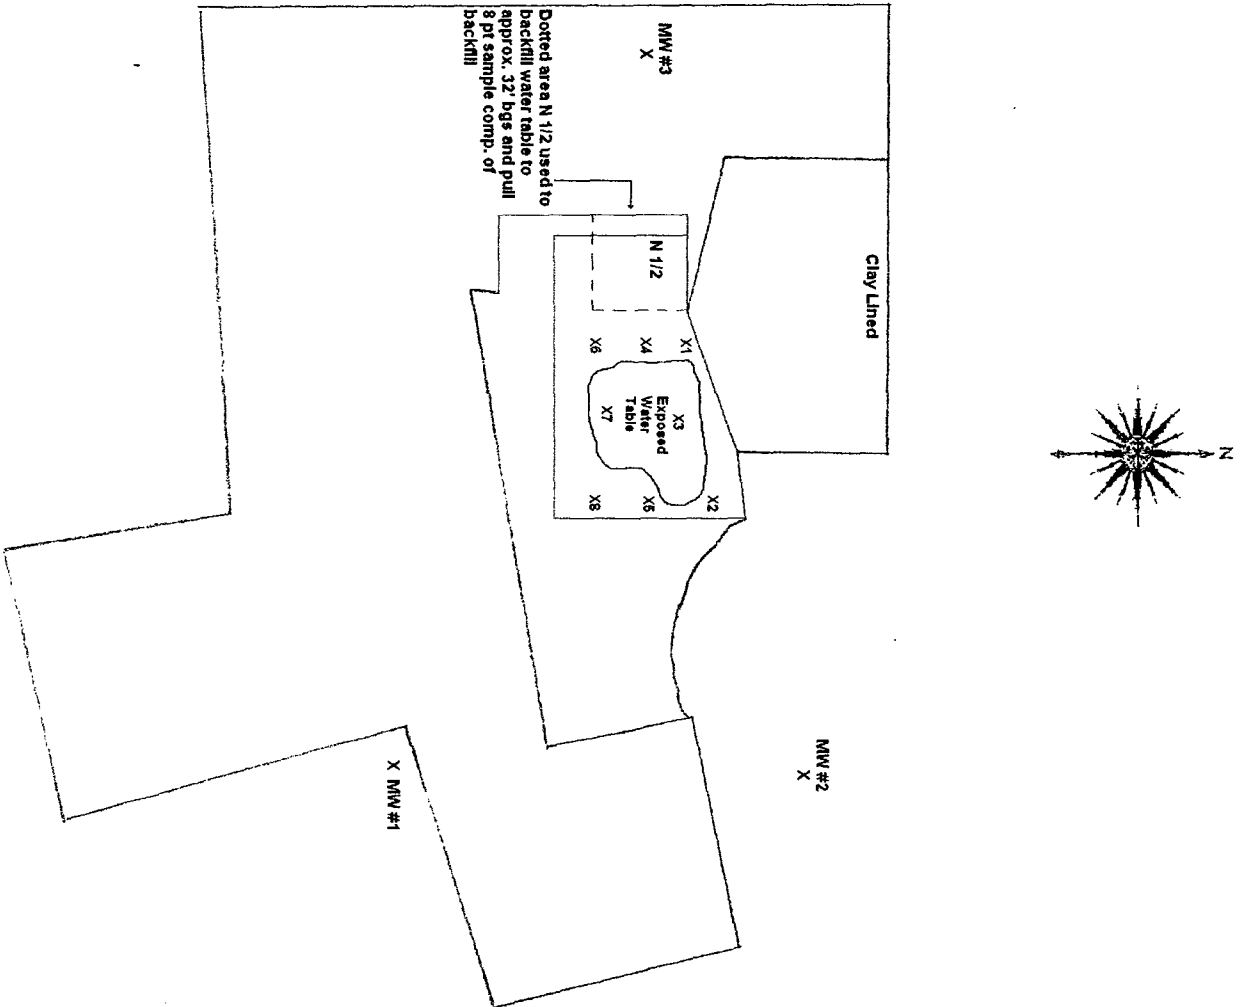
10/24/03 Waste Table Backfill from West Wall  
 Lab # H8113  
 8 pt comp. west wall after backfill

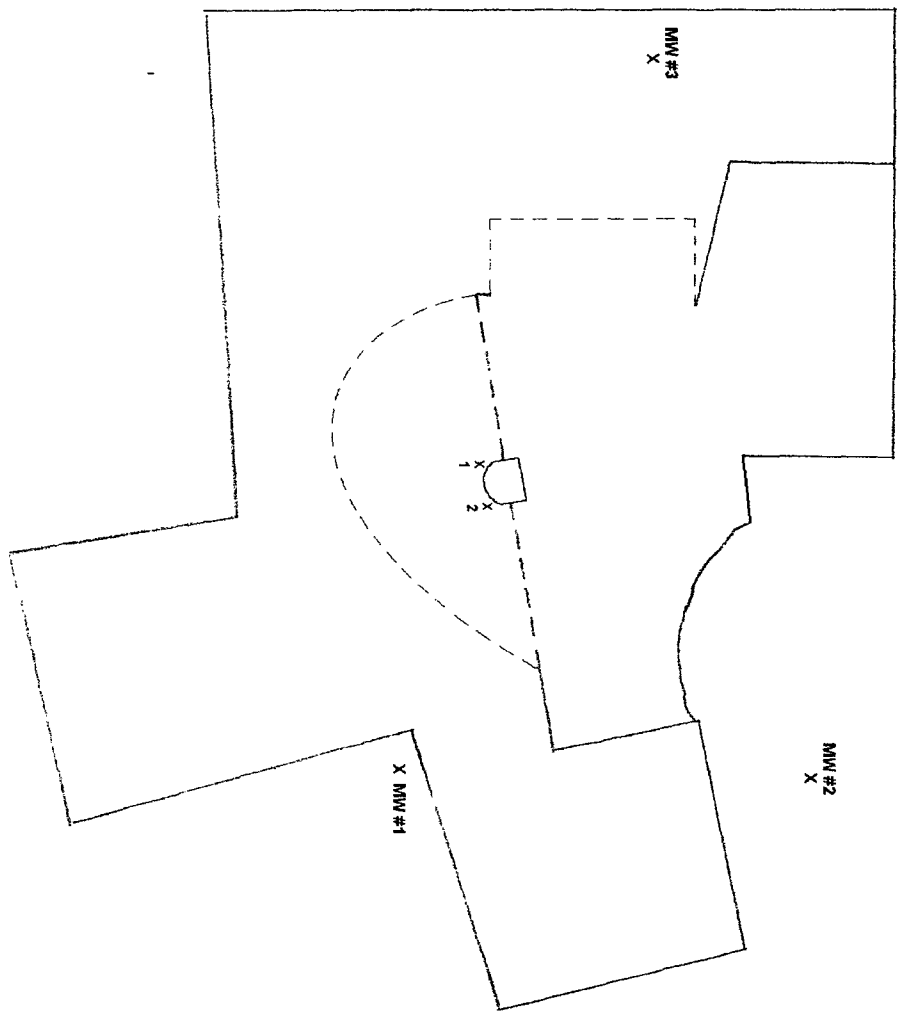
10/30/03  
 Lab #H8129  
 Hobbs I-9 Sample point of last water table  
 area open @ 36' sampled between  
 sandstone (rock) & water level 2 pt comp

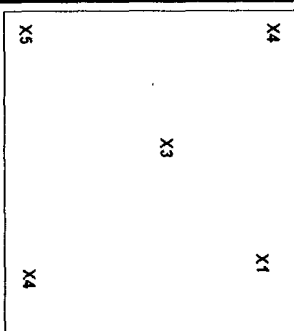
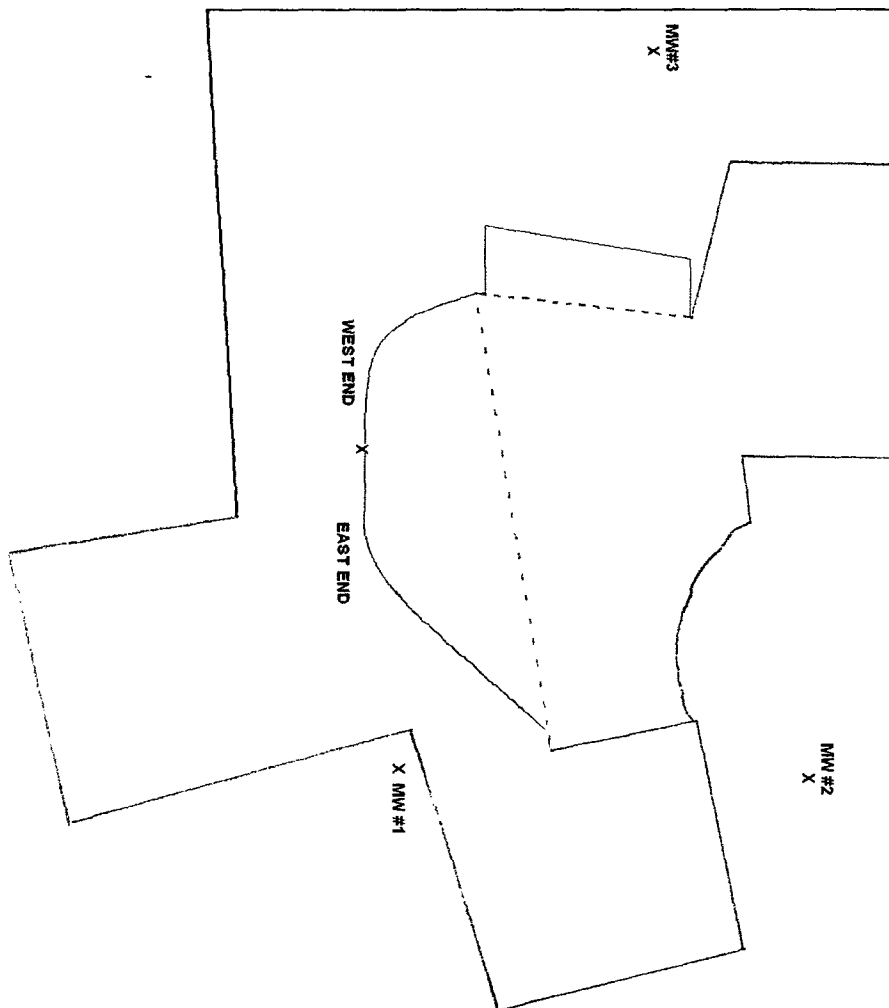
SOUTH WALL SIDE VIEW EAST END

APPROX. 14' BGS  
 W →

APPROX. 32' BGS

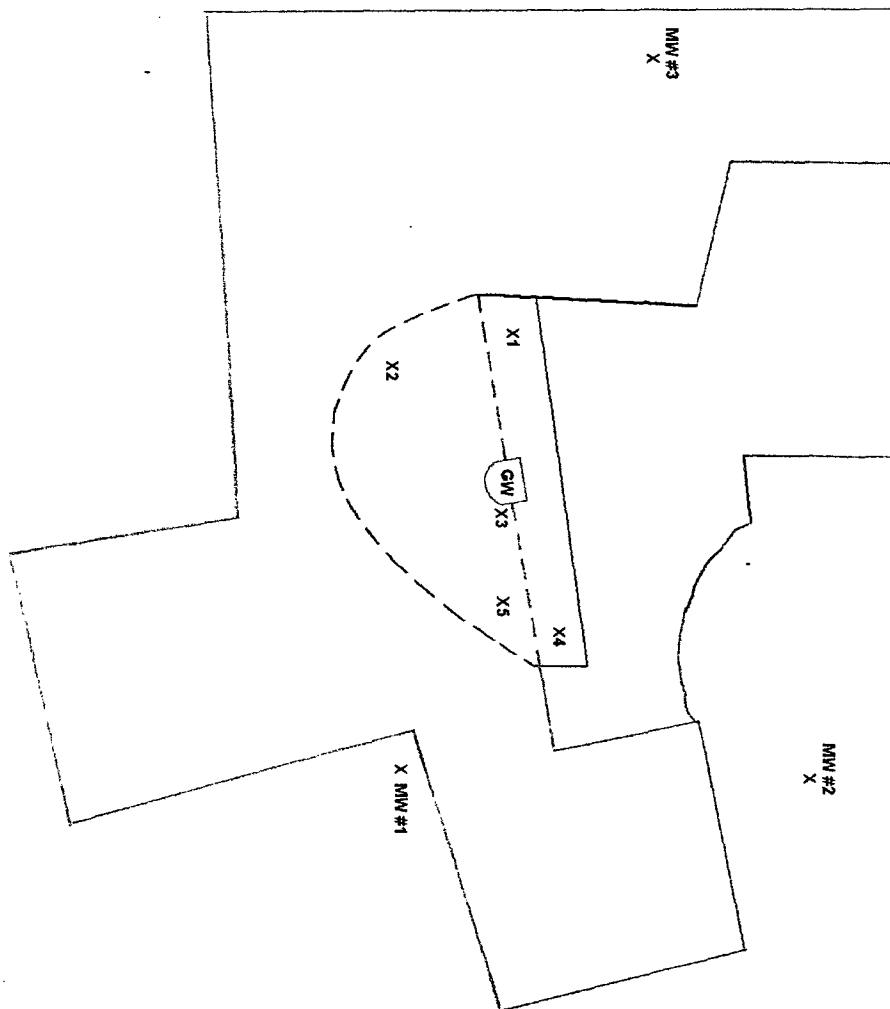
11/6/03  
 Lab # H8148  
 Groundwater backfill south end 5 pt comp

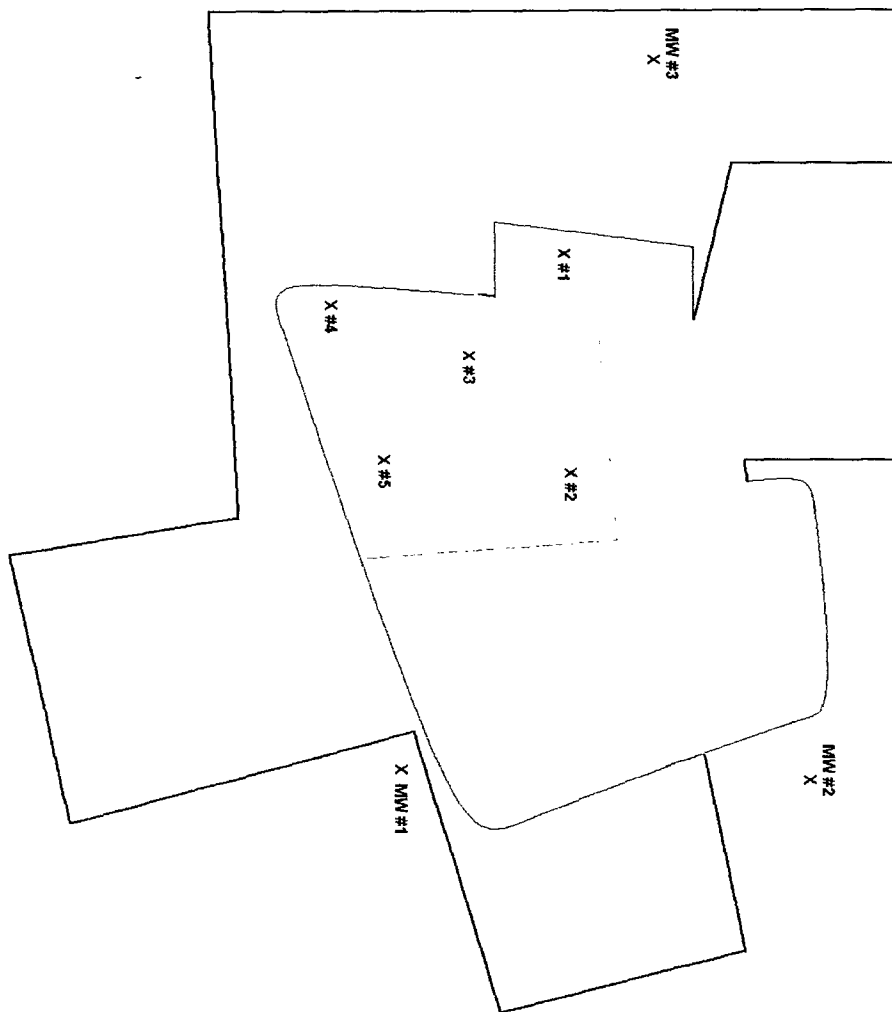
12/9/03  
 Lab #HH8236  
 2nd 5' lift 3rd clay liner 5 pt comp

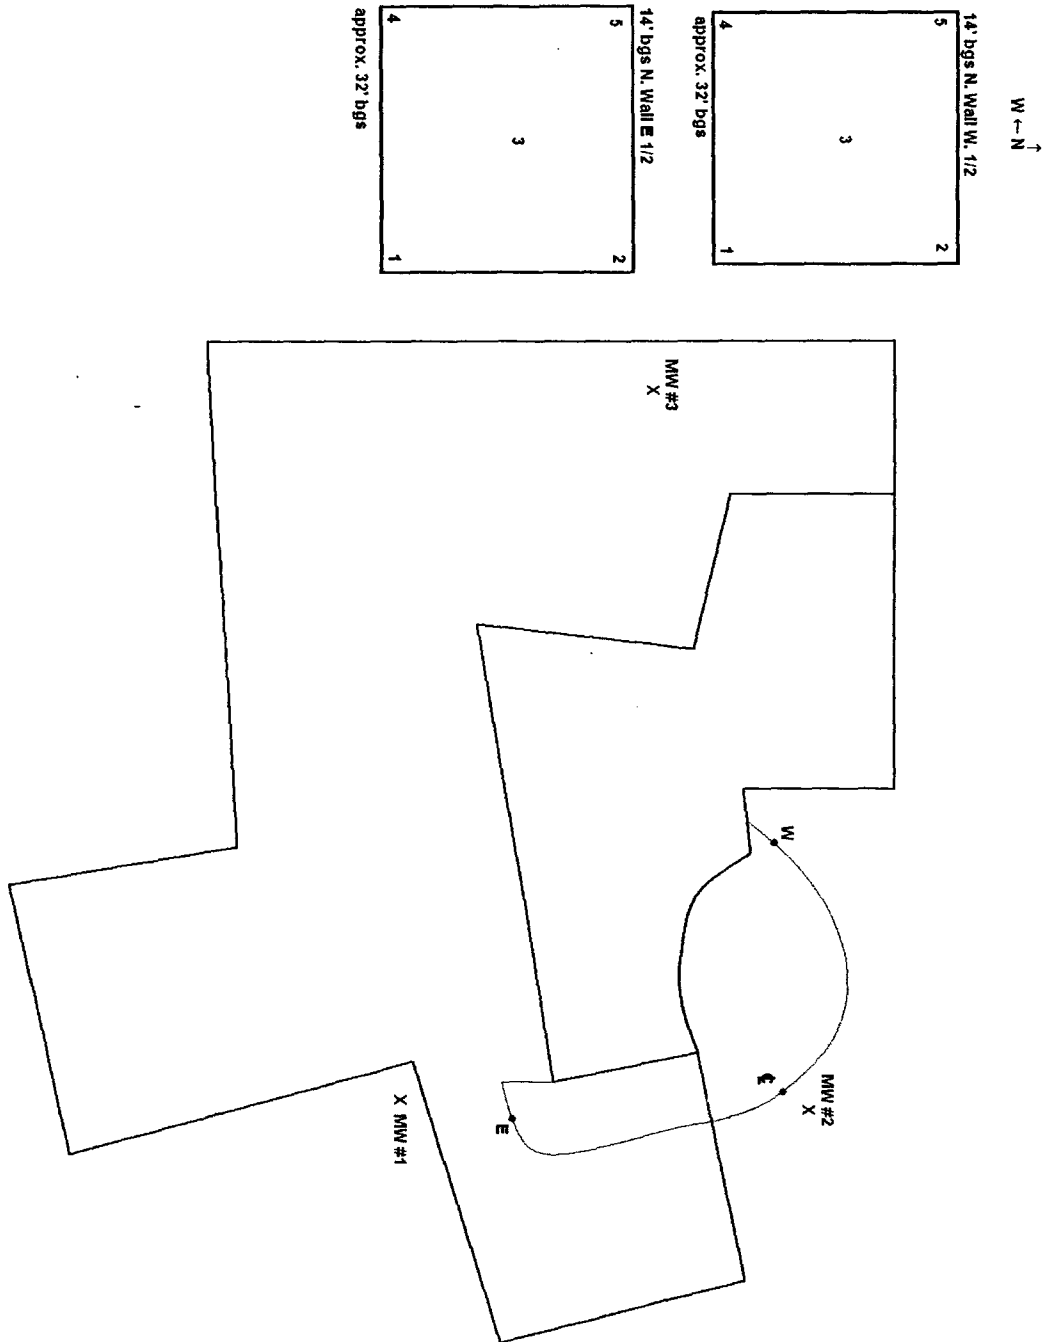
11/20/03  
 Lab # 0308006-1 & 0308006-2  
 N Wall E. 1/2 comp  
 N Wall W. 1/2 comp
