## **JUNCTION I-9**

### **Stage 2 Abatement Report**

Rice Operating Company  
Hobbs, New Mexico

Prepared by:  
ARCADIS G&M, Inc.  
1004 N. Big Spring Street  
Suite 300  
Midland,  
Texas 79701  
Tel 432.687.5400  
Fax 432.687.5401

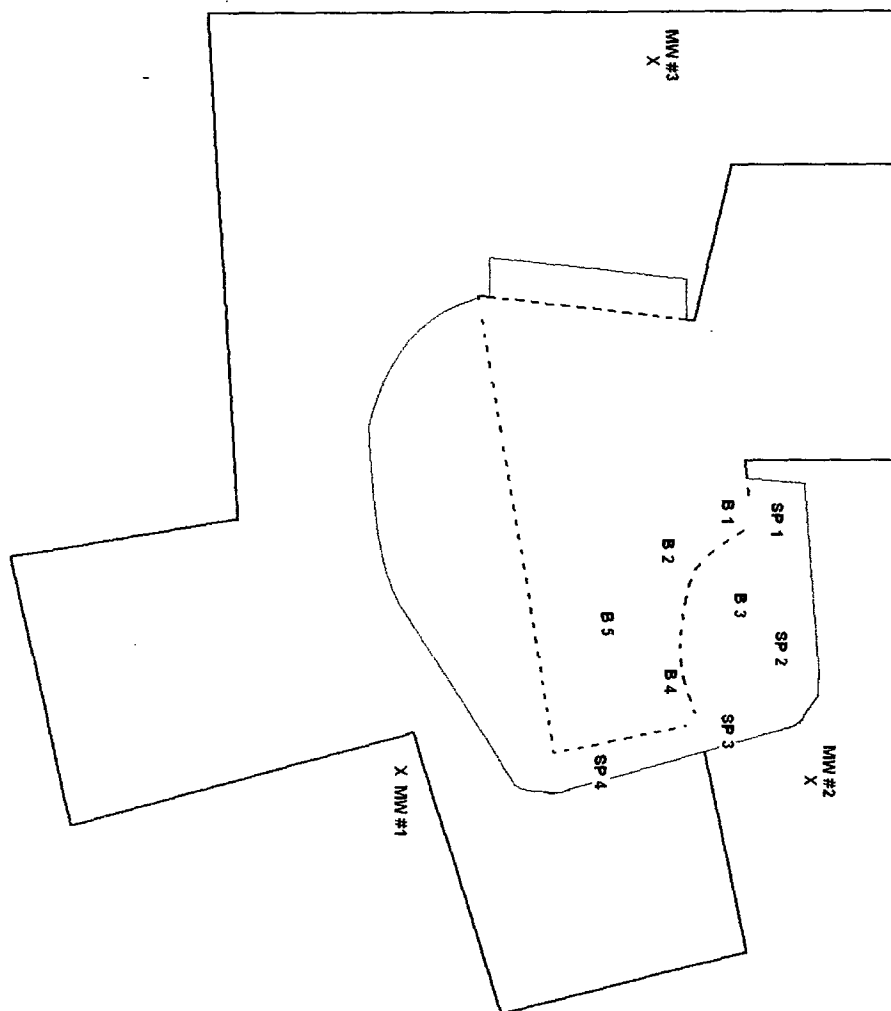
11/21/03  
 Lab #H8202 #1 - #2  
 Base sample points @ approx 32' and  
 4 pt comp @ GW 36'

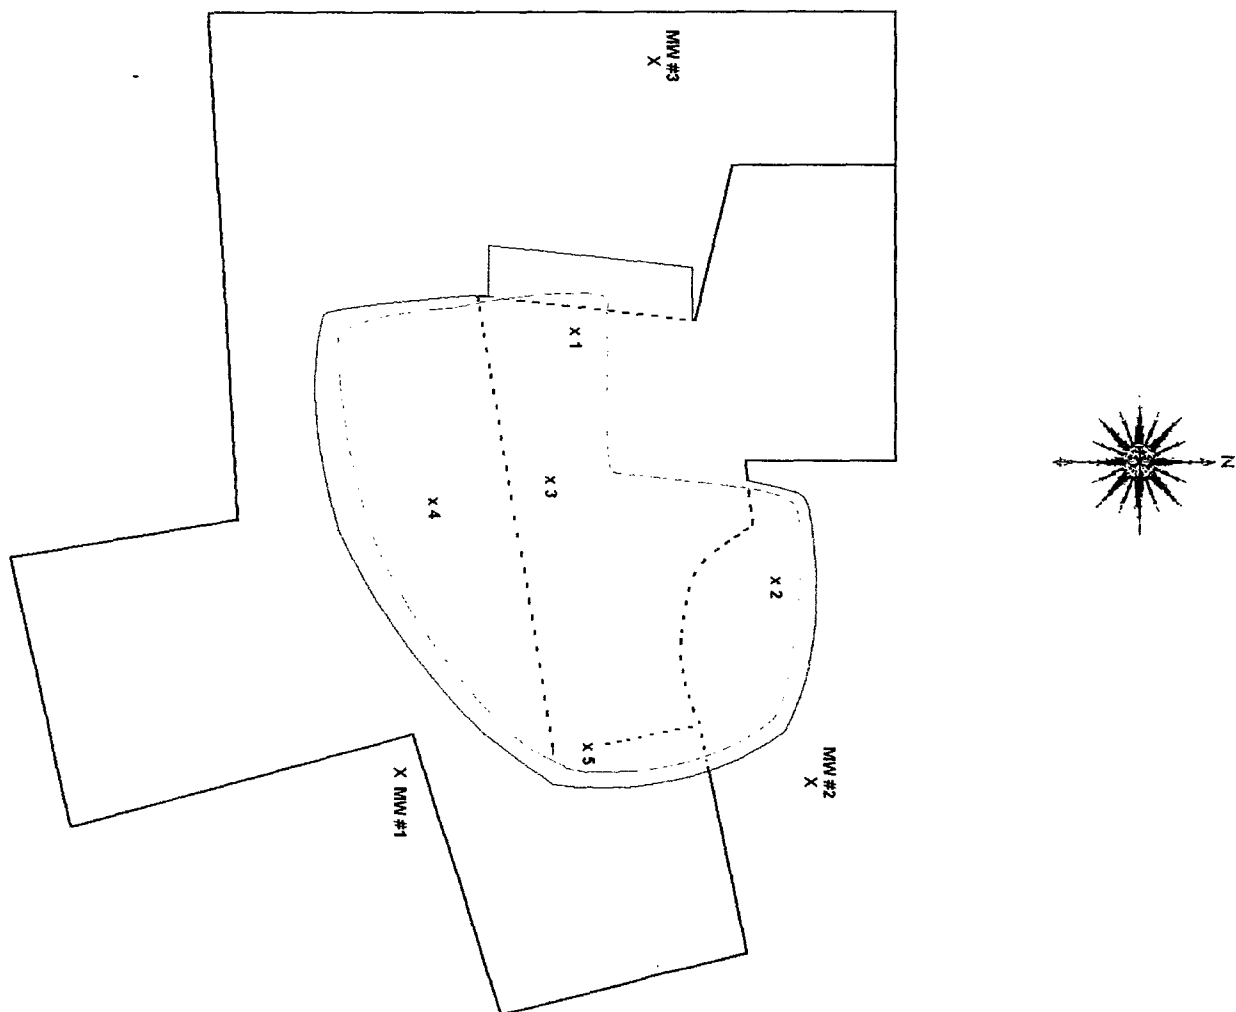
Lab #H8214

1st 5' backfill lift after 3rd clay  
liner sample points 1 - 5

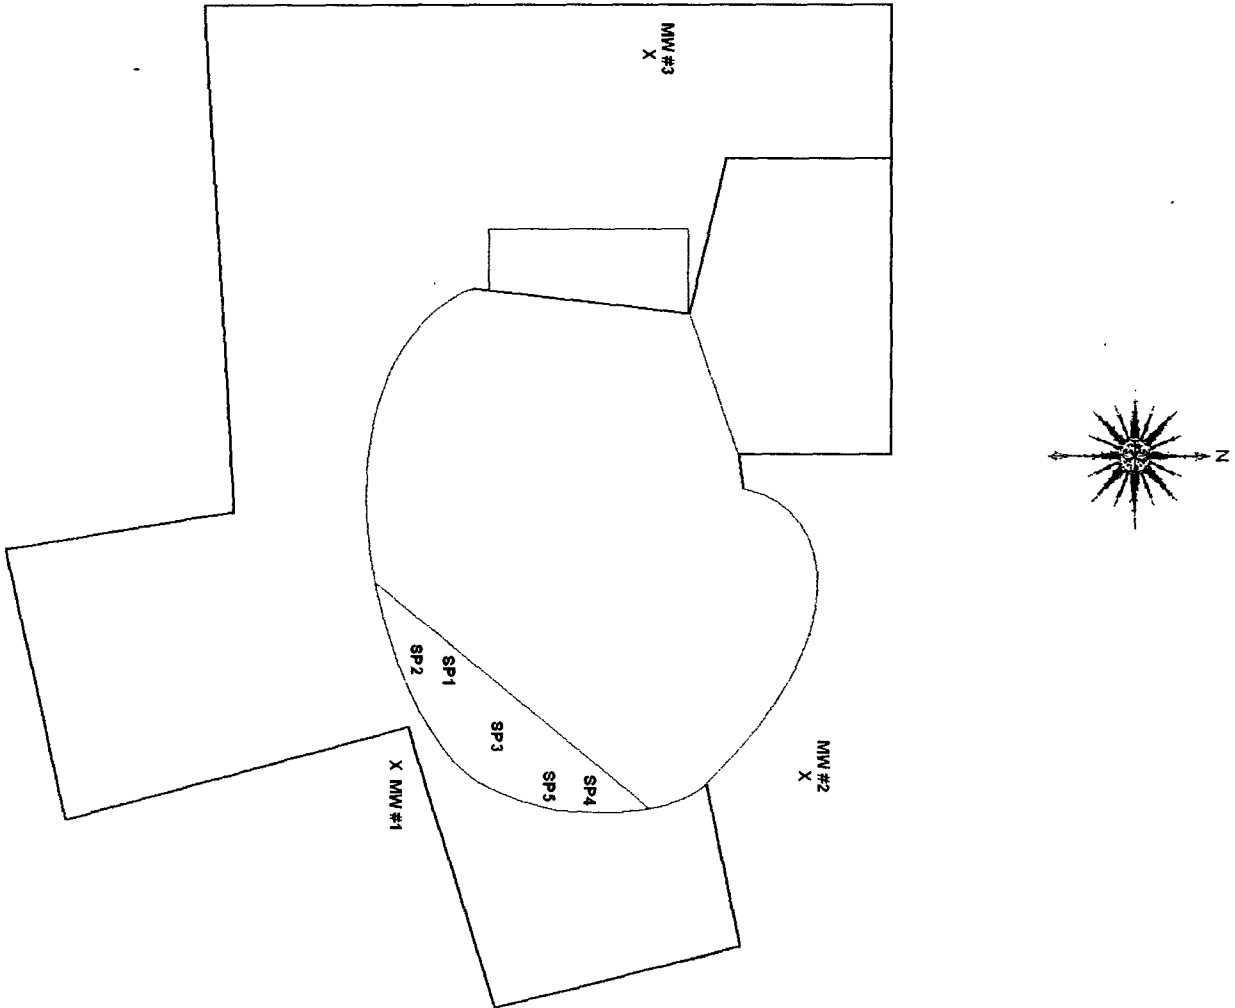
Lab #H8246 #1

1st Backfill 5' lift south side after btm clay liner

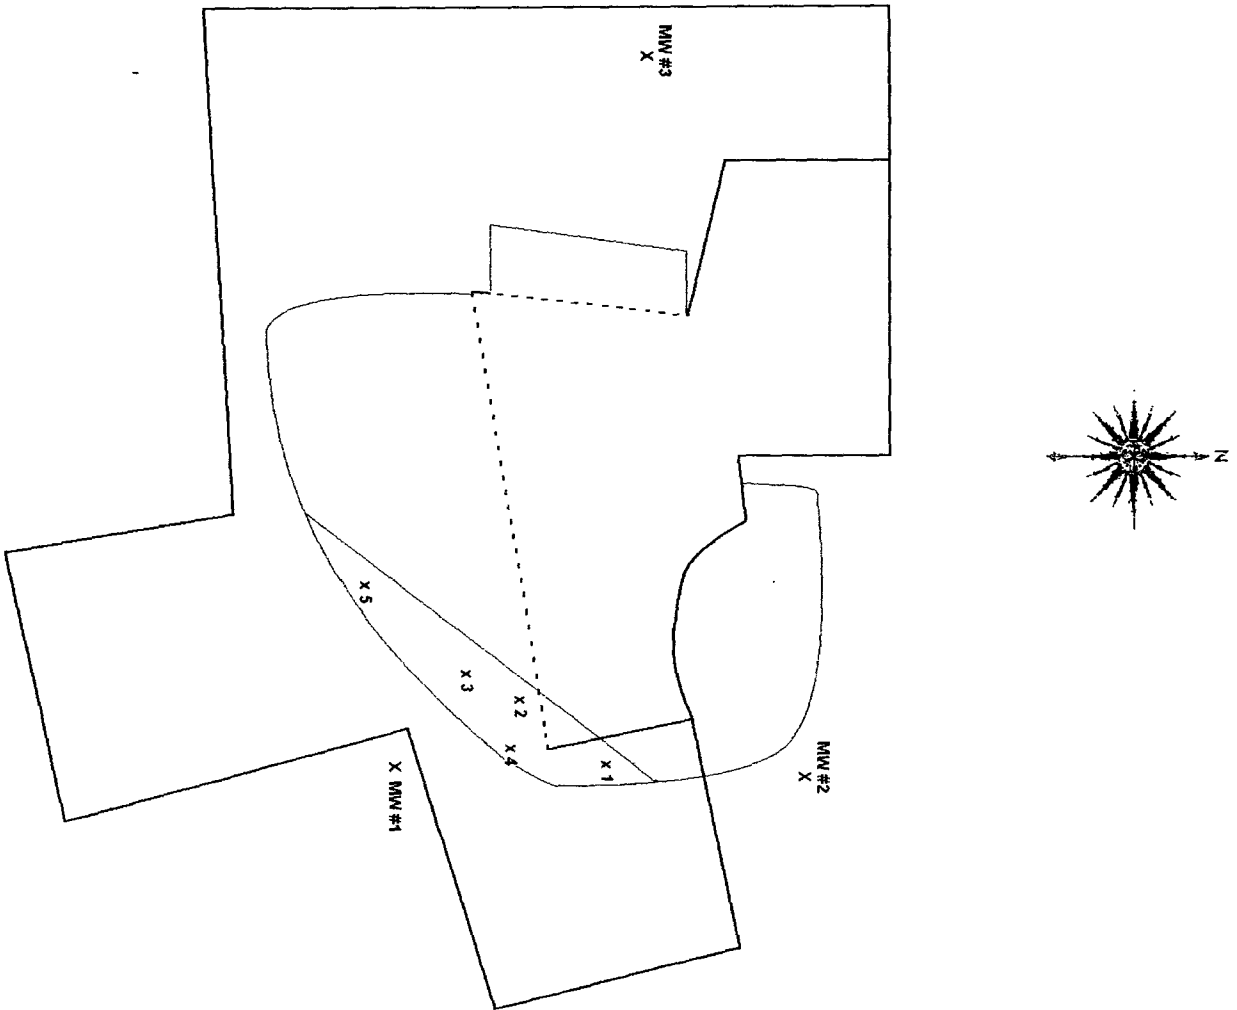
12/17/03  
 Lab # H8265  
 S. end 2nd 5' lift by MW #1

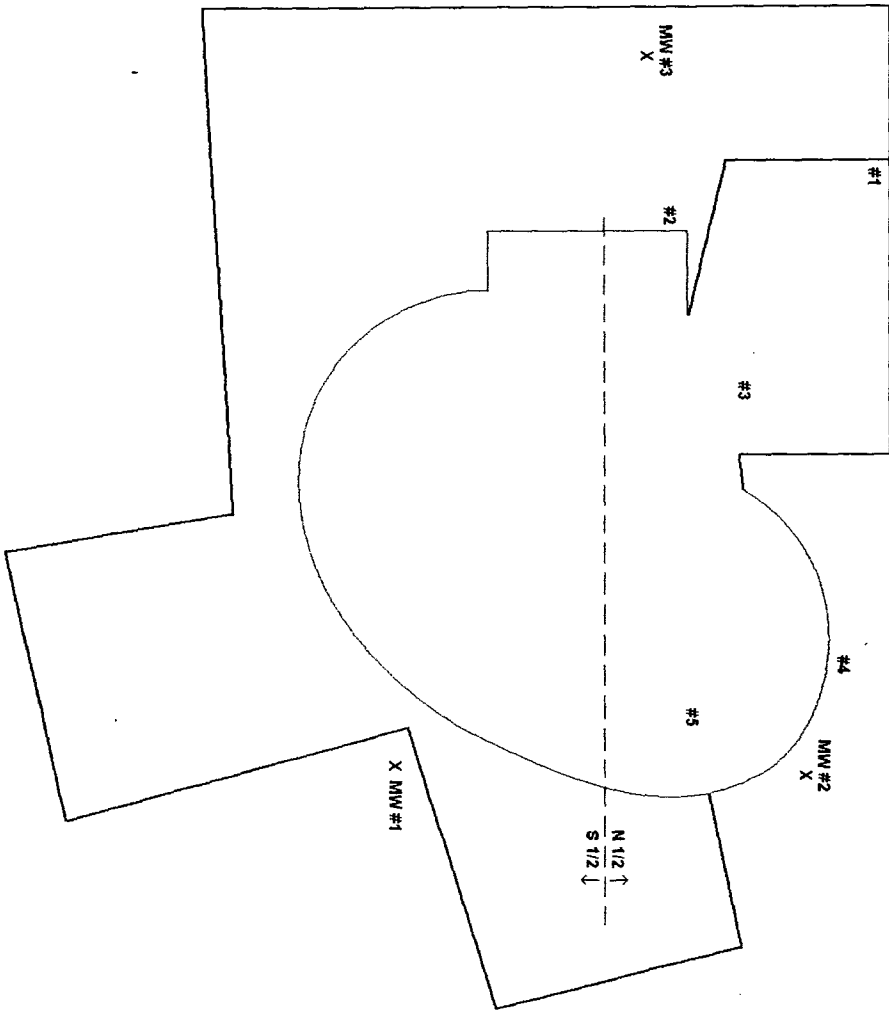
1/26/03  
 Lab #H8407  
 1st 5' lift after clay liner @ 8' bgs N 1/2

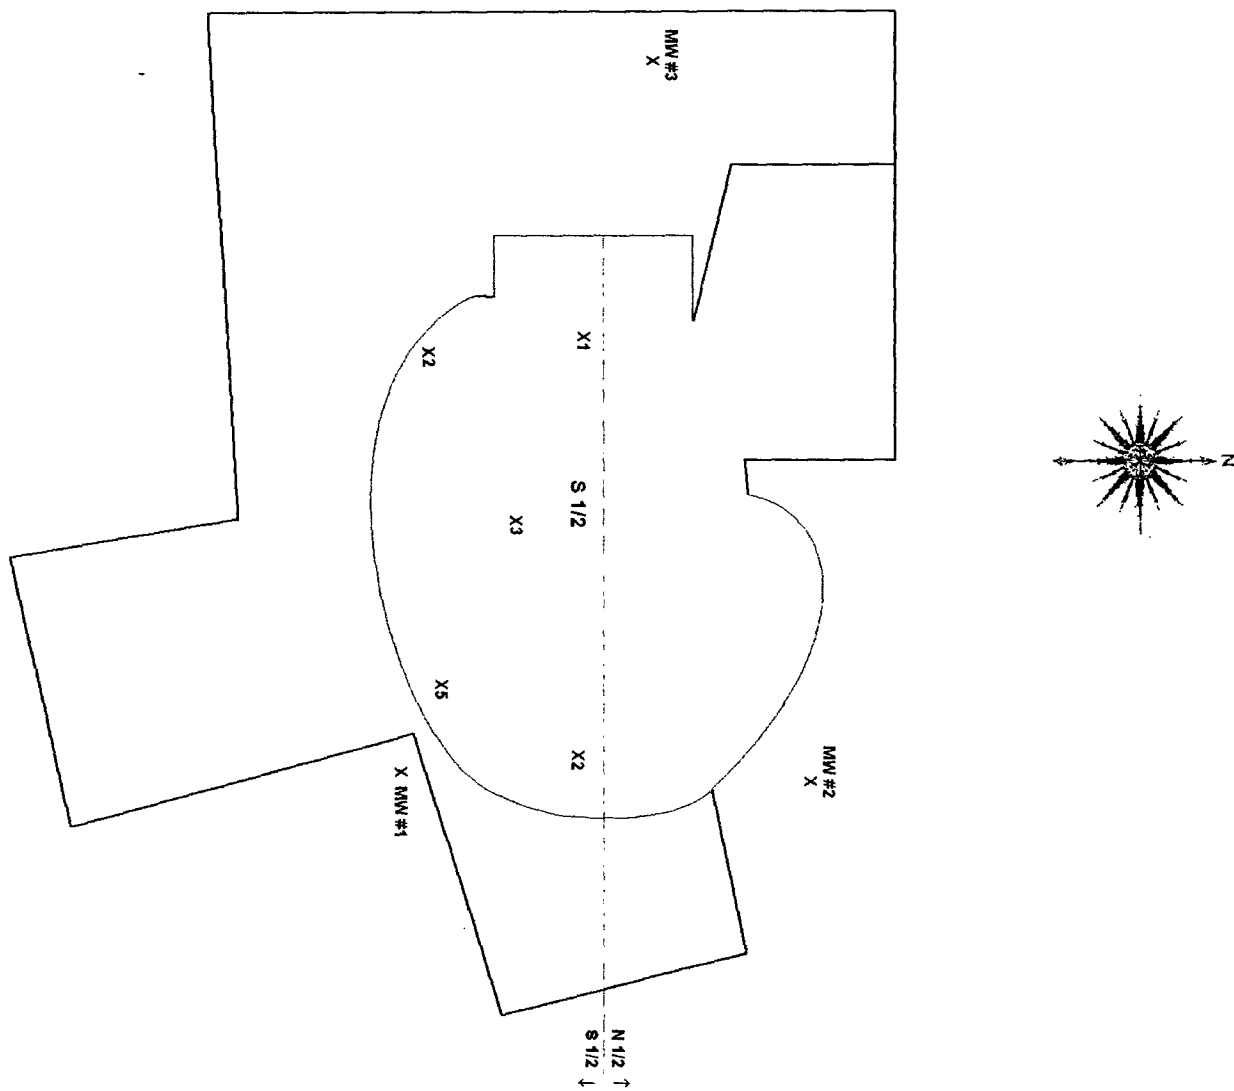
1/29/04  
 Lab #H8420  
 1st 5' lift after caly liner @ 8' bgs S. 1/2

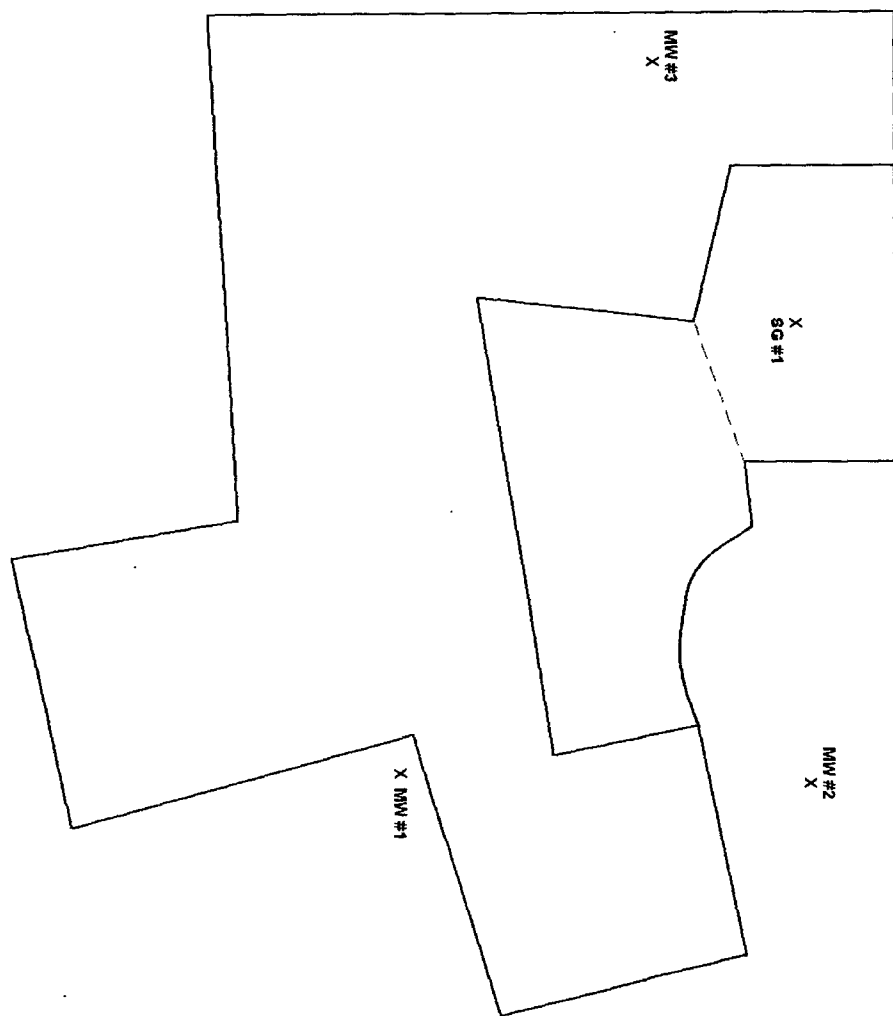
10/2/03 Pettigrew & Associates, P.A.  
 Lab #03 6177  
 1st clay liner density test @ 30'

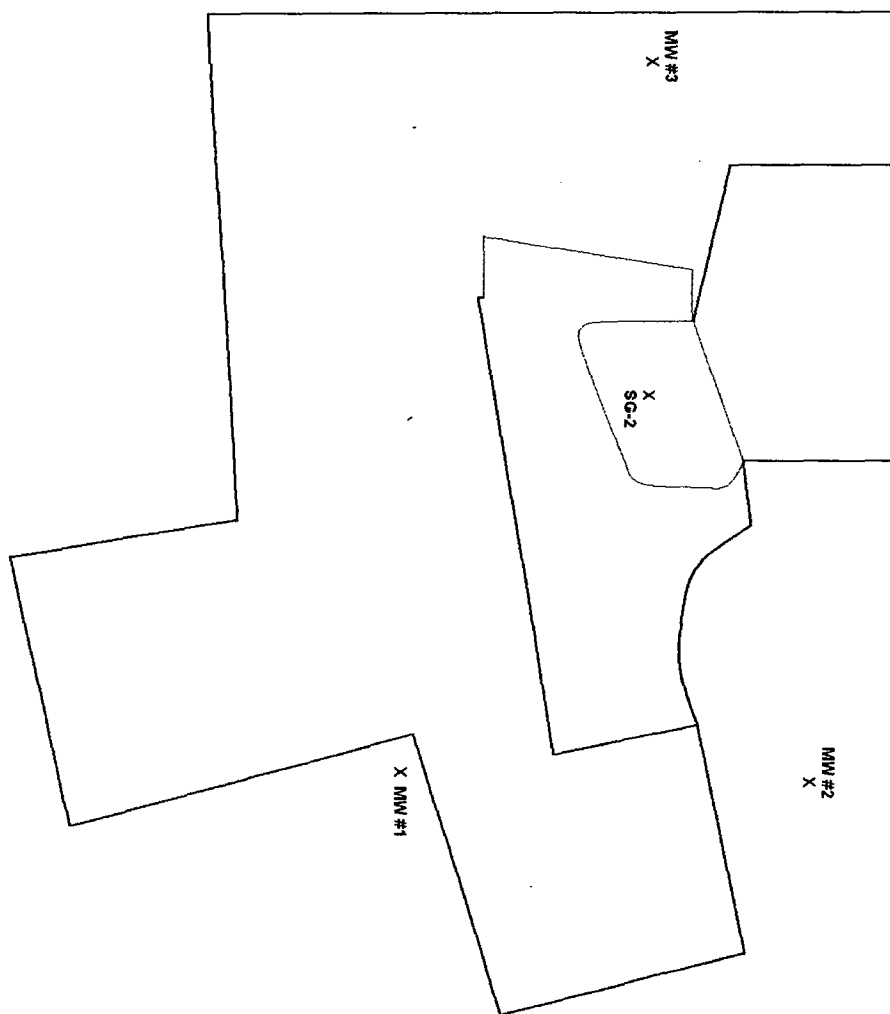
10/28/03 Pettigrew & Associates, P.A.  
 Lab #03 6568  
 2nd clay liner density test @ 30'

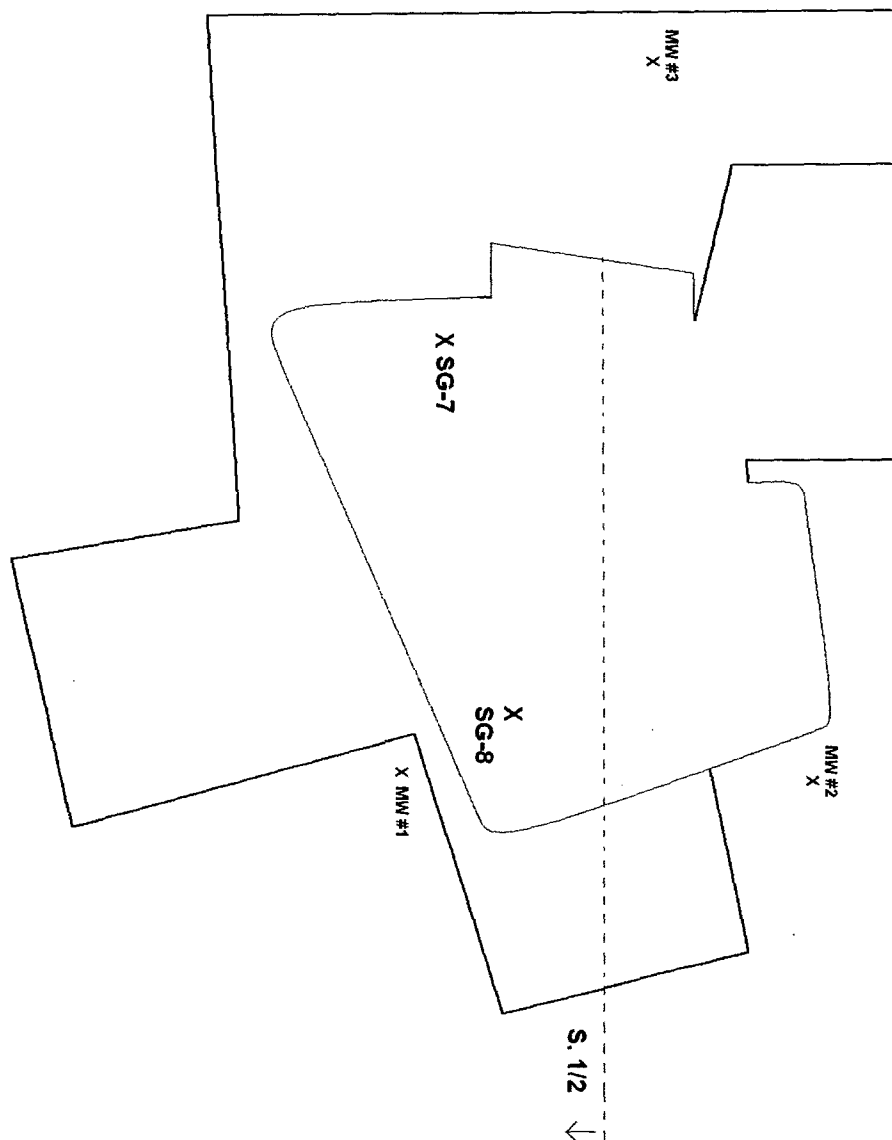
1/3/04 Pettigrew & Associates, P.A.  
 Lab #04 1275-1276  
 Top clay liner @ approx 6' to 7' bgs
