# ANNUAL MONITORING REPORT

## **JUNCTION I-9**

### **2006 Annual Report and Closure Report**

Rice Operating Company  
Hobbs, New Mexico

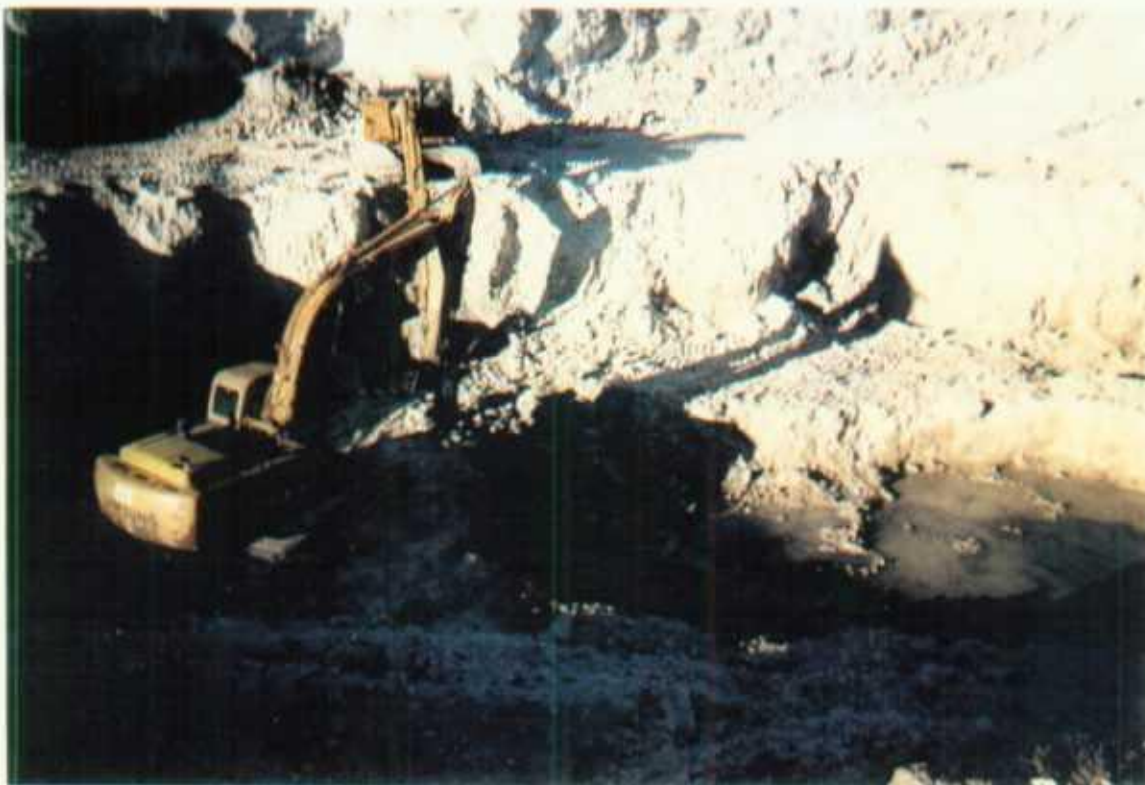
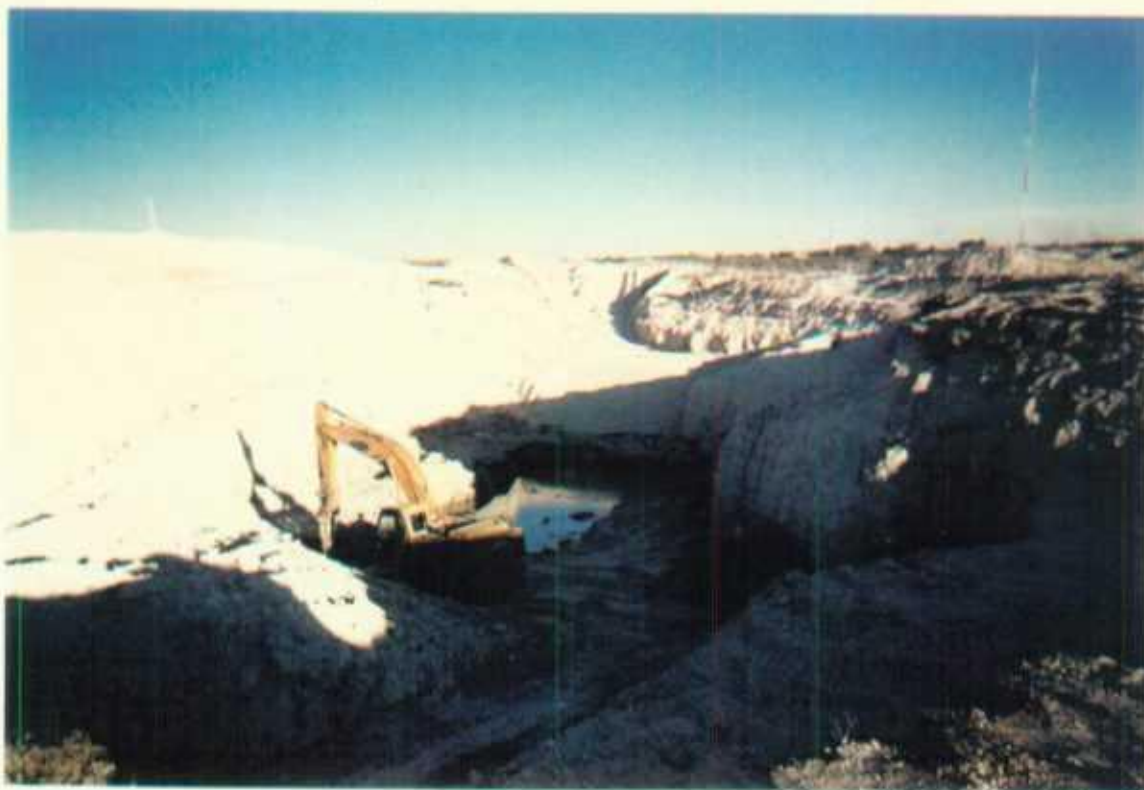
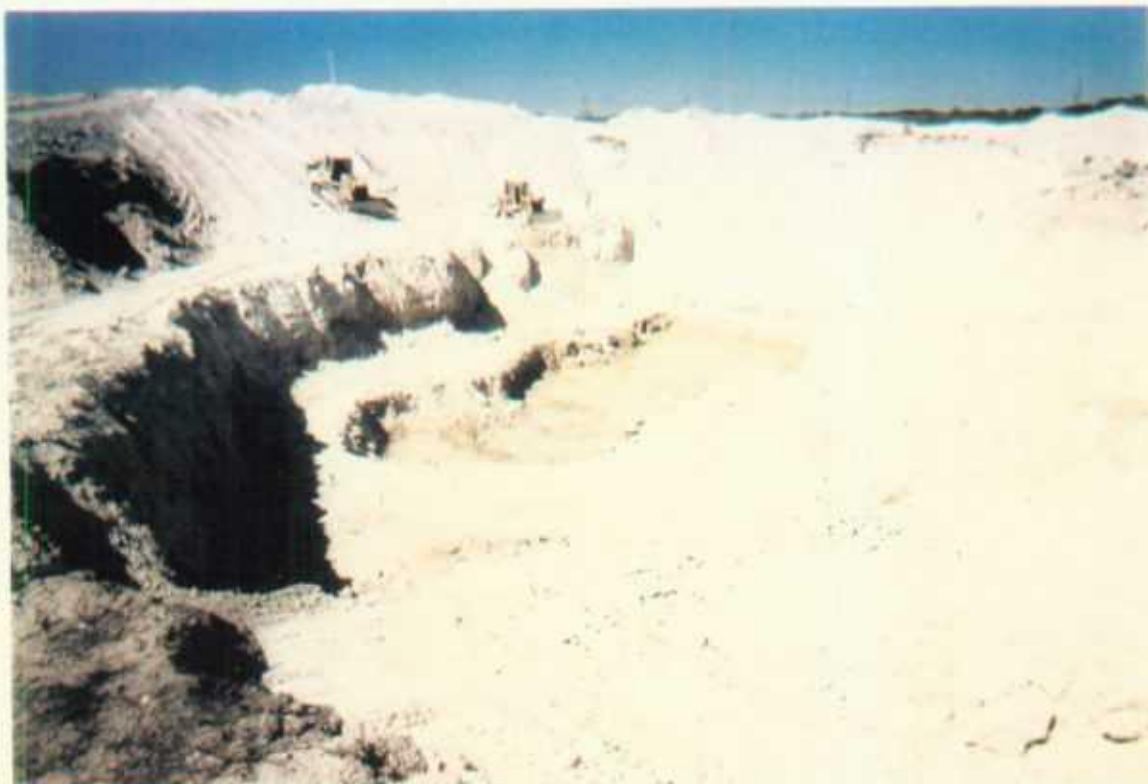
Excavation to groundwater in area where PSH was detected.

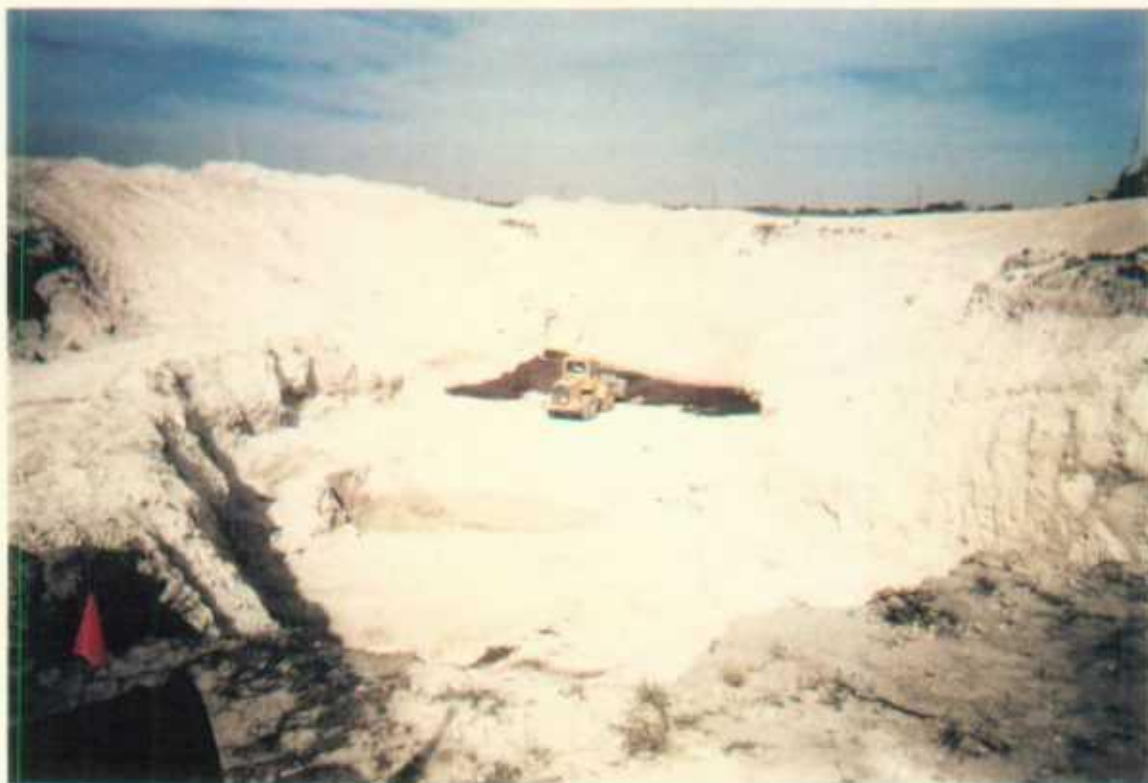
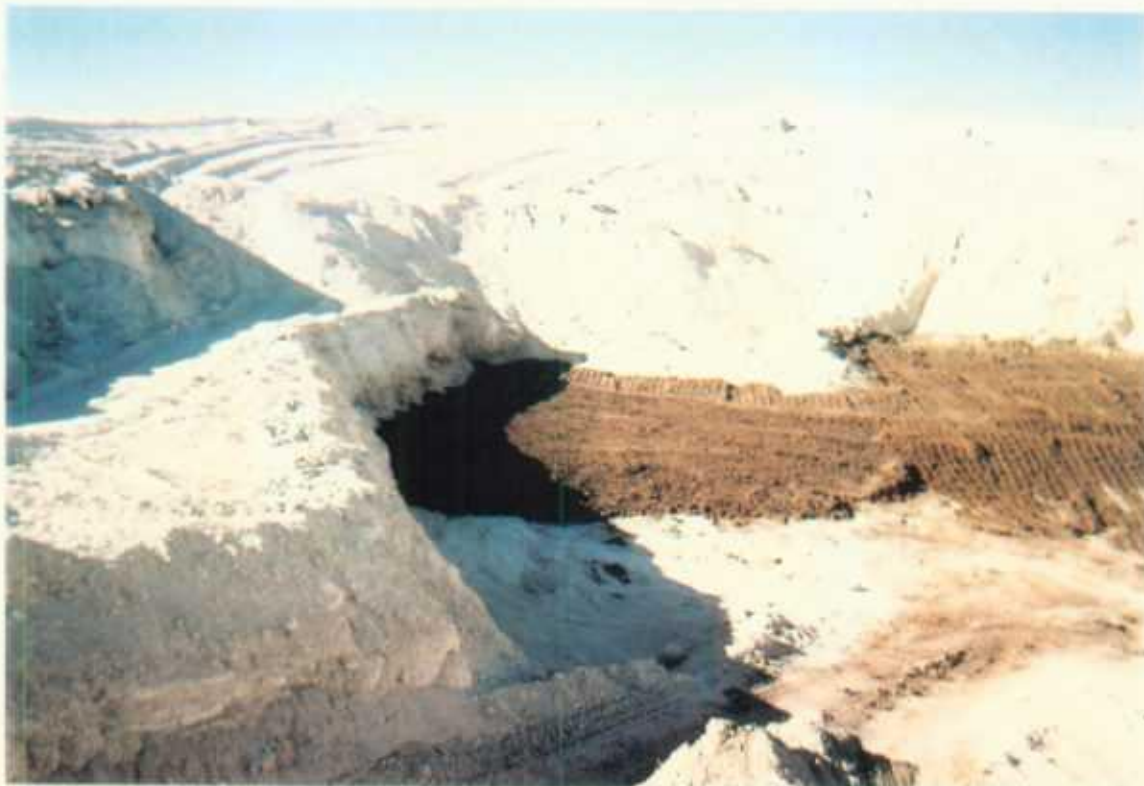
Installation of lower liner.

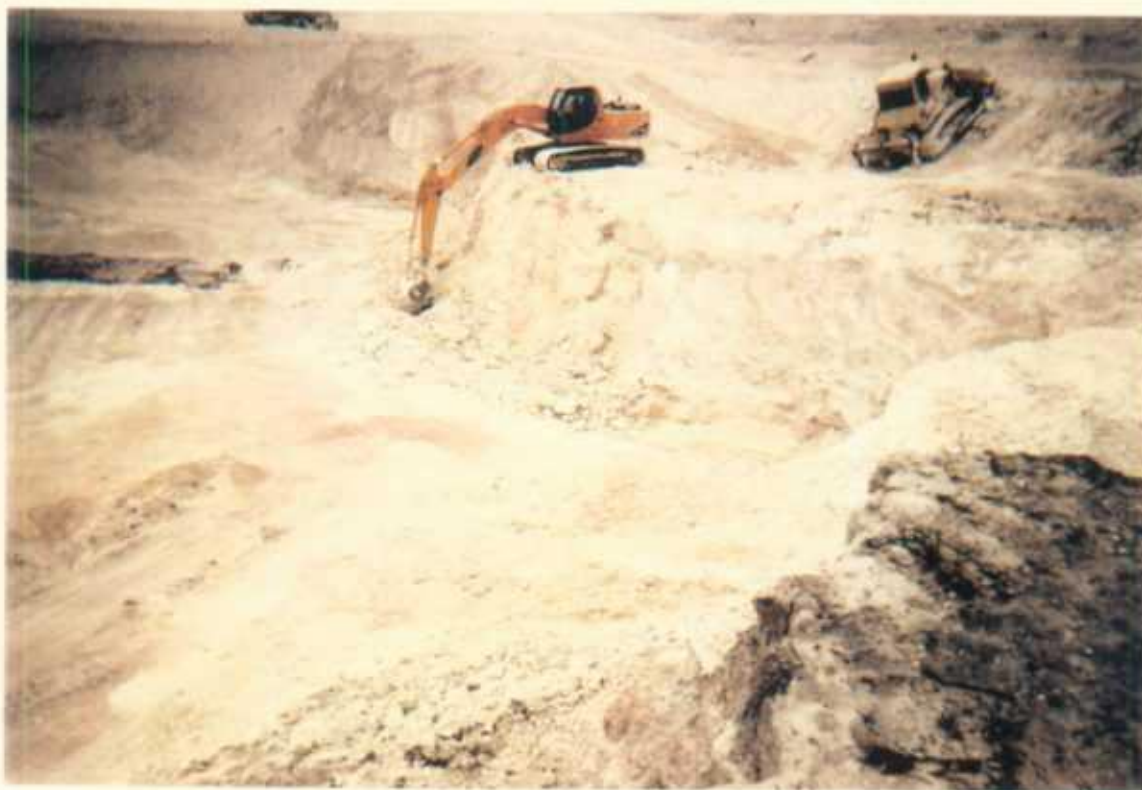
Excavation of sidewalls.

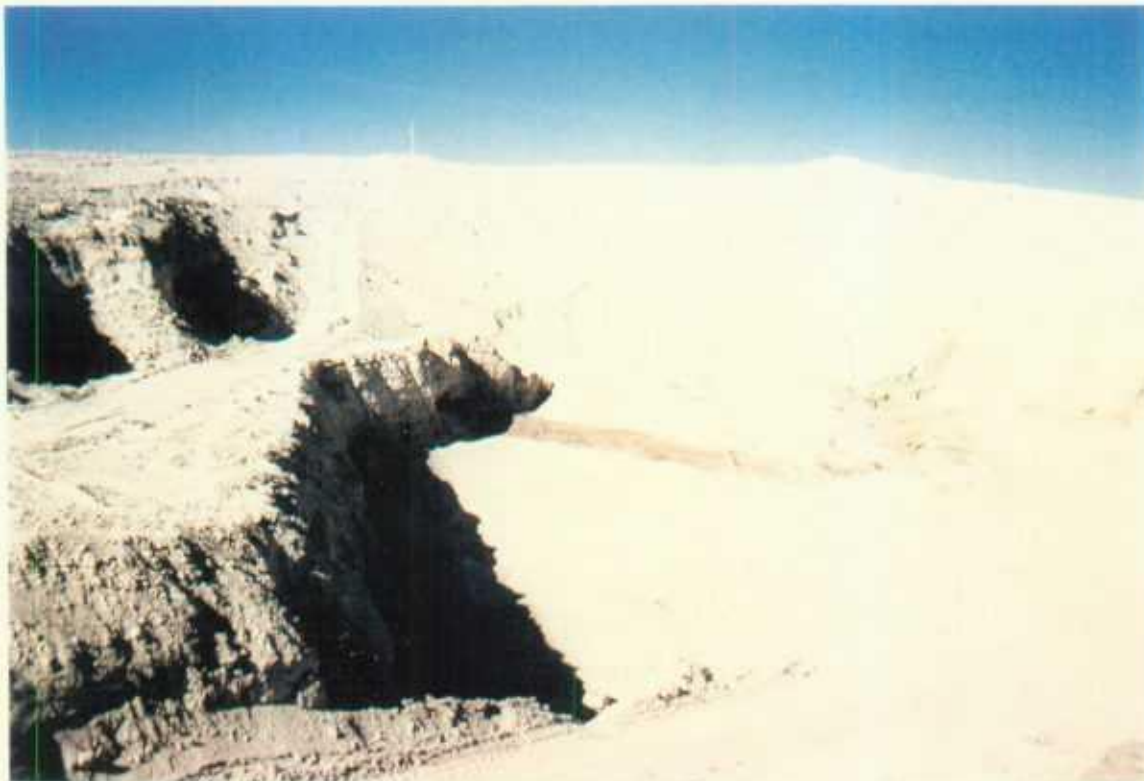
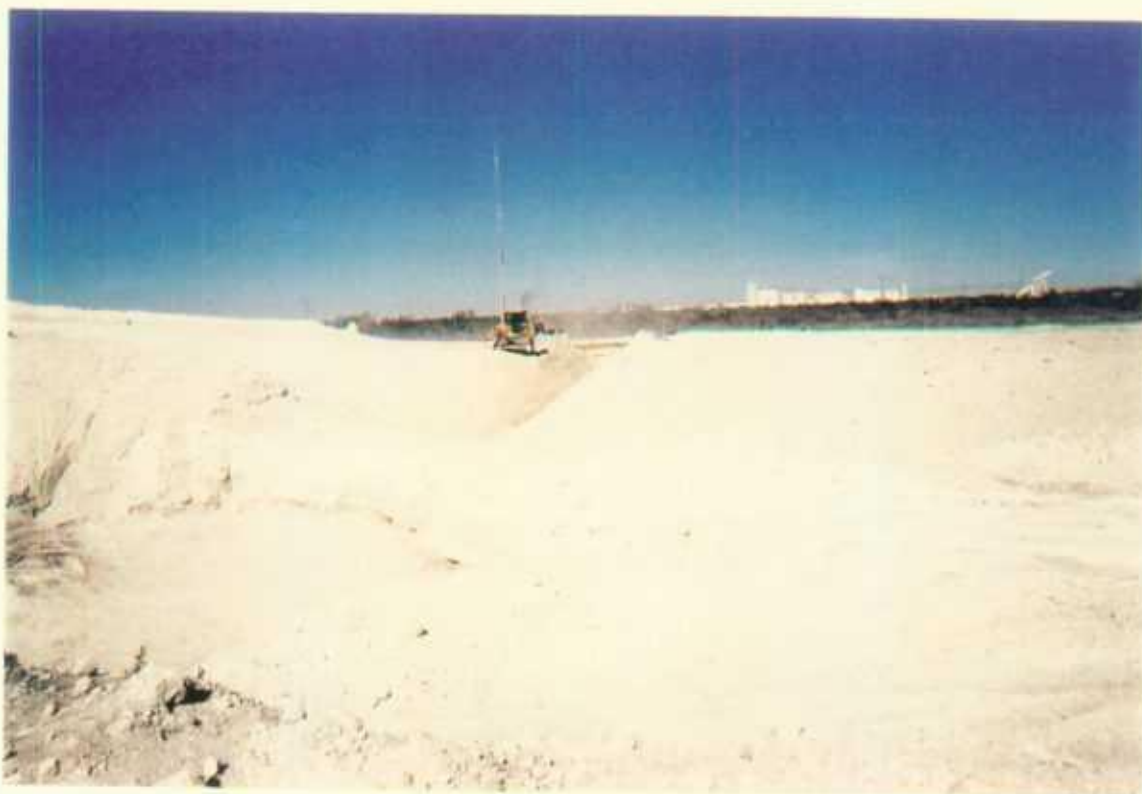
Backfilling over lower liner.

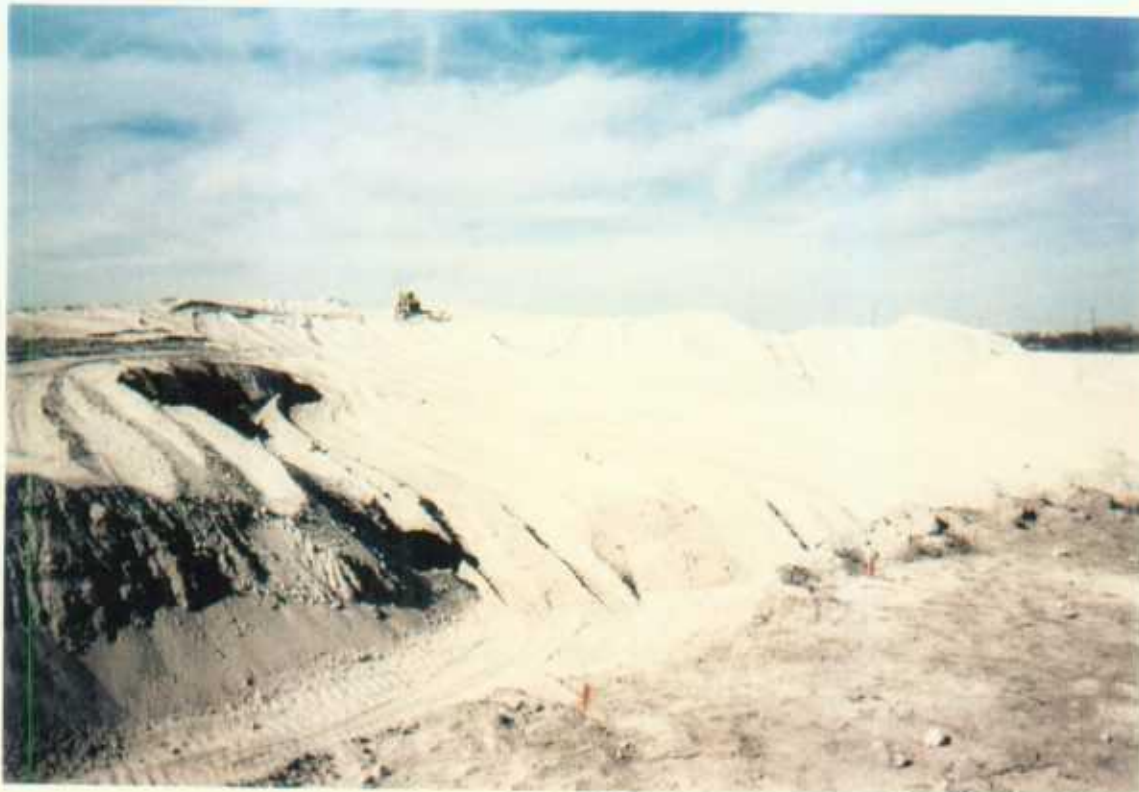
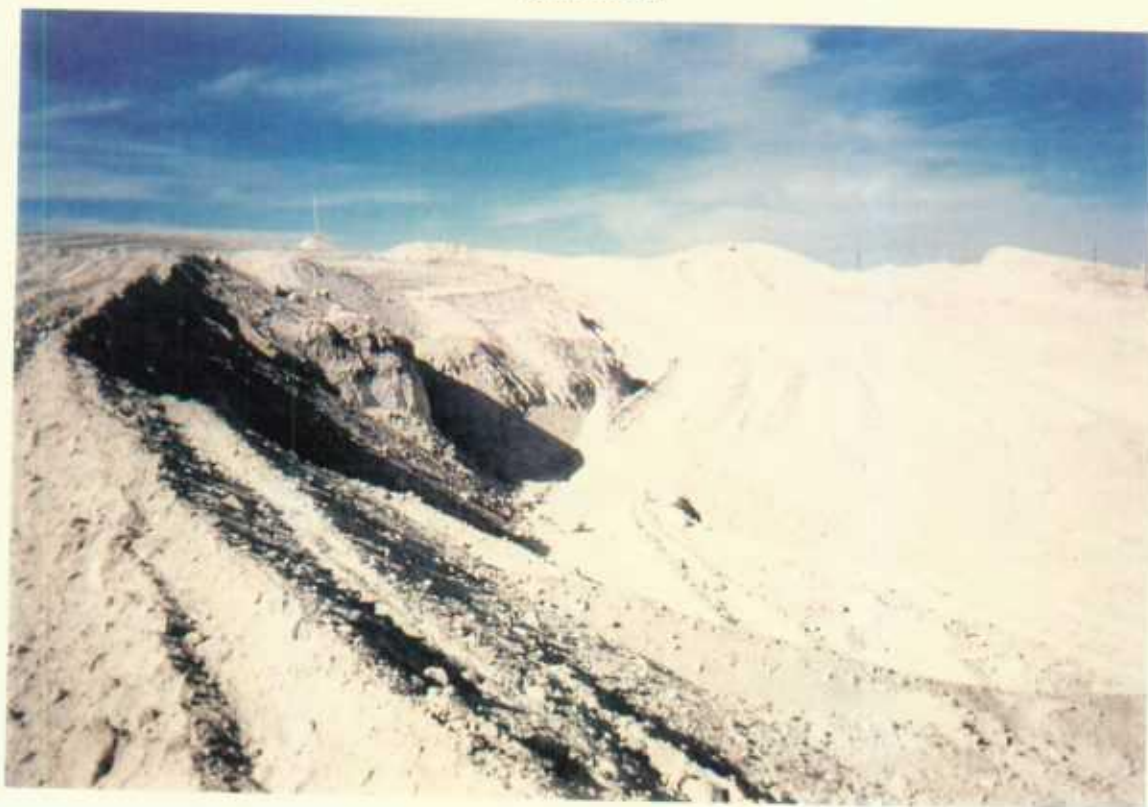
Backfilling.

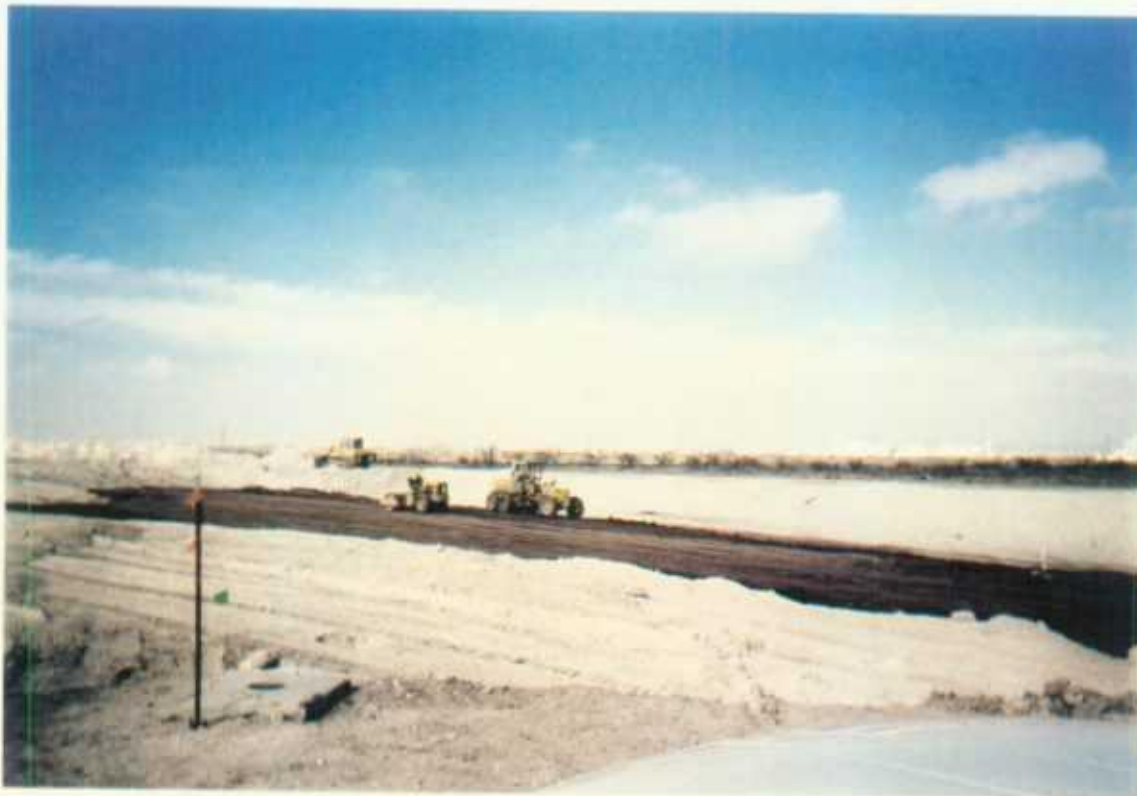
Installation of upper liner.

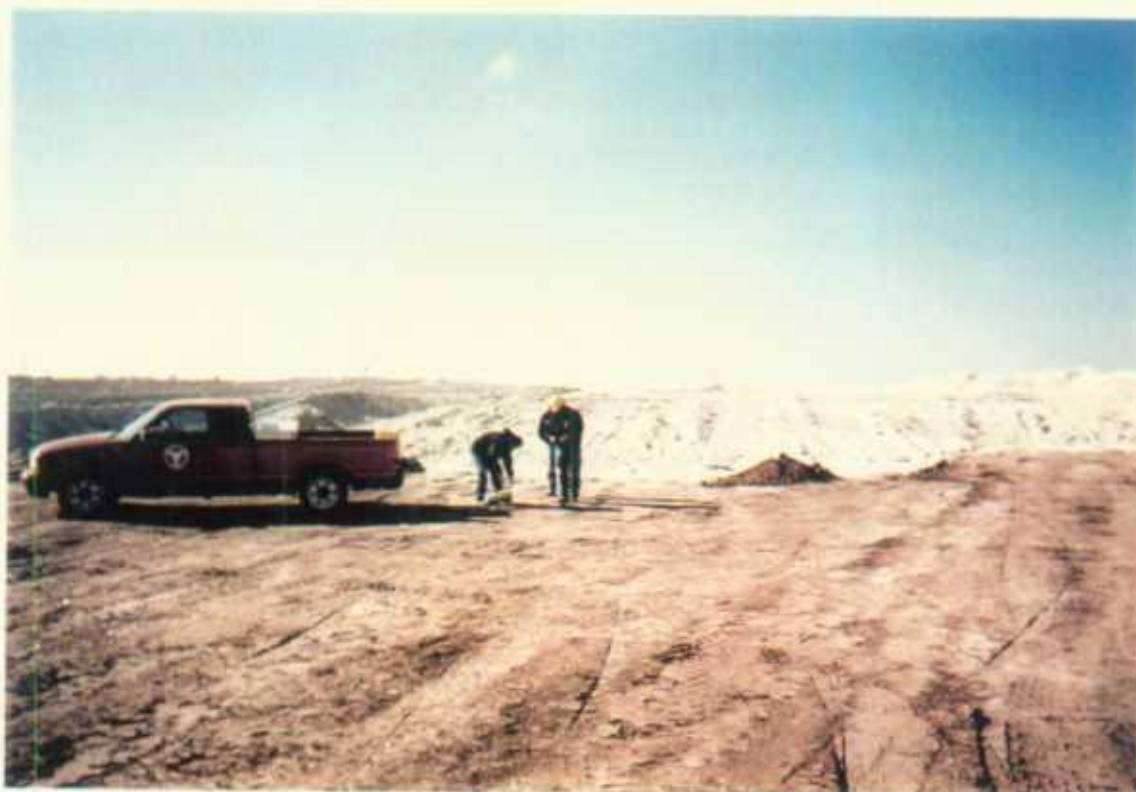
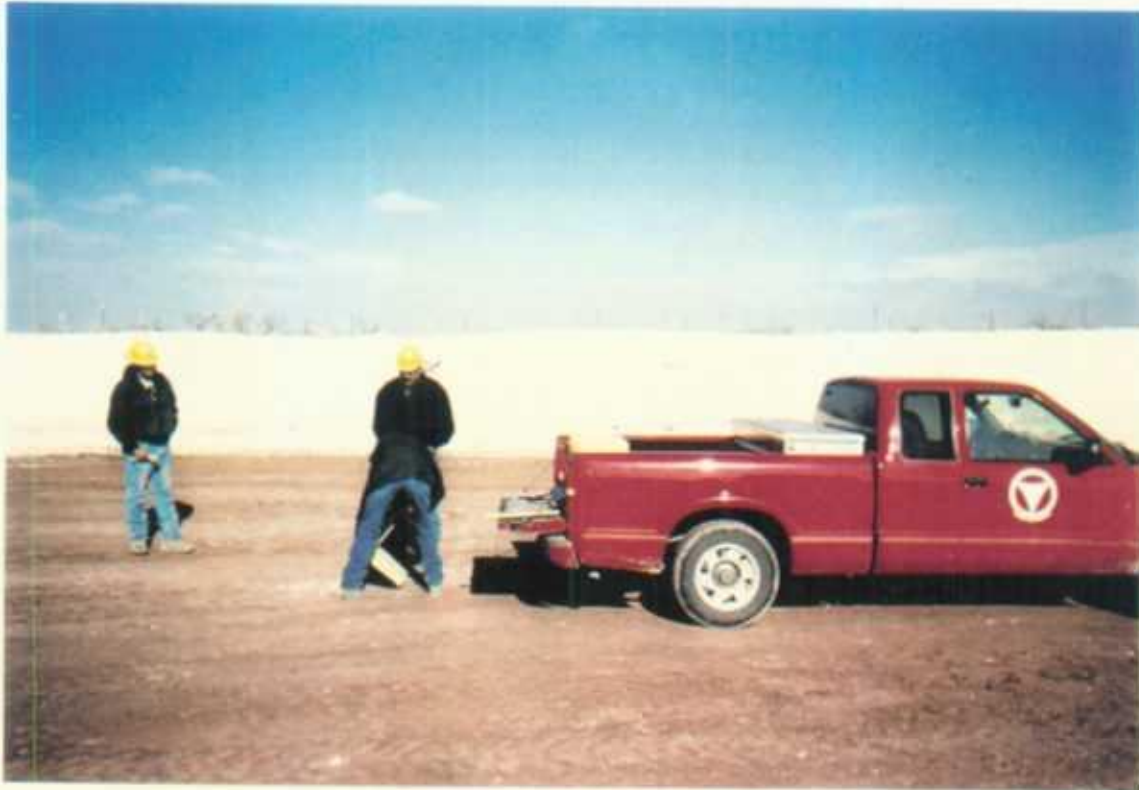
Proctor testing of upper liner.

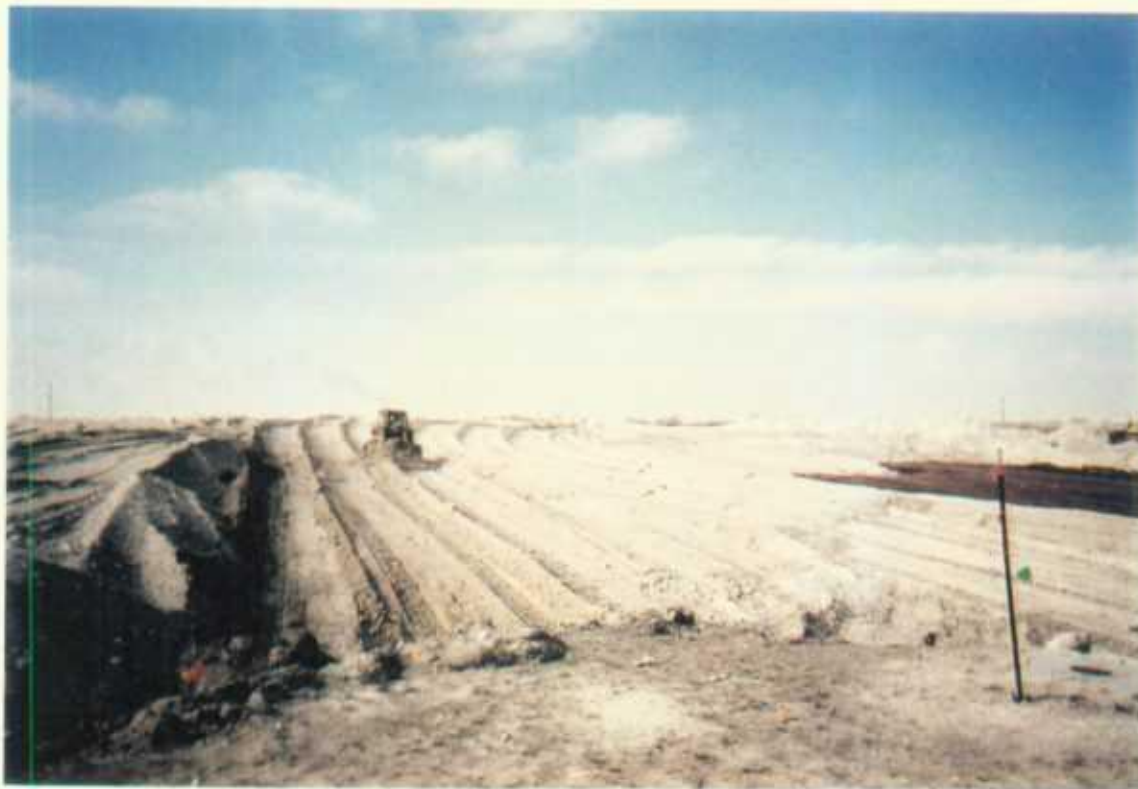
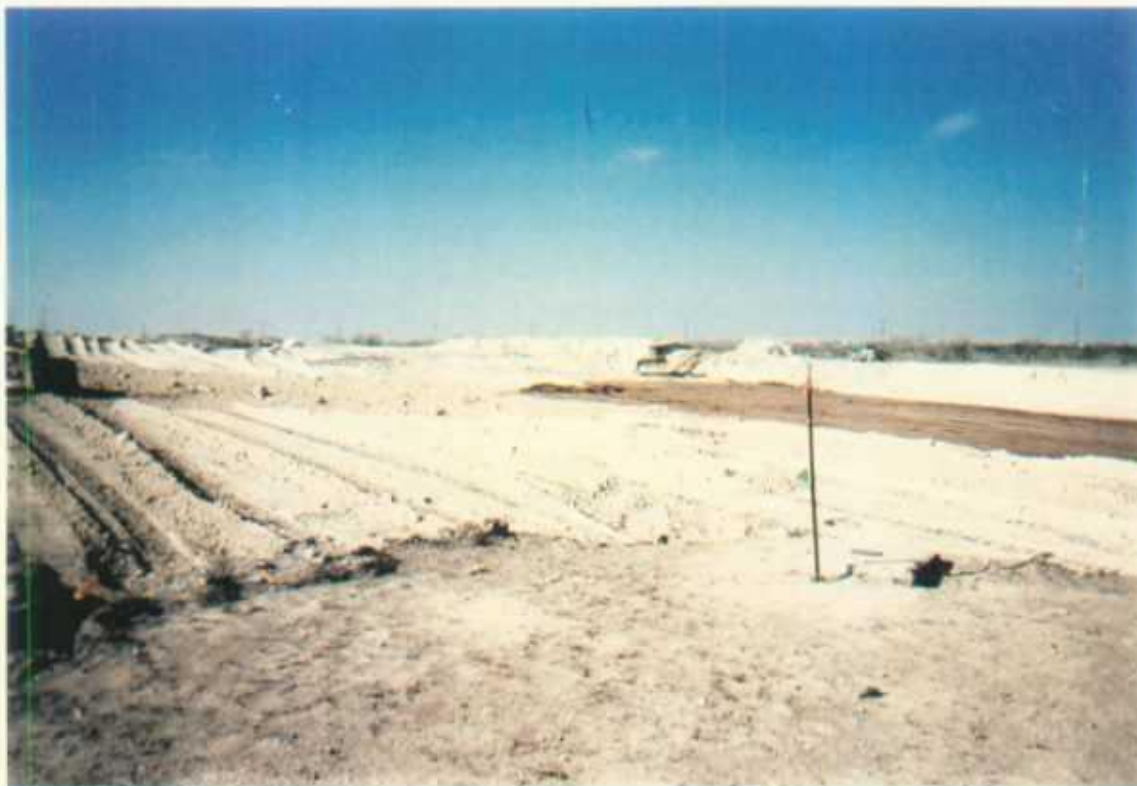
Backfilling over upper liner.

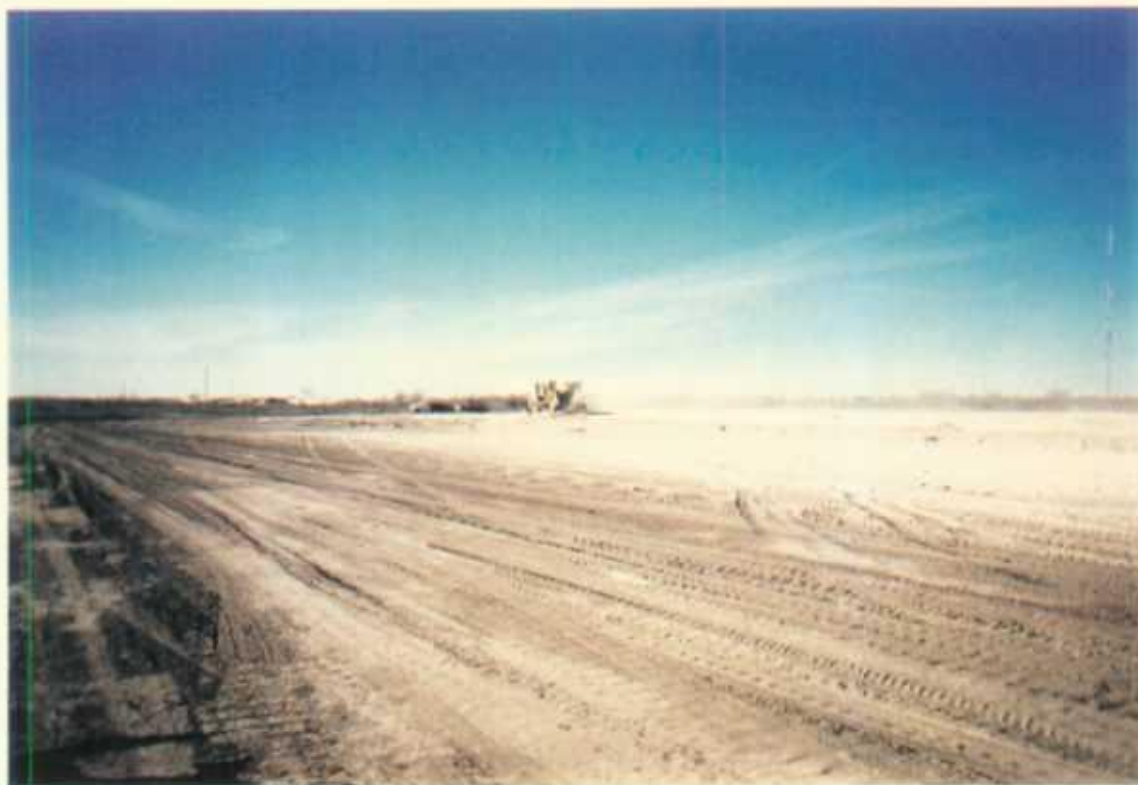
Site grading.
