Navajo Refining Company Hobbs North GSA 6" Gathering Line

Remediation/Cleanup Work Plan Hobbs, Lea County, New Mexico

July 3, 2001

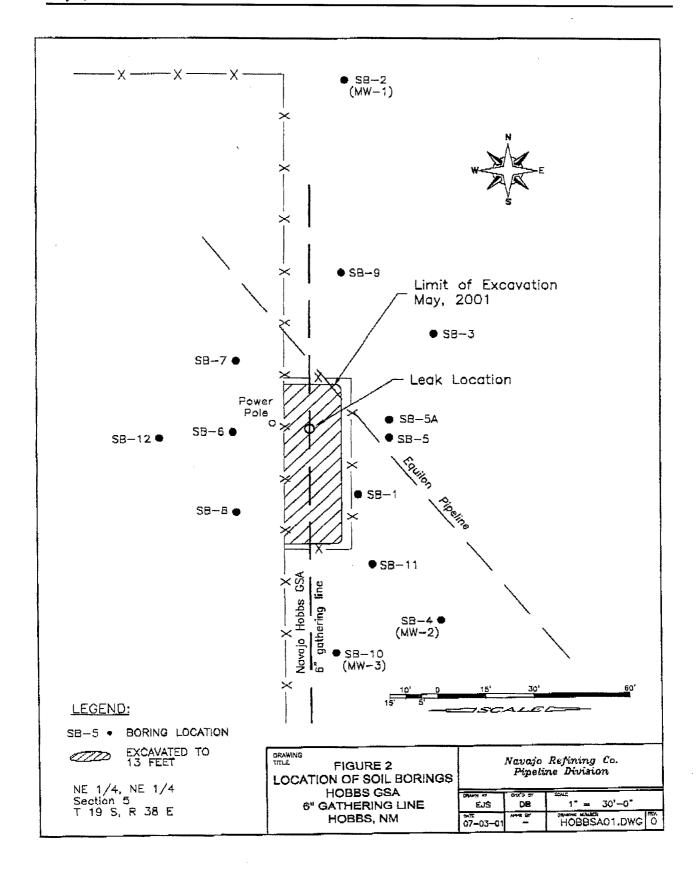
The initial vertical and horizontal extent of the contamination was determined by the excavation as described above and by follow-up drilling performed in February. Additional exploratory boreholes were drilled in May 2001. The soil boring locations are shown in Figure 2. Some boreholes are shallow due to drilling auger refusal in the heavily cemented caliche. Also, two boreholes (SB-5, SB-6) showed evidence of free product saturation at 20-25 ft.

Analyses of the soil samples collected from the sides and bottom of the excavation, and from boreholes are summarized in Table 1. The results of the soil boring program show detectable contamination in an area having a radius of approximately 25 to 30 ft. from the leak location and to a depth of 30-35 ft. in at least two boreholes. Further delineation will be determined by excavation at the time of cleanup as described in the Action Plan below.

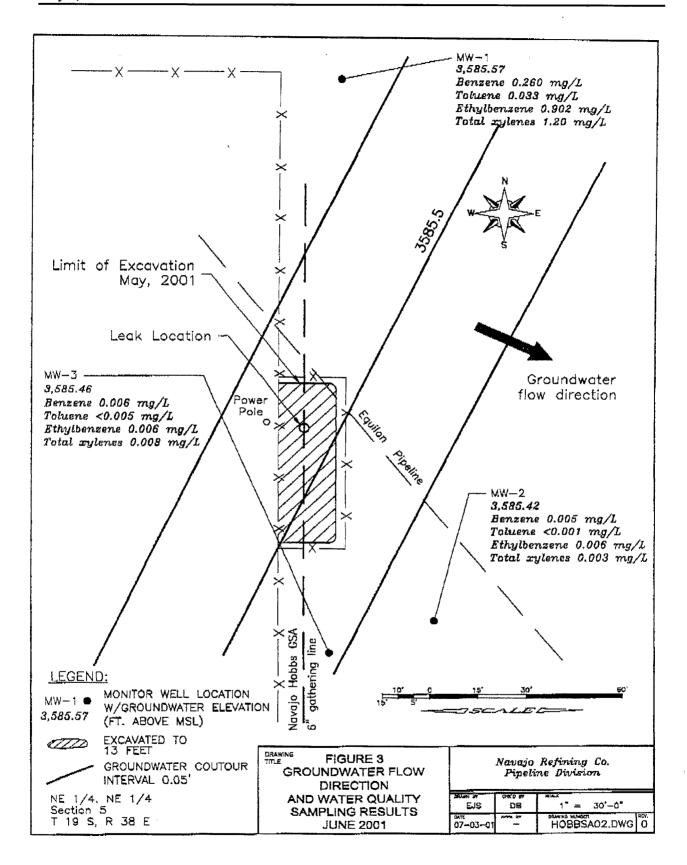
Two groundwater monitor wells were installed at the site in February 2001. A third well was installed in May. The well locations were surveyed, depth-to-water measurements taken, and a groundwater potentiometric contour map drawn. Depth to water in the wells is approximately 35 ft. The map (Figure 3) shows groundwater flow direction to be southeasterly, which is the general direction of groundwater movement in the Hobbs area.

Following installation and development of the three wells, samples for benzene, toluene, ethylbenzene and xylenes (BTEX) were taken on June 1, 2001. These results are also shown on Figure 3. Well MW-1 shows benzene 0.26 mg/L which is in excess of the NM WQCC and NM OCD water quality standard of 0.010 mg/L. Ethylbenzene and total xylenes also exceed water quality standards. The analytical results of sampling of wells MW-2 and MW-3 are at or below sample detection limits for these constituents.

Although BTEX results from this well are highly elevated, the well is both upgradient and off-gradient from the leak location. Discussion with the land owner (Mr. Lewis Wright) revealed that an earlier leak in the area occurred in 1993 at a location 50 to 100 ft. north of MW-1. Therefore, it is unlikely that elevated sample results in MW-1 are a result of the current release.
