**STAGE 1 & 2
REPORTS**

DISCLOSURE REPORT

**RICE OPERATING COMPANY
JUNCTION BOX DISCLOSURE FORM ***

BD jct. F-17

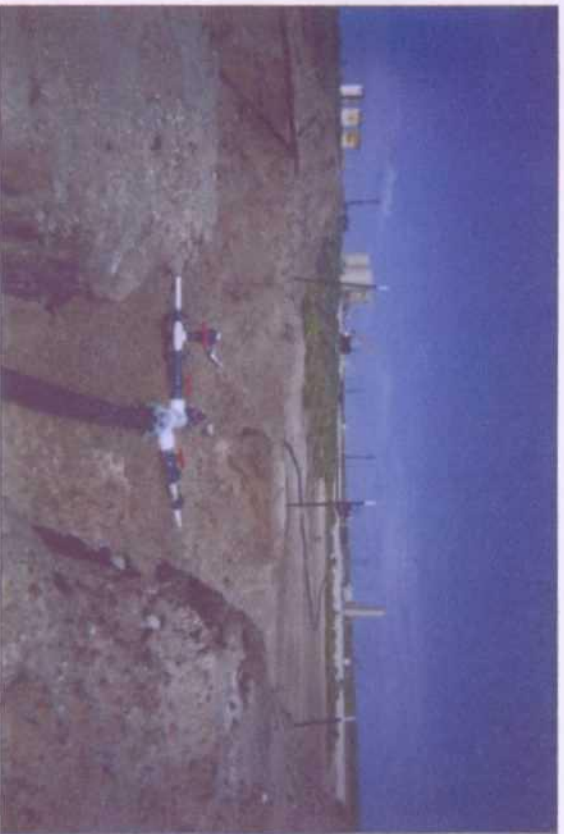
Junction Looking North 10/16/2002

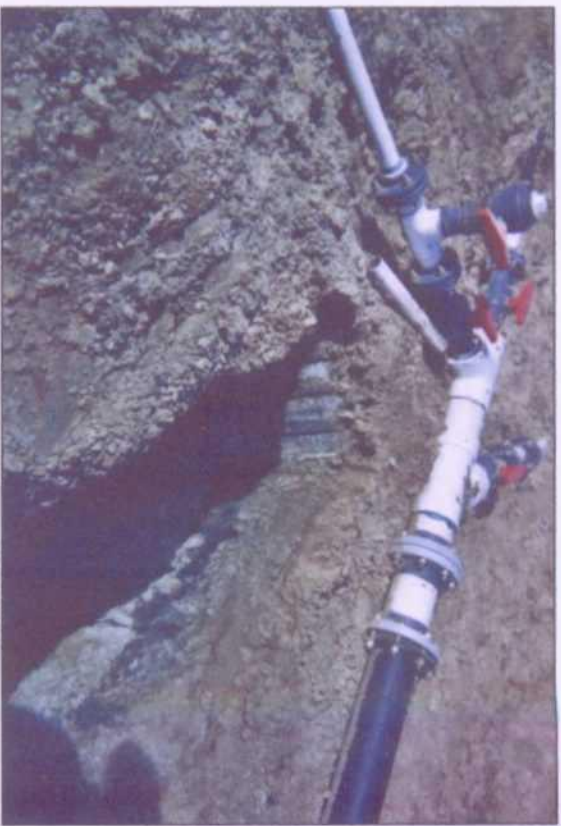
General Description of Remedial Action: Site was delineated vertically and laterally with a backhoe. Chloride impact was consistent vertically, while TPH was visible to 11' bgs.

Delineation Trench at Junction 10/16/2003

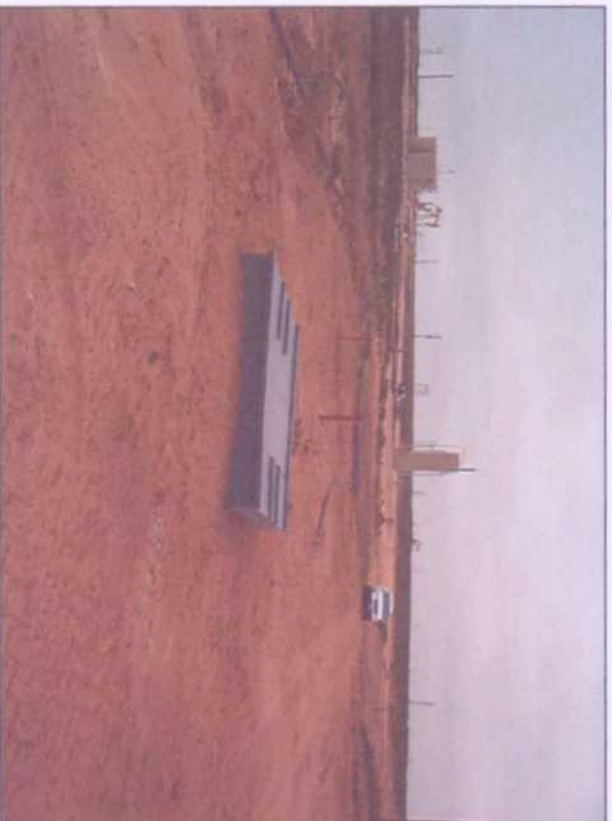
New Junction Box Looking North (monitor well in background; T-post indicating old junction marker)

The site was bored on 11/18/02 and chloride was found to impact groundwater with no indications of TPH. A cased monitor well was installed and the groundwater has been sampled and analyzed quarterly (see annual groundwater report for results). ROC has contracted a hydrologic consultant to assist ROC in developing a remediation plan for the vadose zone at groundwater-impacted sites with the ultimate objective being final closure. The excavation has been backfilled and the junction moved 45 ft south of this site.

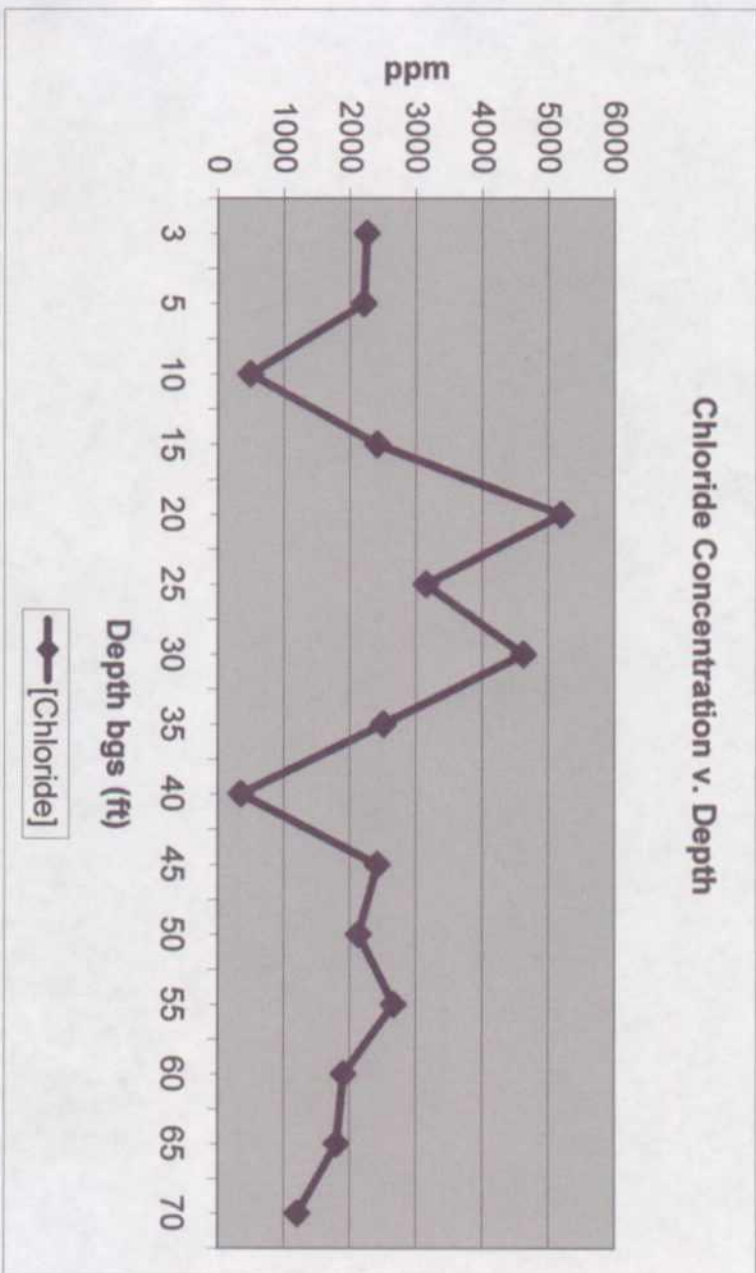
BD jct. F-17

Depth bgs (ft)	[Cl ⁻] ppm
3	2256
5	2212
10	492
15	2412
20	5197
25	3152
30	4628
35	2508
40	352
45	2420
50	2133
55	2665
60	1905
65	1800
70	1209

Groundwater = 72 ft
