XTO Energy, Inc.

Closure Request

**RE: Closure Request  
Palmillo State #1 Flow Line  
Remediation Permit Number 2RP-2849  
Eddy County, New Mexico**

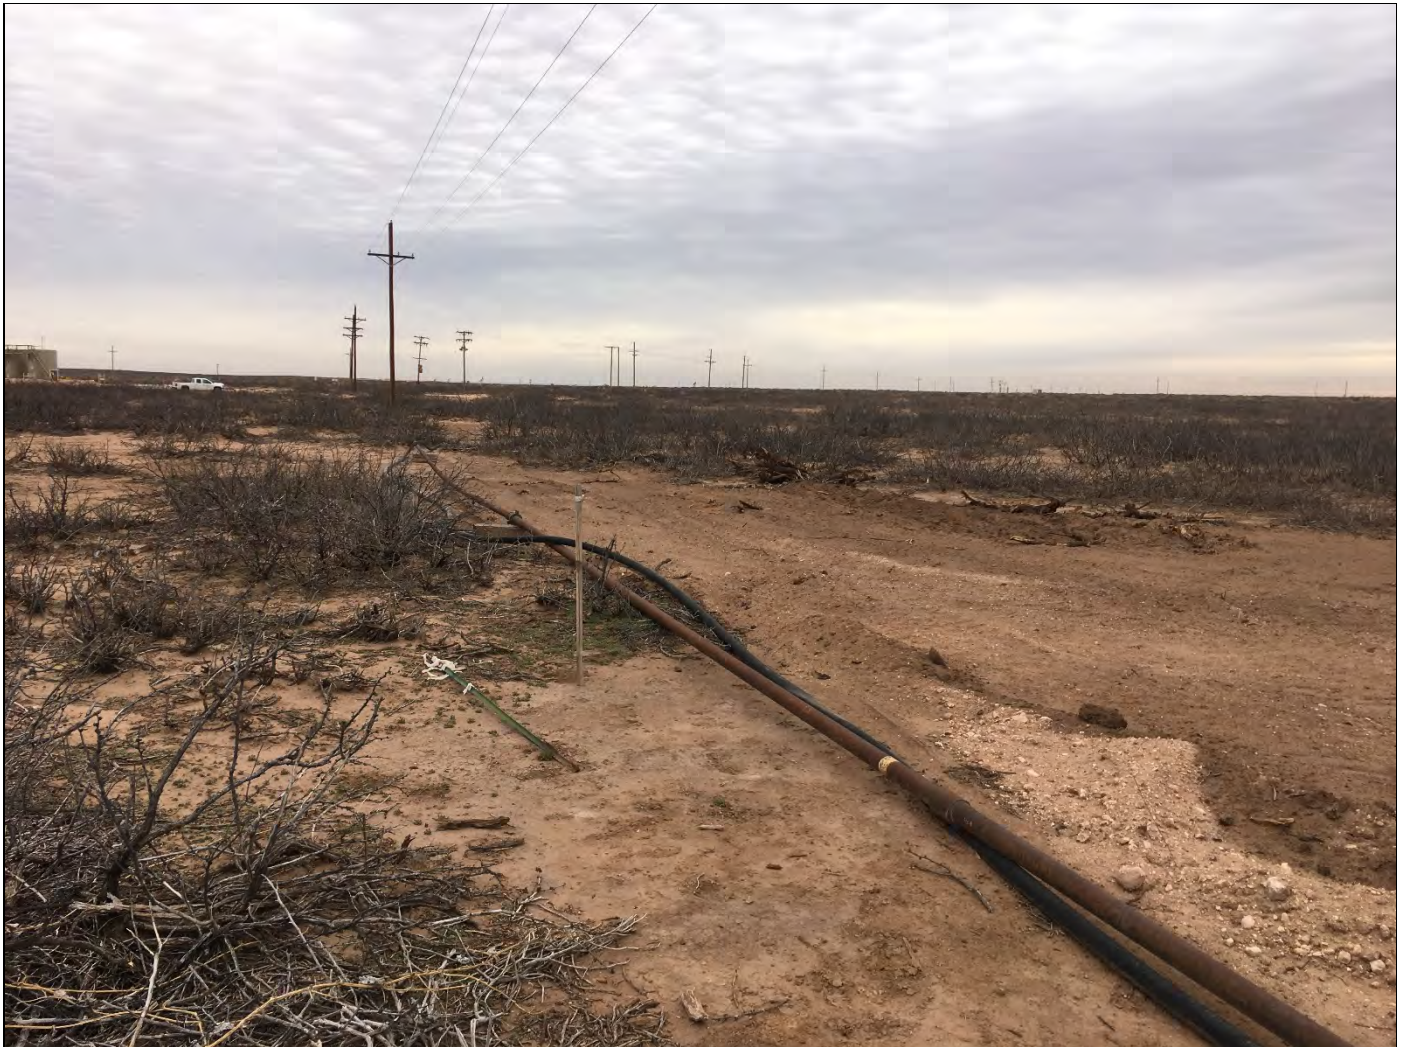
**View of release area prior to excavation.**

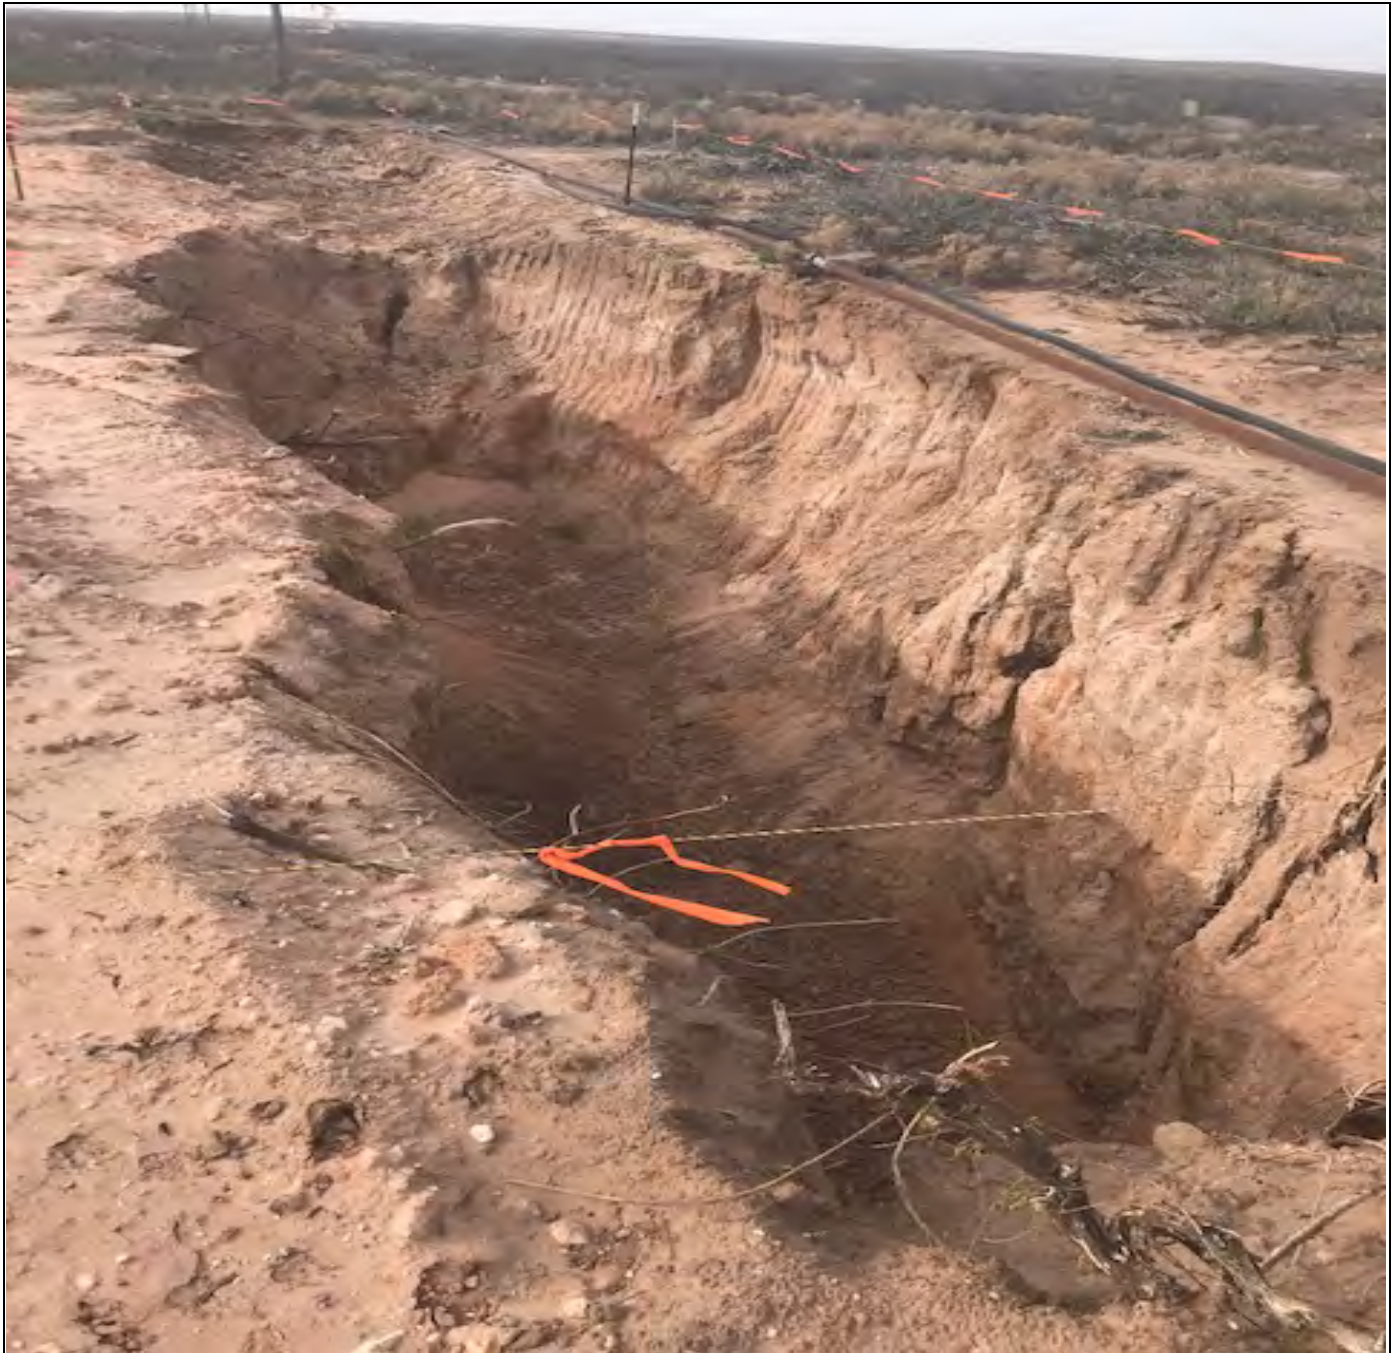
**View of excavation.**

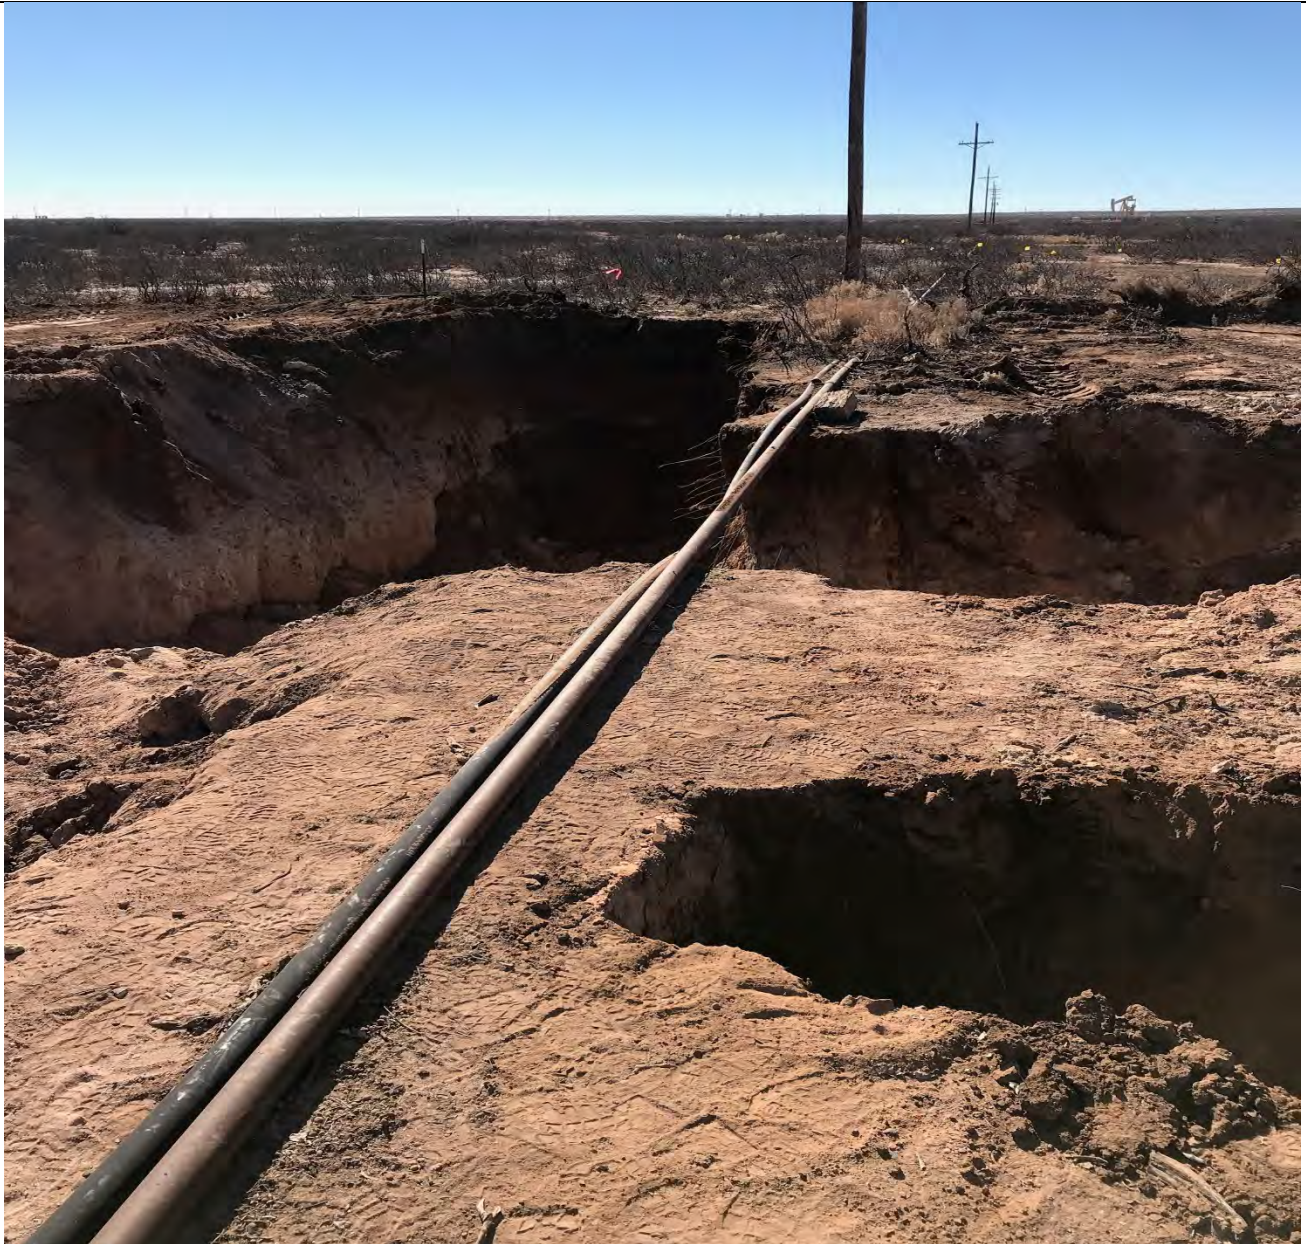
**View of excavation.**
