Release Notification

Site Name	New Mexico S State #35	Site Type	Production Well Facility flow line
Date Release Discovered	8/27/2019	API# (if applicable)	30-025-25381

**RE: Closure Request
New Mexico S State #35
Remediation Permit Number 1RP-5696
Incident Number NRM1926960363
Lea County, New Mexico**

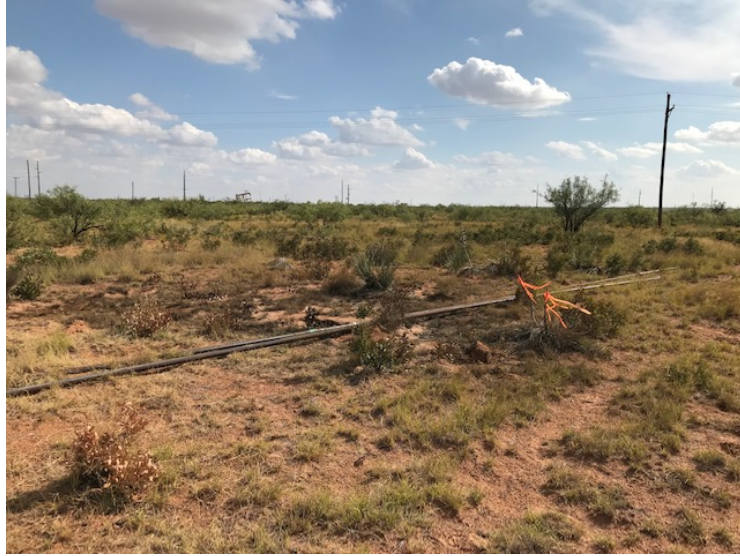
On August 27, 2019, a 2-inch steel flow line developed a hole, resulting in the release of 8.15 barrels (bbls) of produced water and 0.17 bbls of crude oil into the surrounding pasture. The section of the flow line was repaired. No fluids were recovered. XTO reported the release to the New Mexico Oil Conservation Division (NMOCD) on a Release Notification and Corrective Action Form C-141 (Form C-141) on September 6, 2019 and subsequently assigned Remediation Permit (RP) Number 1RP-5696 and Incident Number NRM1926960363.

Photograph 1: Southern view of spill extent.

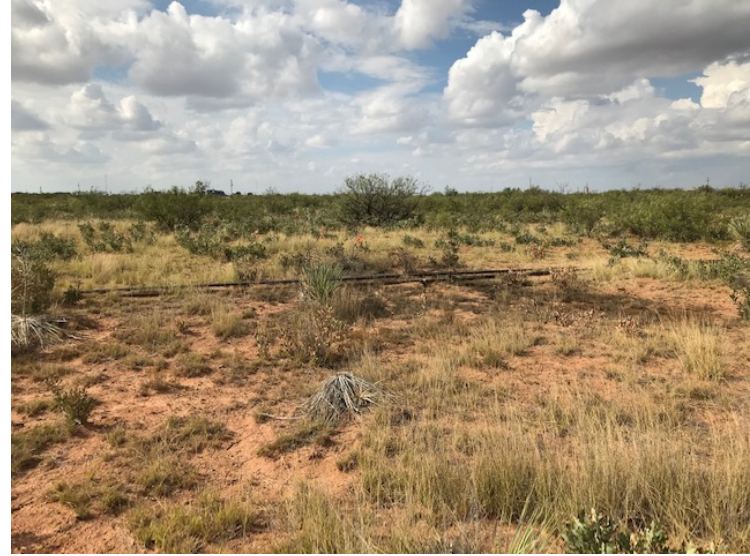
Photograph 2: Northern view of surficial staining.

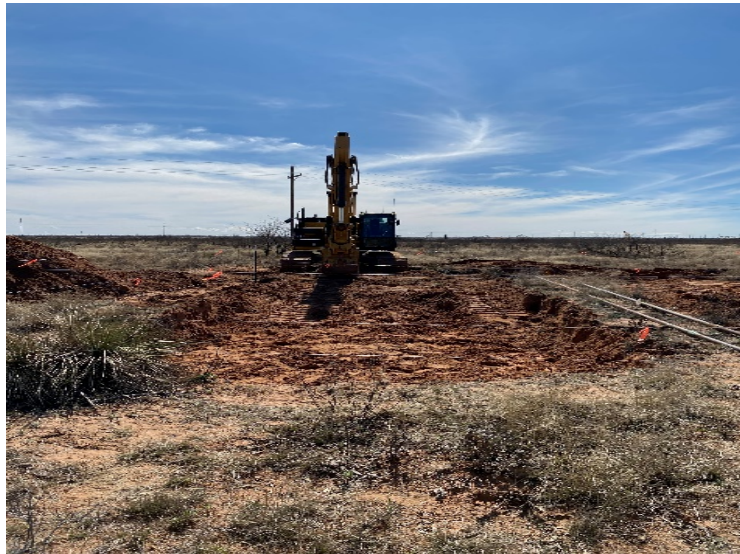
Photograph 3: View of southern excavation facing west.

To achieve the reclamation requirement, LTE personnel oversaw two small excavations with a track-mounted backhoe on March 9, 2020. Following removal of waste-containing soil, LTE collected 5-point composite soil samples on a 200 square foot frequency from the sidewalls and floor of the excavations. The 5-point composite samples were collected by placing five equivalent aliquots of soil into a 1-gallon, resealable plastic bag and homogenizing the samples by

Overall, excavation of impacted soil encompassed an area of approximately 797 square feet in the pasture. A total volume of approximately 65 cubic yards of impacted soil was removed from the Site. The impacted soil was transported and properly disposed of at the R360 Facility located in Hobbs, New Mexico.

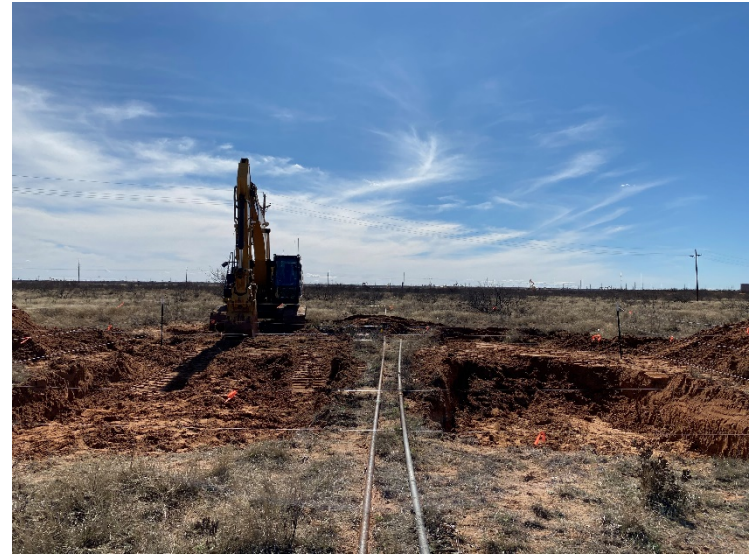
Photograph 4: View of both excavations facing west.
