Release Notification

Site Name	Remuda 500 Battery	Site Type	Tank Battery
Date Release Discovered	2/20/2020	API# (if applicable)

**RE: Closure Request
Remuda 500 Battery
Incident Number NRM2006457917
Eddy County, New Mexico**

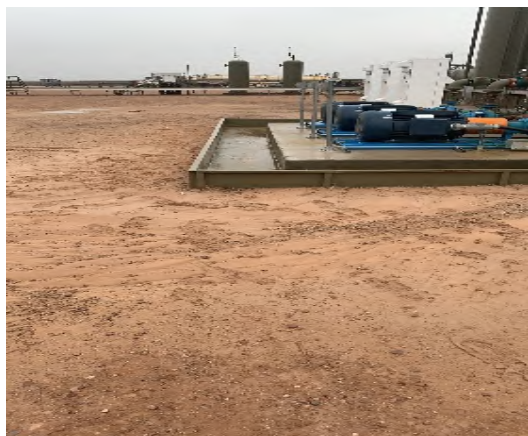
Photograph 1: View of release facing West.

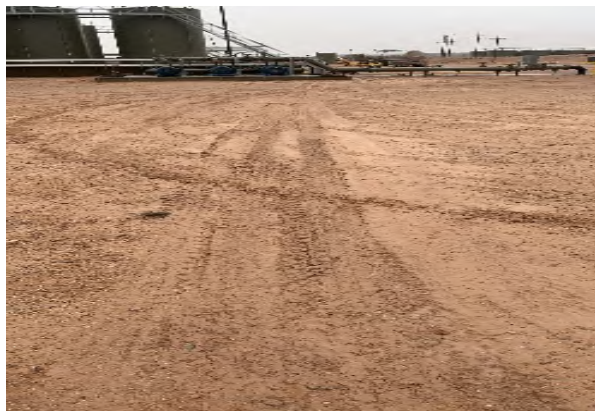
Photograph 2: View of release facing North.

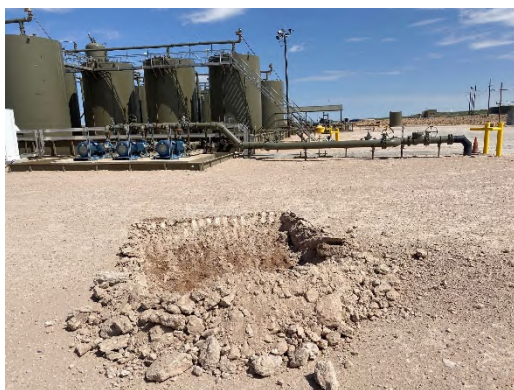
Photograph 3: View of location of FS02 facing North.

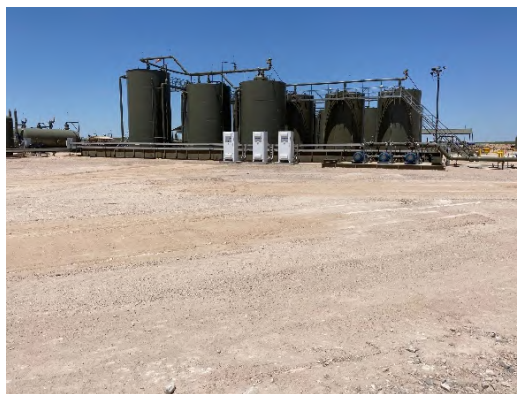
Photograph 4: View of backfilled excavations facing North.

Overall, impacted caliche from the three excavations encompassed an area of approximately 141 square feet on pad. A total volume of approximately 5 cubic yards of impacted caliche was removed from the Site. The impacted material was transported and properly disposed of at the R360 Facility located in Hobbs, New Mexico.

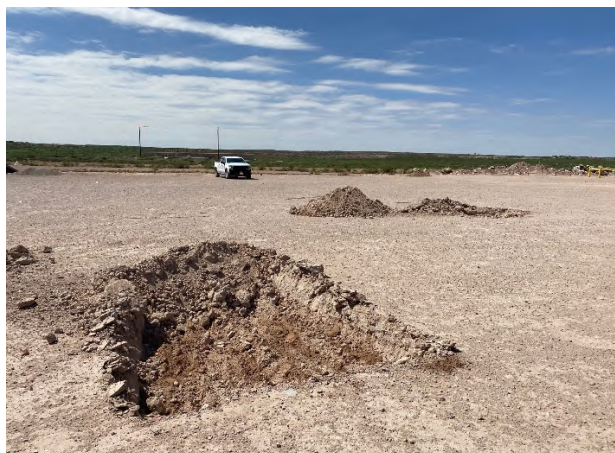
Photograph 5: View of FS02 and FS03 facing south.

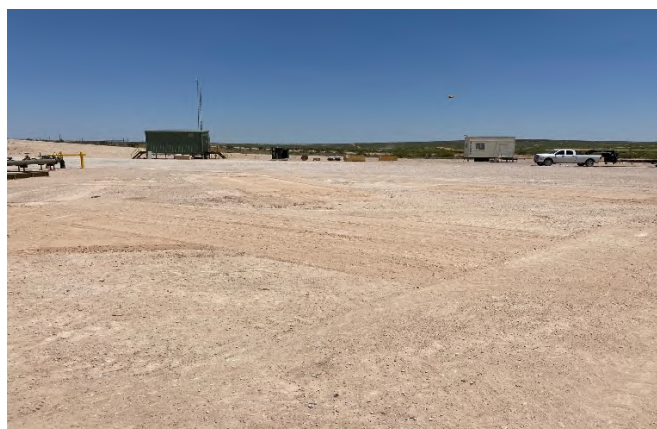
Photograph 6: View of backfilled excavations facing west.
