Release Notification

Site Name Kutz Gas Plant	Site Type Natural Gas Processing Facility
Date Release Discovered 7/24/2020	API# (if applicable)

Kutz Gas Plant

NRM2023330868

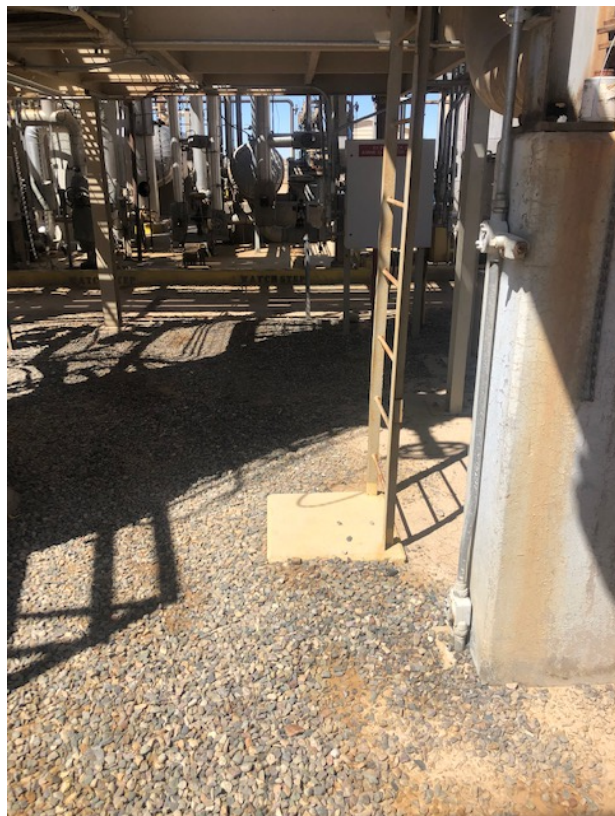
Photo 1: Kutz Gas Plant Release Location

Generator went down on high oil temp. which caused an emergency shutdown at the plant. Pressure safety valve PSV-20041 relieved due to inlet compression staying on for 5 minutes with no place for the natural gas to go. Power was restored with the second generator and plant was put back on. After troubleshooting it was found that there was a controls issue with DeviceNet.

Leak has been repaired.
