Incident ID	NRM2026945362
District RP	
Facility ID	
Application ID

Release Notification

Site Name: Mesa #2H Tank Battery	Site Type: Production Facility
Date Release Discovered: 9/19/2020	API# (if applicable) Nearest well: Mesa #2H API #30-025-41289

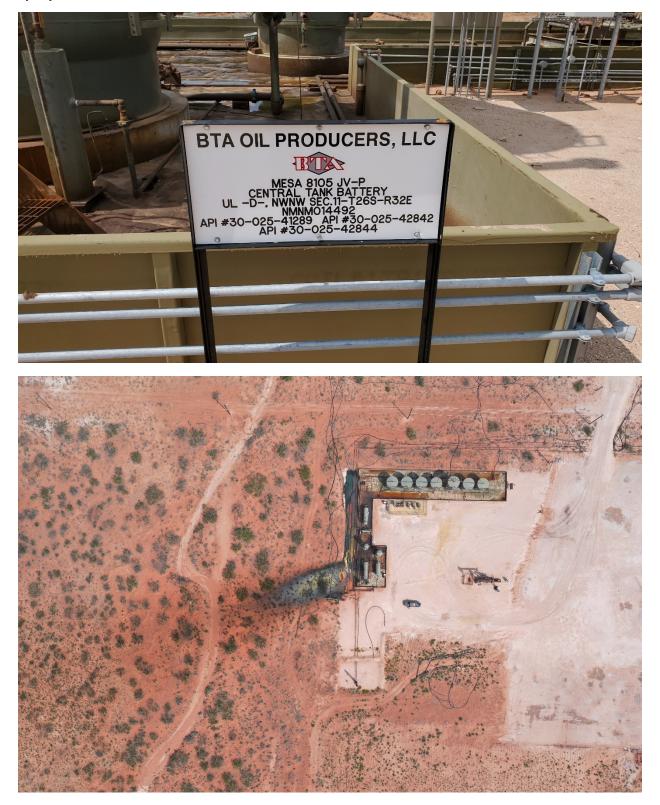
(Length X Width X Depth X 1 ft/12 in) X Porosity 5.615 ft³ / BBL Oil Cut (or Water Cut) Mesa #2H Tank Battery 9/19/2020

A failed gasket on a separator vessel allowed the release of oil and produced water outside of the containment onto the ground as free liquid and spray. On the same day as the release, a backhoe was on location to scrape the impacted area that wasn't covered by surface flow lines. Also, 20 BBL of oil and water was recovered.

ADDITIONAL INFORMATION: It should be noted that on 9/19/2020, a backhoe was on location to scrape the impacted area not covered by flowlines. (Pictures attached). The area containing the lines on the surface will require hand digging to complete the remediation activities.
