August 7, 2020

**Re: Work Plan Report
Emerald PWU 20 #1H
API No. 30-015-38338
GPS: Latitude 32.6525154 Longitude -104.1045456
UL "D", Sec. 20, T19S, R29E
Eddy County, NM
NMOCD Ref. No. 2RP-779; 2RP-4281; 2RP-5167; 2RP-5377**

Emerald PWU 20 #1H
API 30-015-38338
Eddy County, NM
Location Map

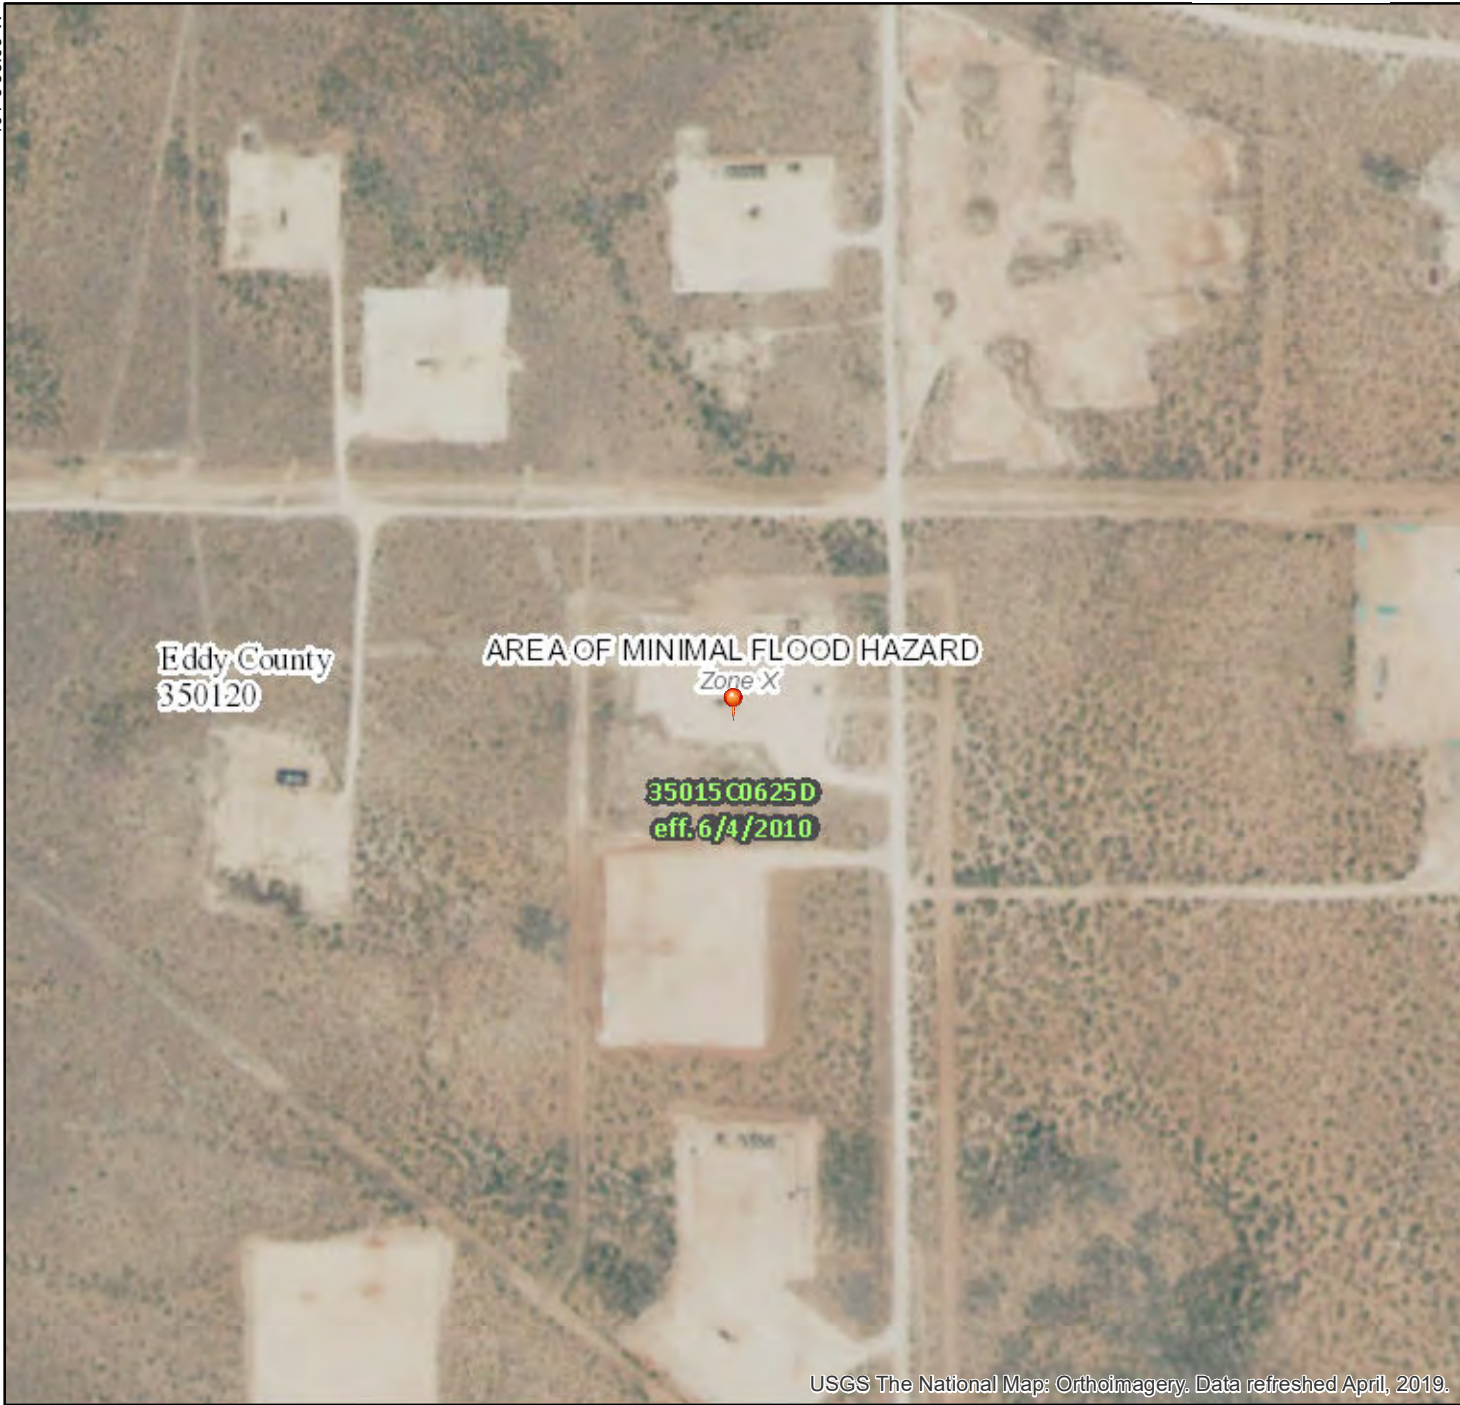
National Flood Hazard Layer FIRMette

The flood hazard information is derived directly from the authoritative NFHL web services provided by FEMA. This map was exported on 6/10/2020 at 1:40:02 PM and does not reflect changes or amendments subsequent to this date and time. The NFHL and effective information may change or become superseded by new data over time.

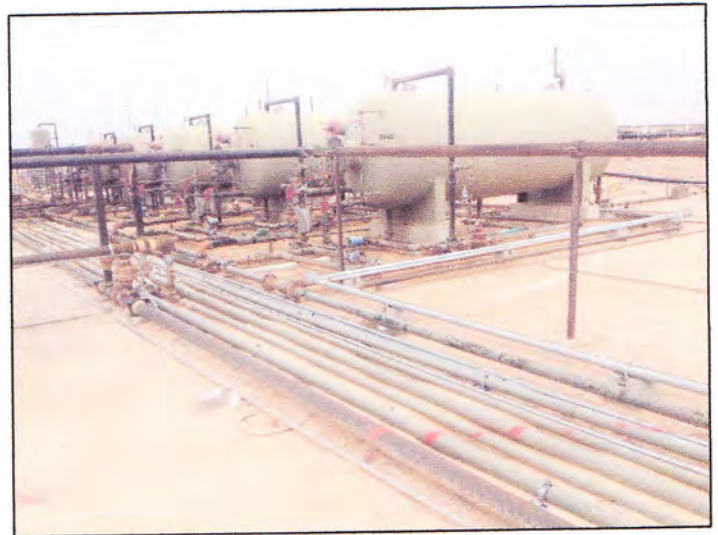
Devon Energy Production Company-Emerald PWU 20 1H

At the time of discovery, wells flowing to the battery were shut in and the repairs made to the three-phase separator. All released fluids remained on the caliche pad and no area off the pad was impacted. The impacted area is in a highly congested area of surface equipment and is approximately 20' x 20'. Two sample points were selected for soil sampling by use of a hand auger. (See attached chloride field test and lab analysis.)

Due to hazards associated with working around the above ground piping/vessels and the sheer congestion of the area, the excavation of the impacted soil will have to be done with hand tools. I propose to hand excavate the impacted soil around the surface equipment to a depth of 1' BGS. The hand excavated soil will be stockpiled on plastic and disposed of at a division permitted facility. Fresh base course will be used for back fill with the area being brought back to grade, leveled, and raked.
