Release Notification and Corrective Action

Name of Company	Chevron Environmental Management Co.	Contact	Kegan Boyer
Address	1400 Smith Street Room 07076	Telephone No.	(713) 372-7705
Facility Name	New Mexico O State #40	Facility Type	Reserve Pit

FINAL REPORT

Site Closure Report

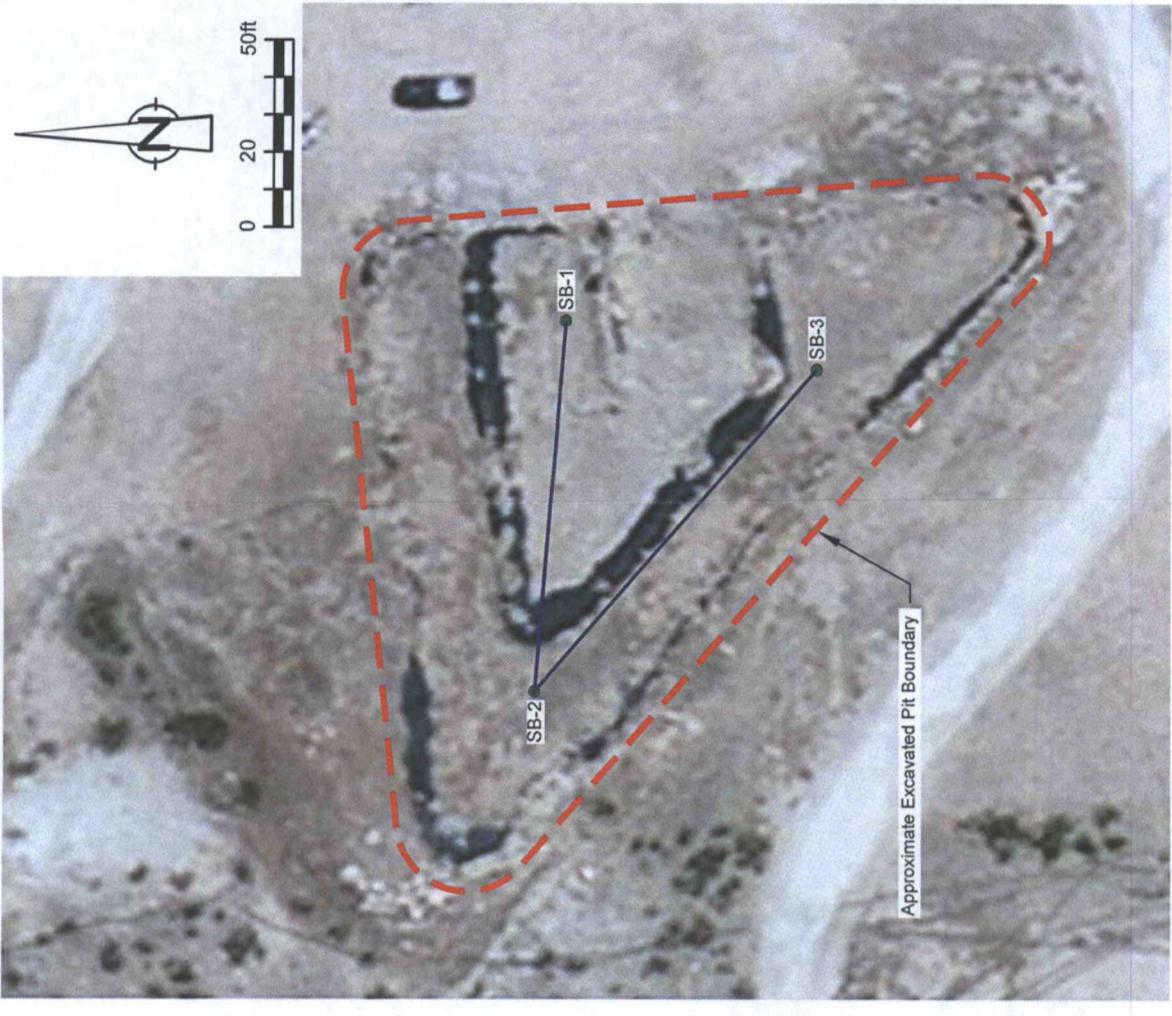
figure 2
**SOIL CROSS-SECTION
 NEW MEXICO "O" STATE #40 PIT
 SECTION 36, T17S, R34E (RP#2673)**
Chevron Environmental Management Company

remedial excavation to a depth of 100 feet below ground surface bgs. All three soil borings SB-1 (70'-69.8 mg/kg), SB-2 (70'-108 mg/kg) and SB-3 (70'-29.8 mg/kg) demonstrated decreasing chloride levels with depth to well below recommended remediation and delineation levels.

1. Soil borings advanced May 7 and 8, 2013.
2. Samples evaluated using drill cuttings and split spoon sampler.
3. Boundaries between soil units are approximate.
4. Harrison & Cooper (Lubbock, Texas) drilling contractor. Six-inch borehole using Ingersol Rand 11RTH60 (2006) drill rig.
5. All borings plugged with drill cuttings and approximately 20 bags of bentonite.

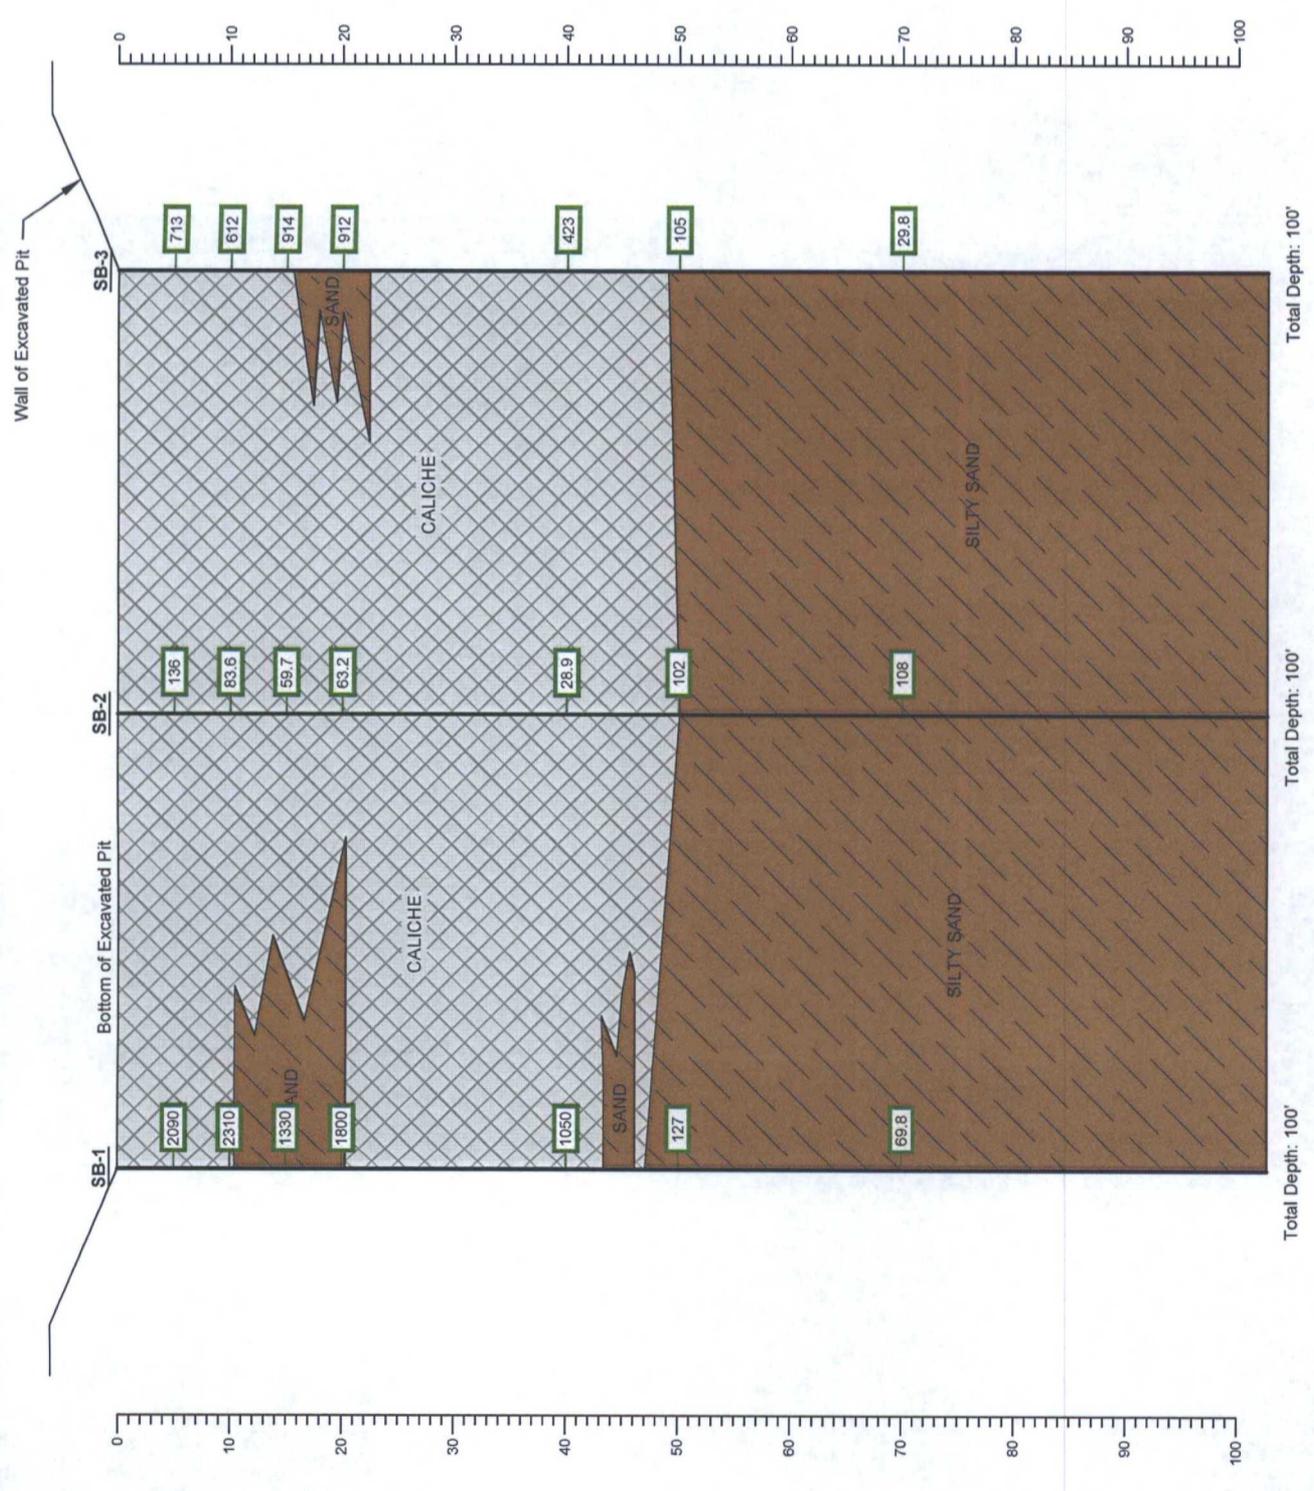
431 Chloride Concentration (mg/kg)
 Analysis by EPA Method 300/300.1.

- CALICHE - White, tan, dry, indurated at top of unit. Dense to very dense, increasing in silty sands toward base of unit.
- SILTY SAND - Reddish brown, tan, firm to dense, moist toward bottom of unit.

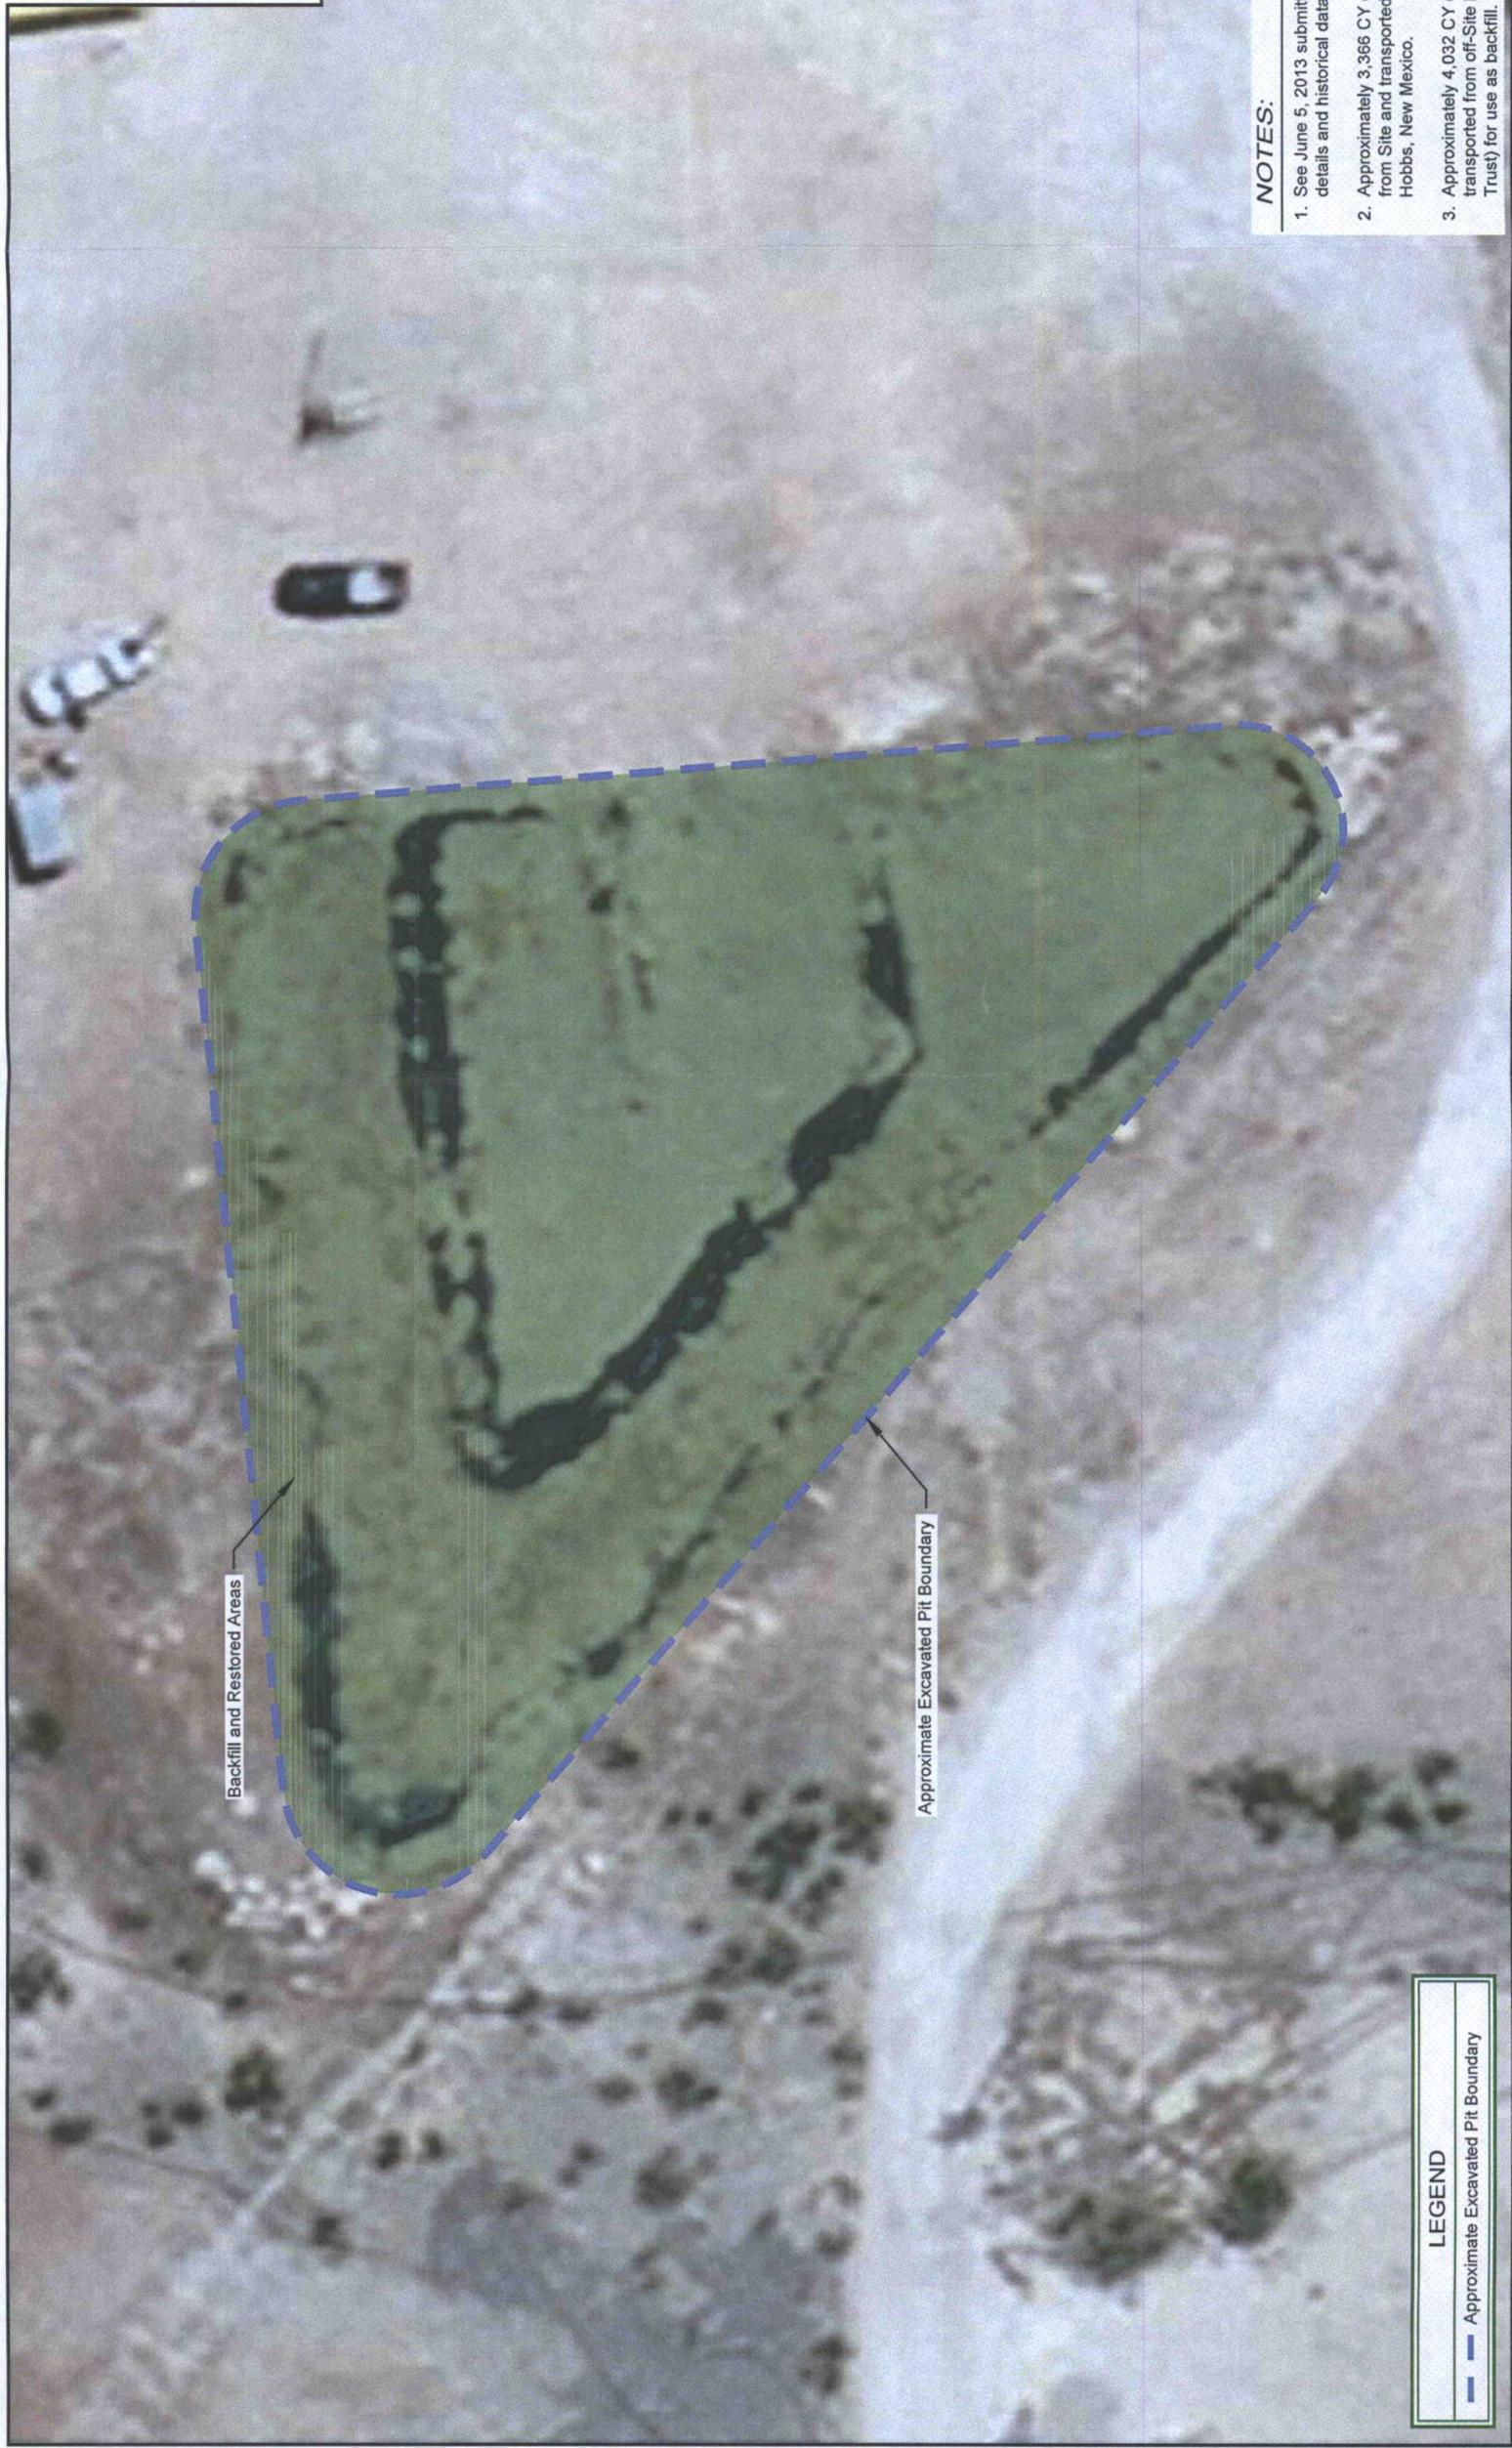
Backfill and Restored Areas

Approximate Excavated Pit Boundary

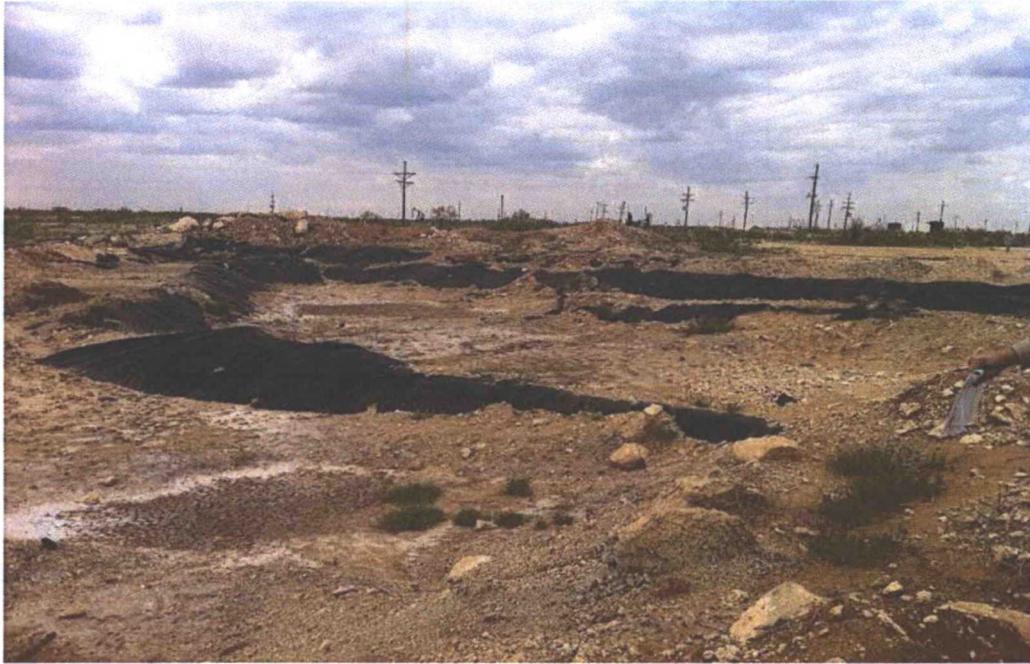
PHOTO 1: View of reserve pit facing north before any remedial work activities

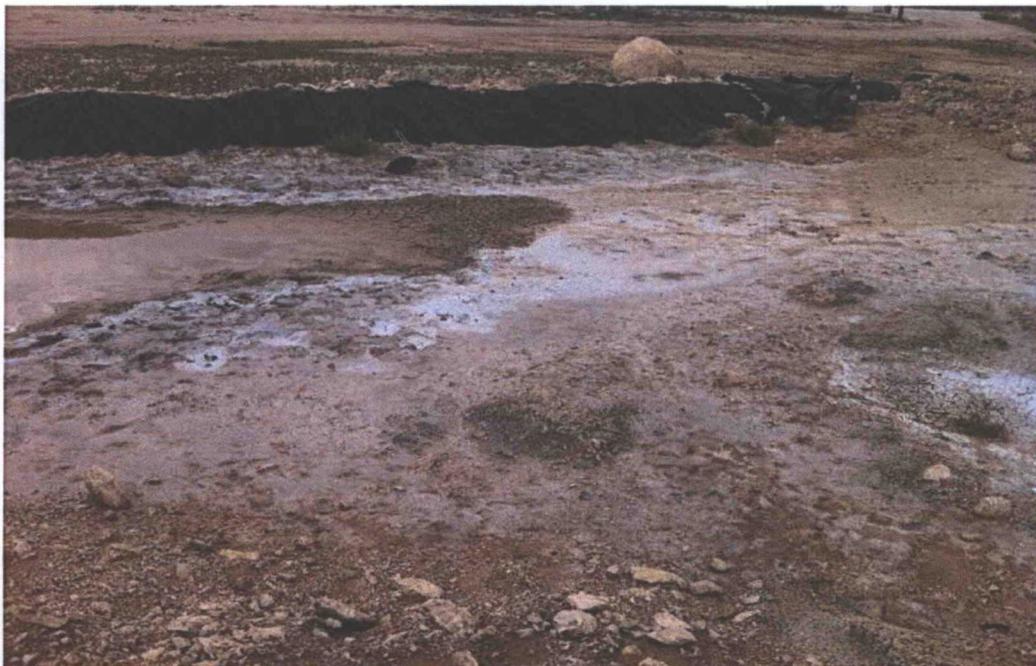
PHOTO 2: View of reserve pit facing south before any remedial work activities

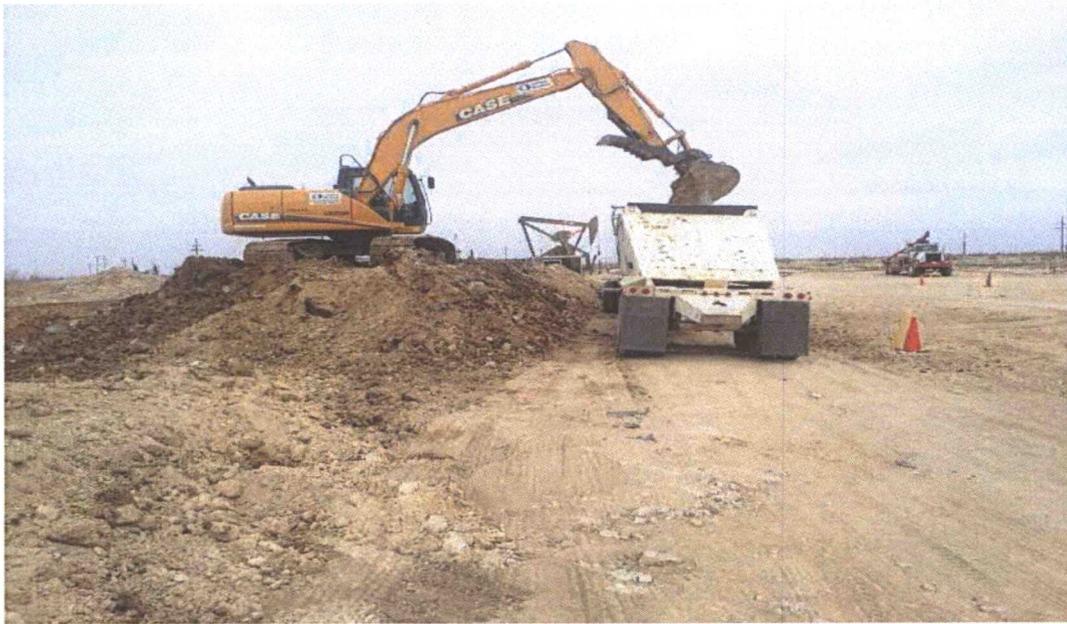
PHOTO 3: View of excavation/waste removal activities

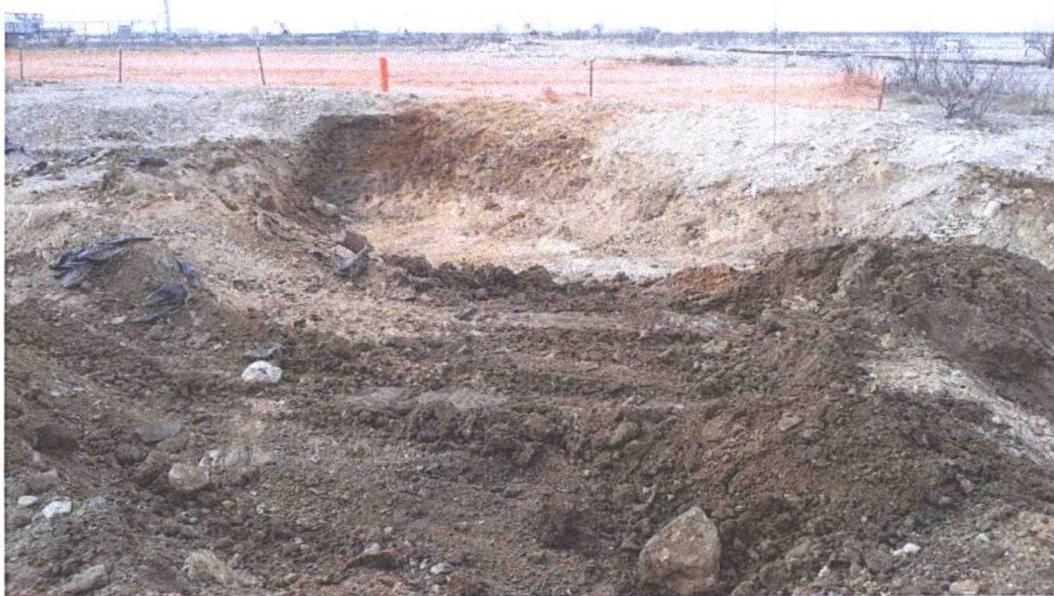
PHOTO 4: View of excavation/waste removal activities facing southwest

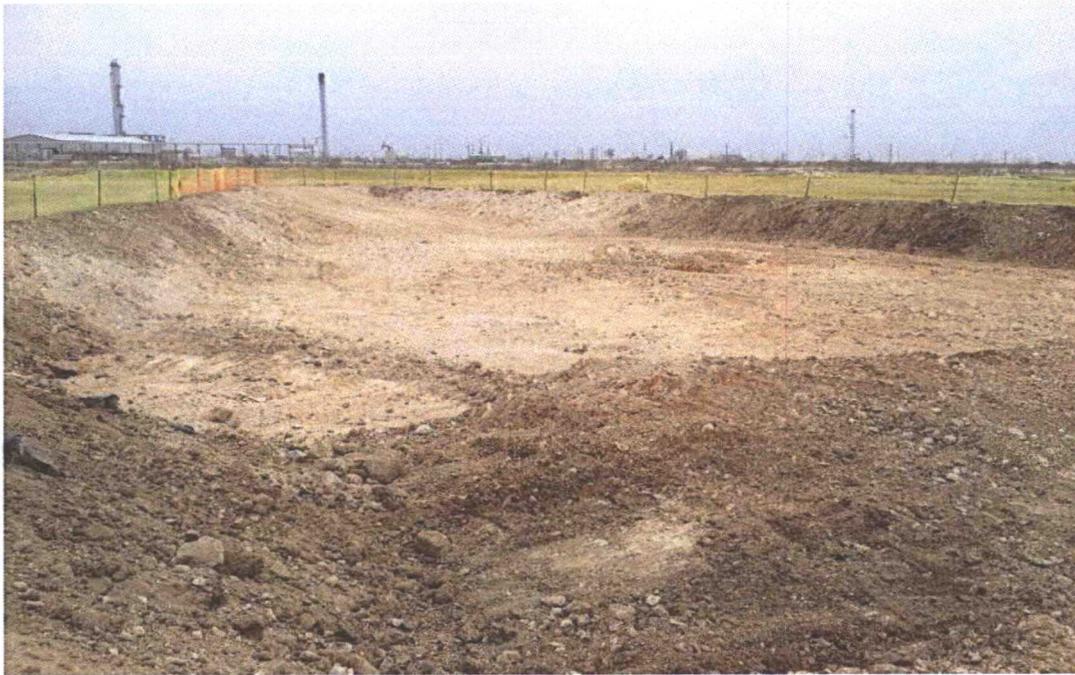
PHOTO 5: View of excavated reserve pit facing south

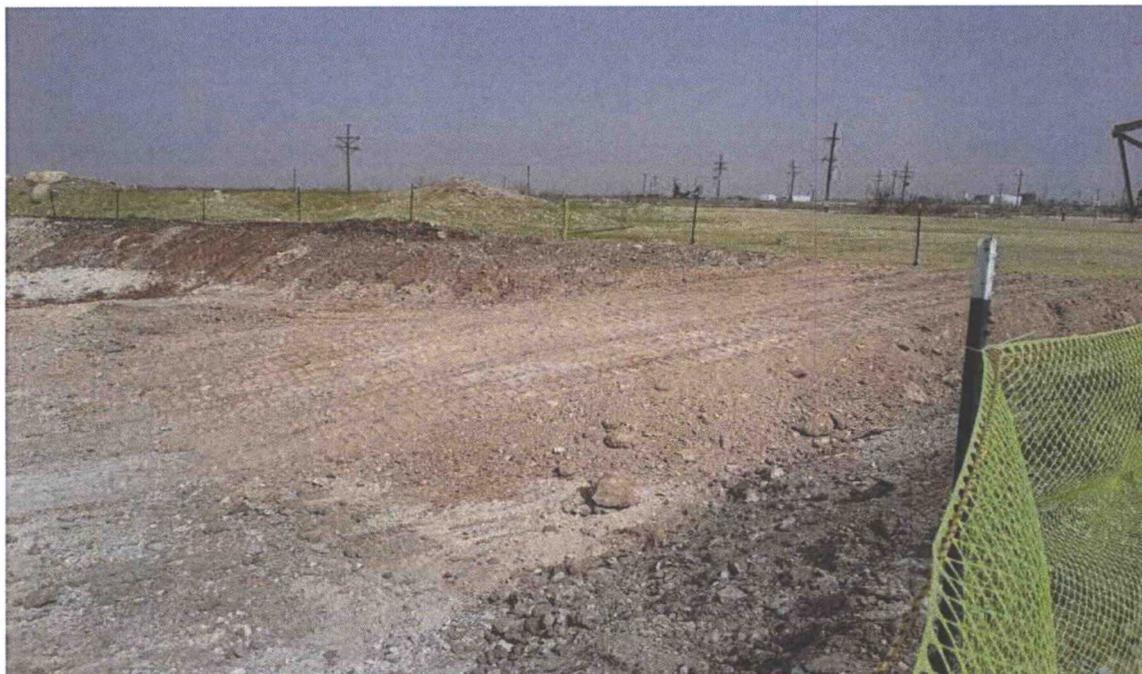
PHOTO 6: View of excavated pit and entrance ramp facing north

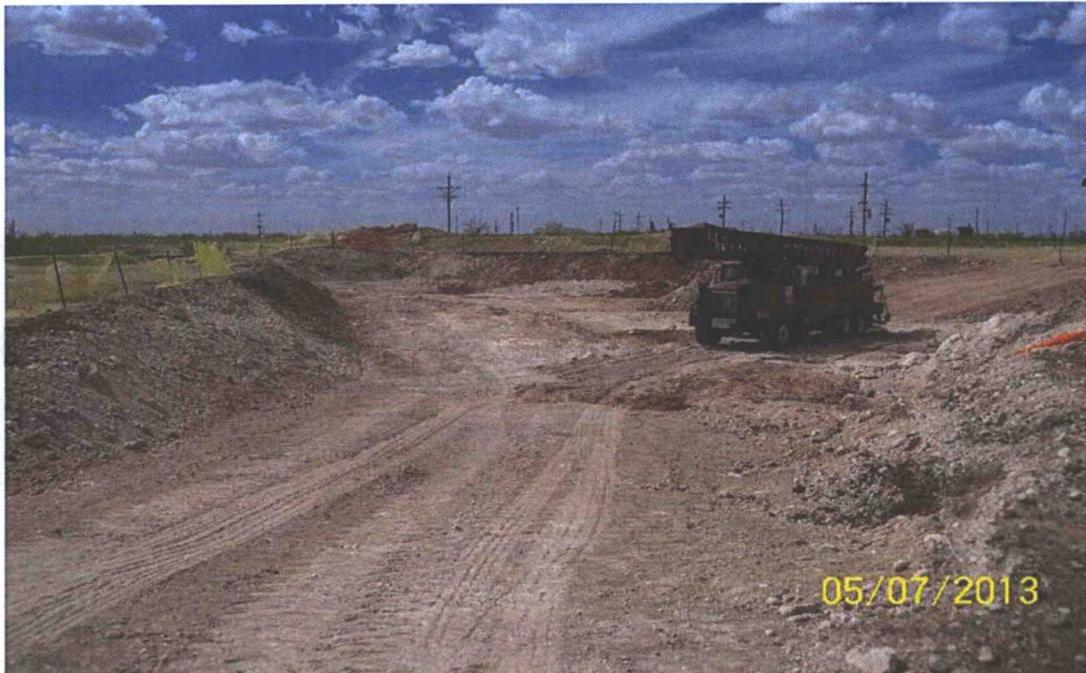
PHOTO 7: View of drill rig inside excavated reserve pit facing north

In May 2013, after discussions and approval from the NMOCD Hobbs District I office, three soil borings (SB-1, SB-2, and SB-3) were installed within the existing remedial excavation to a depth of 100 feet below ground surface bgs. Soil samples were collected at 5 to 10 foot intervals in an effort to horizontally and vertically evaluate the extent of chloride impacts. All three soil borings SB-1 (70'-69.8 mg/kg), SB-2 (70'-108 mg/kg), and SB-3 (70'-29.8 mg/kg) demonstrated decreasing chloride levels with depth to well below recommended remediation and delineation levels. A soil boring analytical summary is provided in Table I. A soil cross section depicting subsurface conditions is provided in Figure 2. Certified Laboratory Reports for the 2013 soil sampling events are provided in Appendix E.

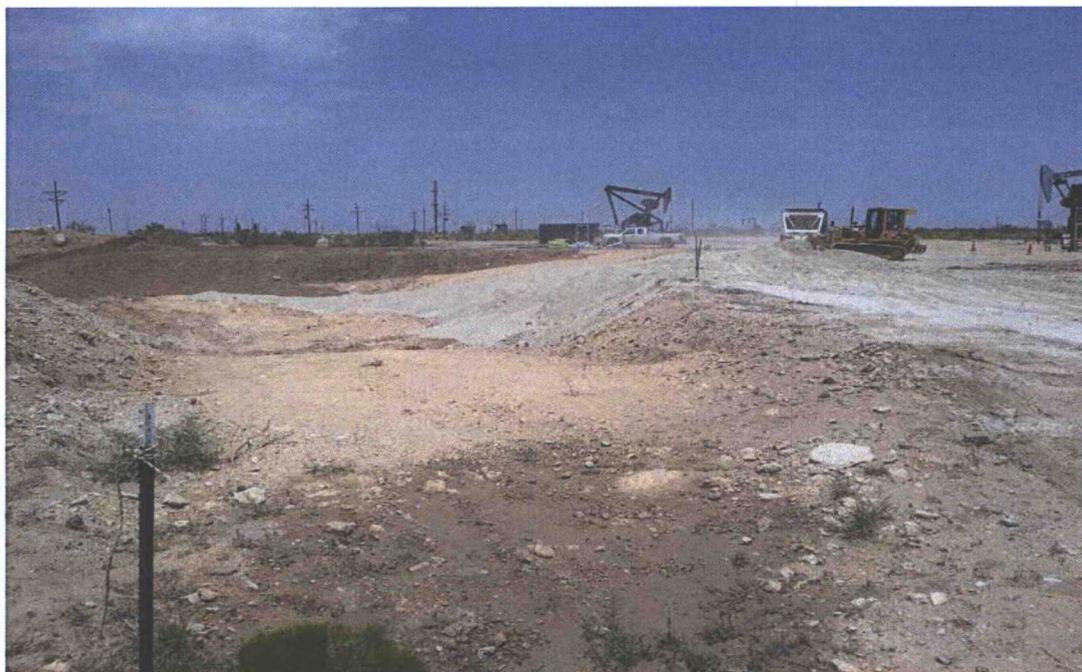
PHOTO 8: View of backfill activities facing north

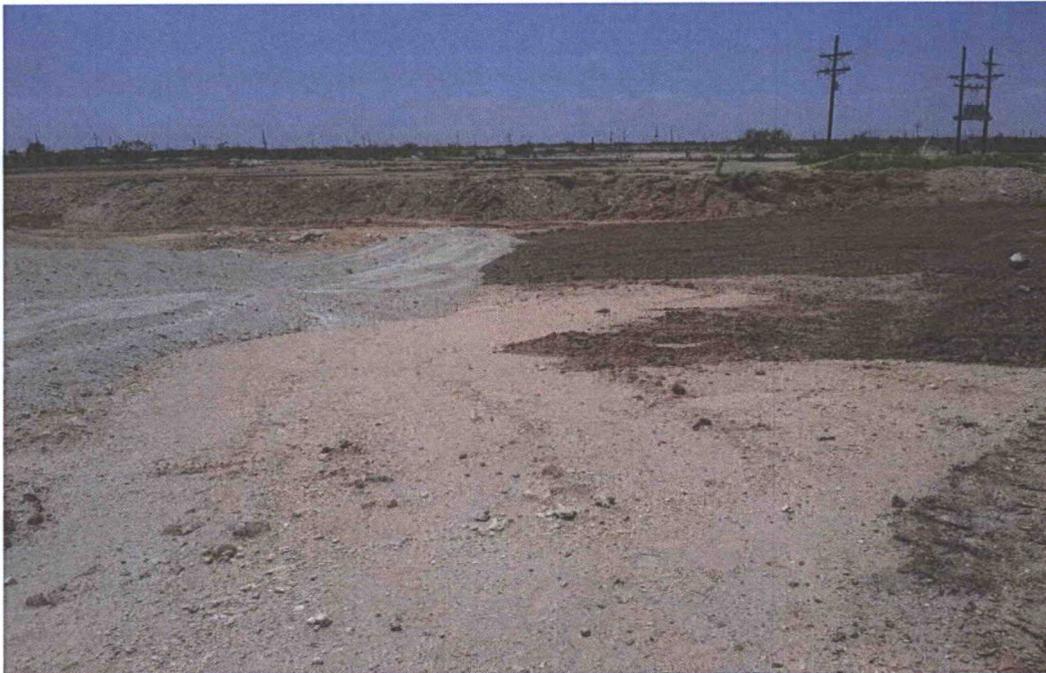
PHOTO 9: View of backfill activities facing west

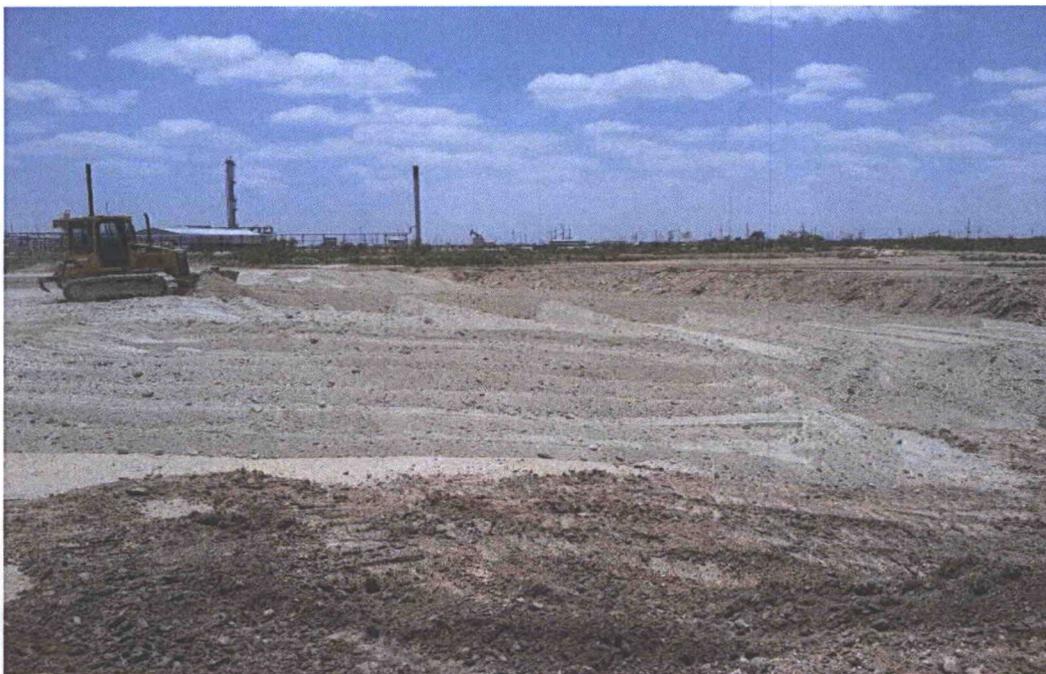
PHOTO 10: View of backfilling activities facing south

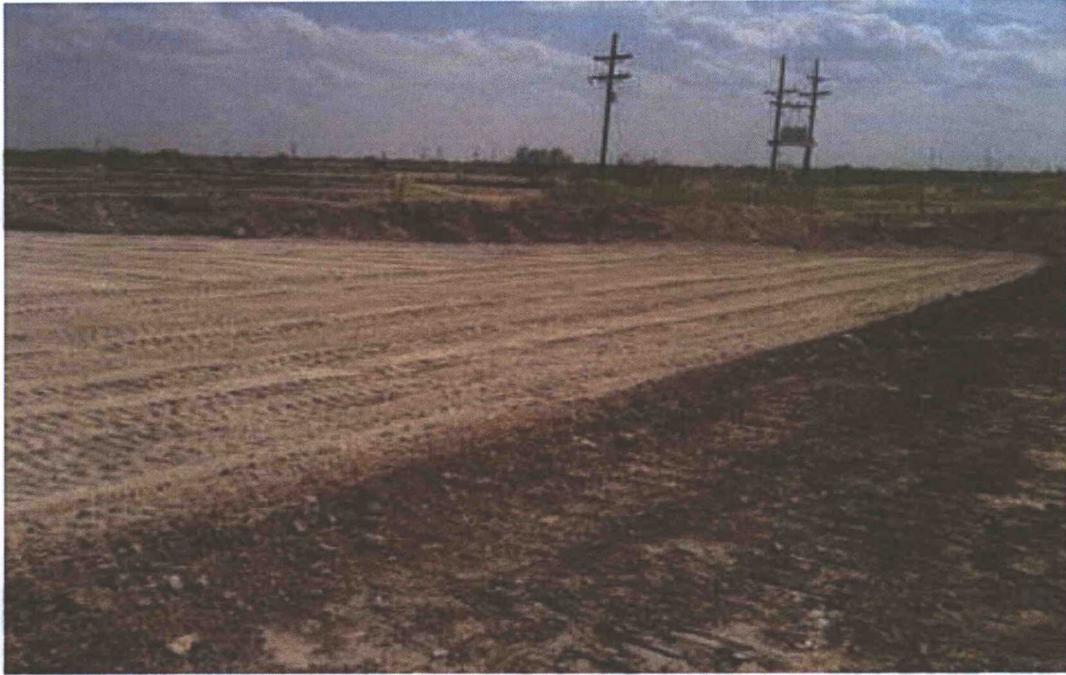
PHOTO 9: View of backfill ready for 20 mil poly liner installation facing northwest

July 3, 2013 (Wednesday)	Pit is ready for liner install on July 5 th . 24 truckloads hauled today, totaling 432 cy today and 1548 cy hauled to date. Site secured at EOD.
July 4, 2013 (Thursday)	NO WORK TODAY - JULY 4 TH HOLIDAY
July 5, 2013 (Friday)	On-Site personnel attend FMT briefing meeting. Receive FMT PTW. RWI on-site w/ 4 trucks. Liner installation began and was completed today. Backfilling activities resumed. Total of 56 truckloads hauled today, totaling 1008 cy for day, and 2556 cy hauled to date.
July 6, 2013 (Saturday)	On-Site personnel attend FMT briefing meeting. Receive FMT PTW. RWI on-site w/ 4 trucks. Dozer having trouble keeping up with truckloads, trucks slowed down. Worked an extra hour today. Backfill complete. Topsoil haul start tomorrow. A total of 56 truckloads hauled today, totaling 1008 cy for day, and 3564 cy hauled to date.
July 8, 2013 (Monday)	On-Site personnel attend FMT briefing meeting. Receive FMT PTW. RWI on-site w/ 4 trucks. Hauling of topsoil is completed today. A total of 26 loads, 9 per truck where hauled today. End of day haul total is 468 cy. This marks the end of backfilling activities. Total project backfill hauled to date is 4,032 cy. Site has been graded and seeded w/ BLM #4 seed mixture. Demob of machines will take place July 9, 2013. Site is clean and secure.

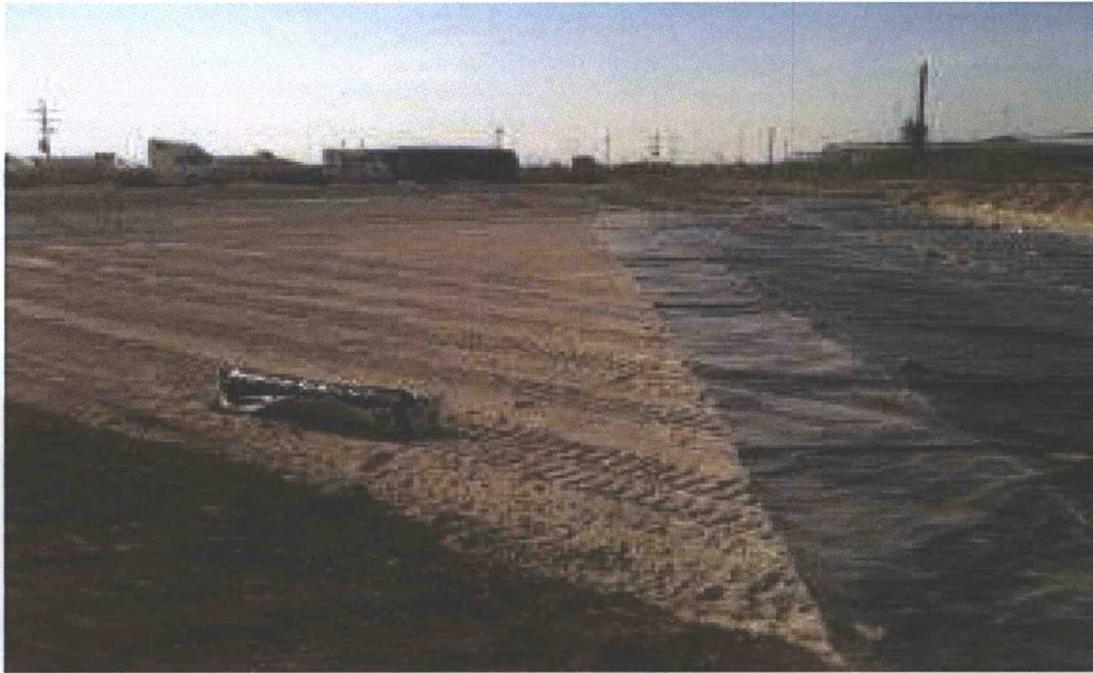
PHOTO 11: View of 20 mil poly liner installation facing southeast

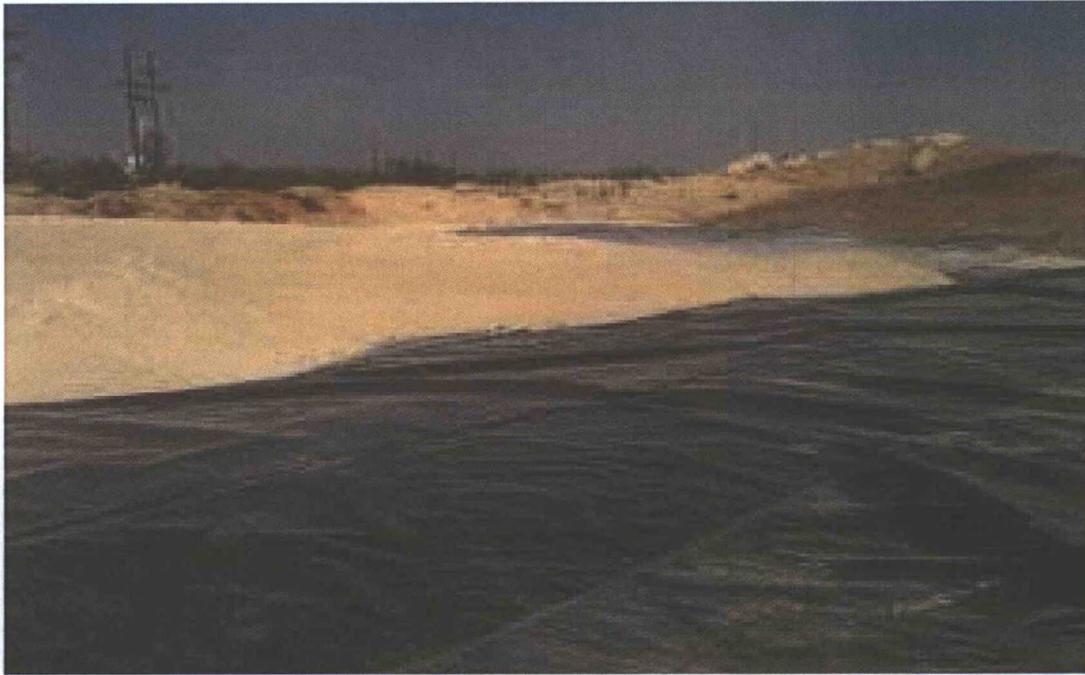
PHOTO 12: View of 20 mil poly liner installation/backfill facing northwest

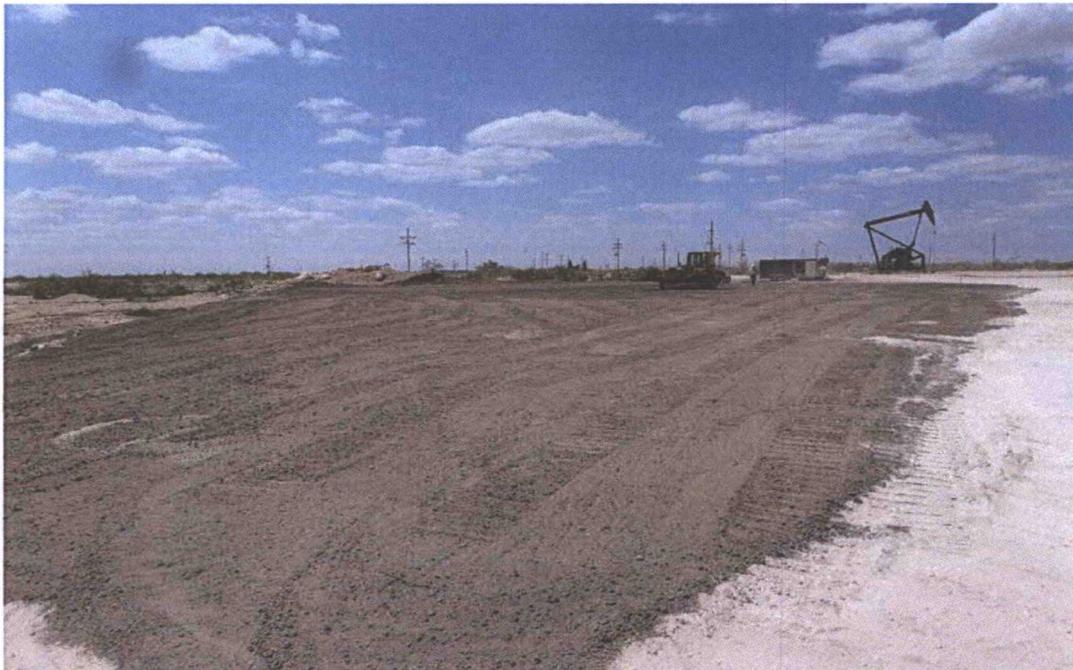
PHOTO 13: View of final grading and seeding activities facing north
