## Release Notification and Corrective Action

Name of Company: BOPCO, L.P. 2100737 Contact: Tony Savoie  
Address: 522 W. Mermod, Suite 704 Carlsbad, N.M. 88220 Telephone No. 575-887-7329  
Facility Name: North Indian Flats 26 Federal #1 Facility Type: Exploration and Production

## **Photo Illustrations of Historical Events**

### Post Remedial Closure Summary

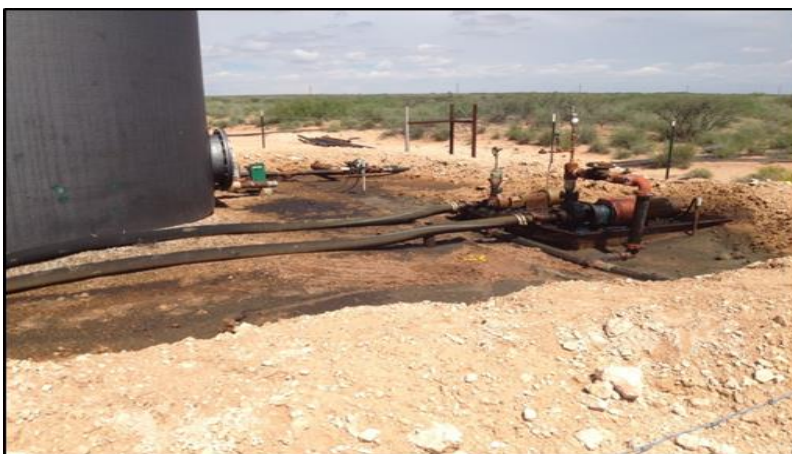
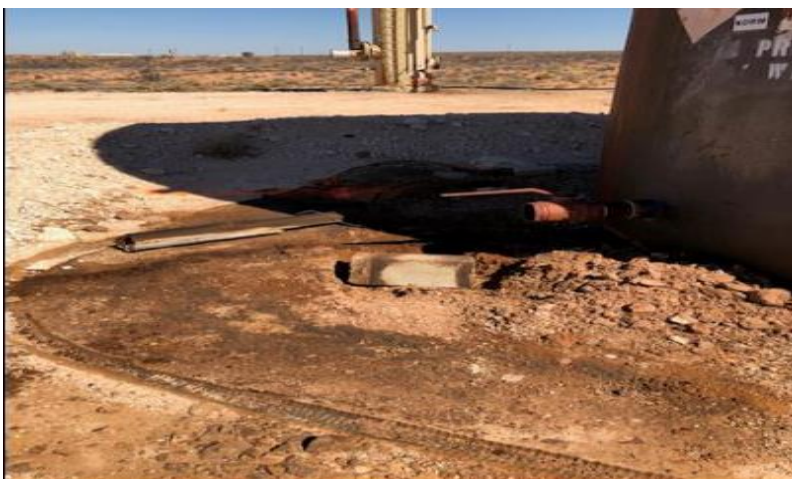
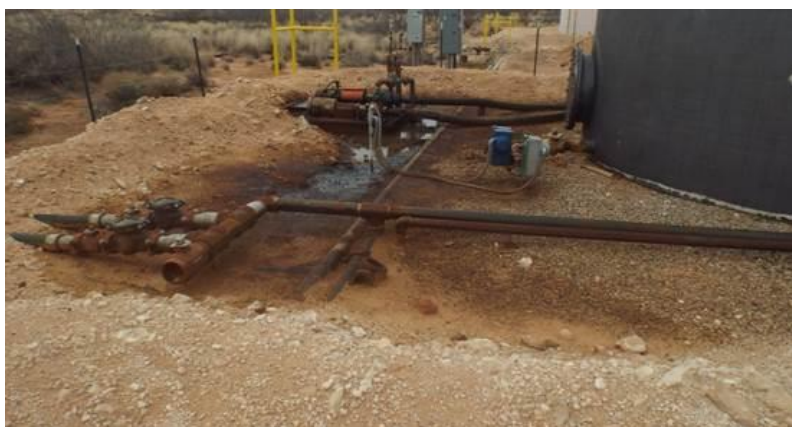
A flange gasket failed on the water transfer pump. The flange gasket was replaced. The spill affected approximately 450 sq. ft. of earthen containment berm around the water storage tank.

An air eliminator on the water transfer pump failed, the part was replaced. The spill affected approximately 450 sq. ft. of earthen containment berm around the water storage tank. The area impacted is the same as previous spill on 9/24/2014, reference spill report 2RP-2523.

The body of a check valve developed a pinhole due to corrosion and fluids were released to the well location. The failed check valve was replaced. The leak affected approximately 2,731 square feet of caliche pad and free standing fluids were immediately recovered.

The crew was attempting to remove flowline from oil tank on location. Upon striking hammer union, threads connecting valve and swedge cracked, causing a release of oil into earthen containment. Vacuum truck was dispatched and recovered all standing fluid. Damaged connection was repaired and all recovered oil was returned to oil tank.

Describe Cause of Problem and Remedial Action Taken.\* A flange gasket failed on the water transfer pump. The flange gasket was replaced.

Describe Cause of Problem and Remedial Action Taken.\* An air eliminator on the water transfer pump failed, the part was replaced.

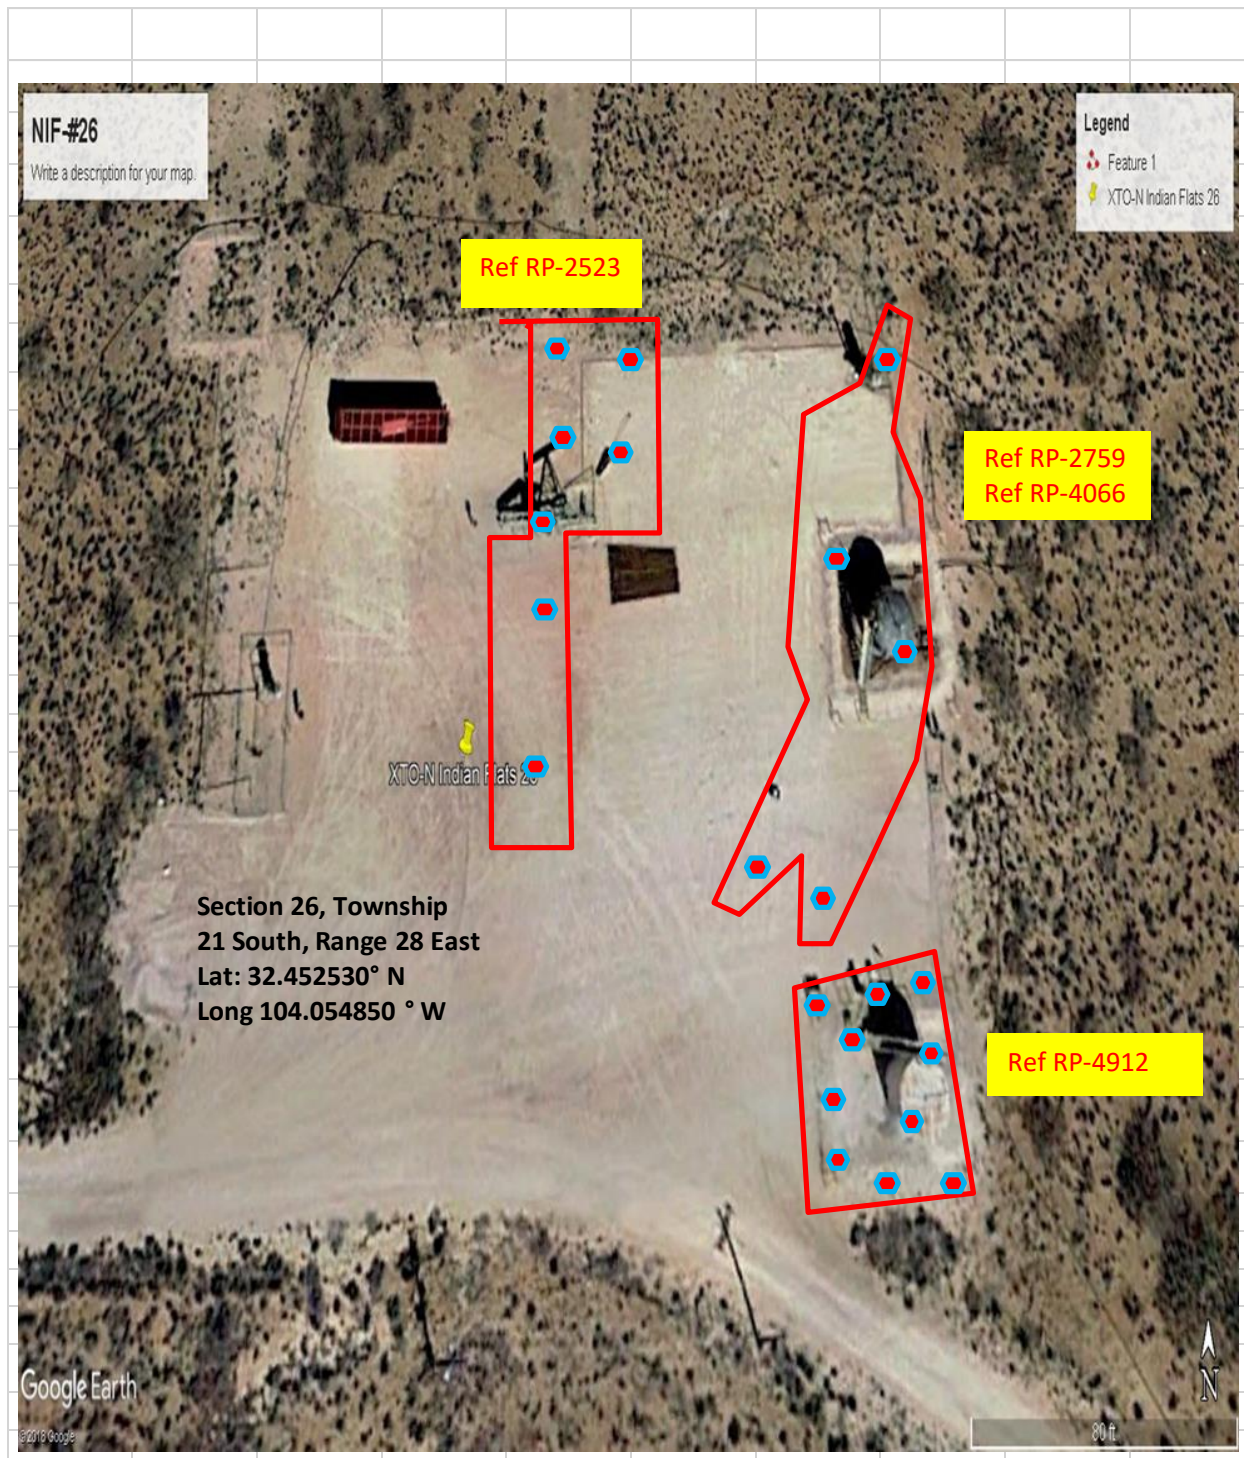
## Aerial of Location and Sampling Plots

PJ7-North Wall-Composite	0-3'	5/16/2019	Dry	<0.00199	<0.00199	<0.00199	<0.00199	<0.00199	<14.9	<14.9	<14.9	<14.9	4.99	
S1-North Area-Composite	0-3'	5/16/2019	Dry	<0.00202	<0.00202	<0.00202	<0.00202	<0.00202	<15.0	<15.0	<15.0	<15.0	7.72	
S2-East Center Area	0-3'	5/16/2019	Dry	<0.00199	<0.00199	<0.00199	<0.00199	<0.00199	<15.0	<15.0	<15.0	<15.0	5.01	
S3-South Center	0-3'	5/16/2019	Dry	<0.00200	<0.00200	<0.00200	<0.00200	<0.00200	<15.0	<15.0	<15.0	<15.0	5.02	
S4-S.E Leg	0-3'	5/16/2019	Dry	<0.00199	<0.00199	<0.00199	<0.00199	<0.00199	<15.0	<15.0	<15.0	<15.0	4.99	
S5-S.W Leg	0-3'	5/16/2019	Dry	<0.00199	<0.00199	<0.00199	<0.00199	<0.00199	<15.0	<15.0	<15.0	<15.0	5.03	
NMOCD Criteria				<10mg/kg				<50mg/kg				<100mg/kg	<600mg/kg

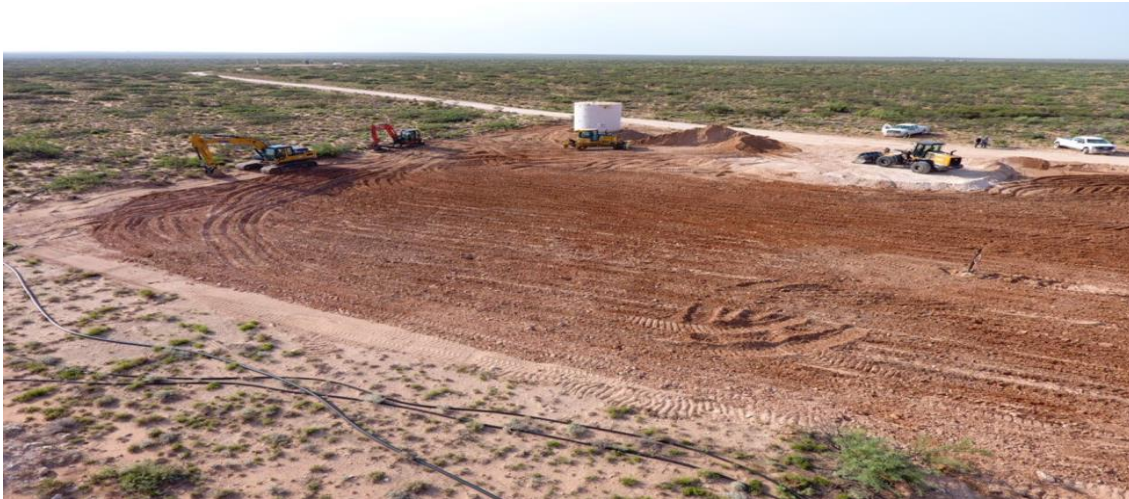
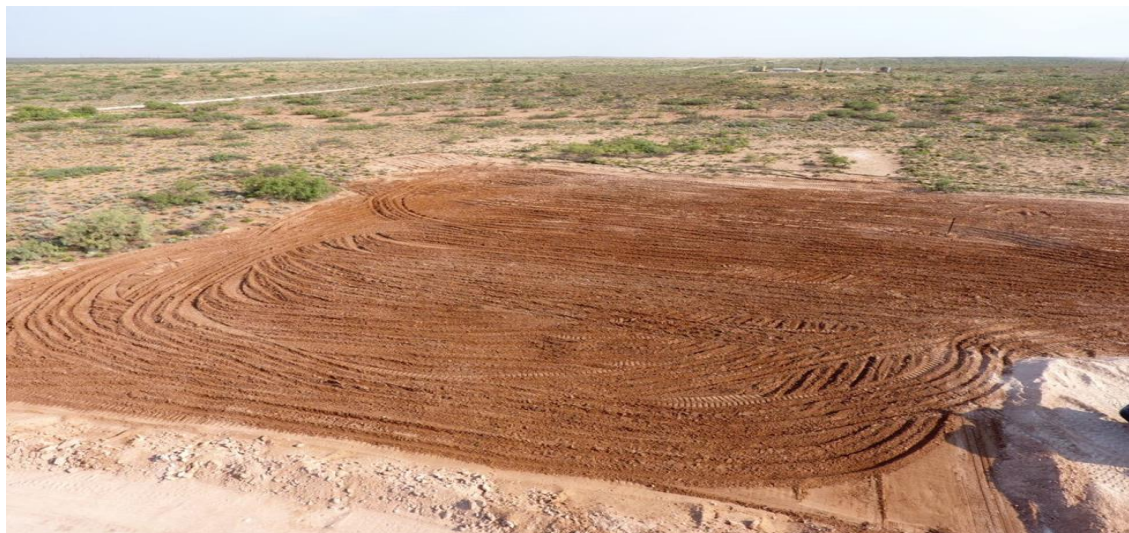
## Closure Photo Gallery

Following Remediation, this final summary report was prepared to document the project in its entirety for **XTO Energy** to submit a no further action release request to the New Mexico Oil Conservation Division (NMOCD). Additional submittal may be requested by the Bureau of Land Management (BLM). This final closure report documents the execution of the remedial services performed. An aerial map illustrates the area affected by the spill occurrence; locations of remedial sampling to delineate the impacts, and sampling locations to confirm successful remediation. Areas of contamination identified in the analytical process were vertically and horizontally delineated. Post-remediation sampling data indicates the site meets compliance with NMOCD standards and confirms no remaining soils exceeds elevated contamination levels.

HydroChemPSC recommends XTO Energy provide the NMOCD District Office and the BLM a copy of this Remediation Summary & Site Closure Request. HydroChemPSC on behalf of XTO Energy request closure of the RP files.
